PNGL Wairoa – Gisborne 296.3 - 390.5km Track Formation Repair Works Civil Construction Work Packages 30%Design & Pricing – October 2019

Date: 10th October 2019

Project: FGL 1331

Prepared by: Maurice Fraser - Fraser Geologies Ltd

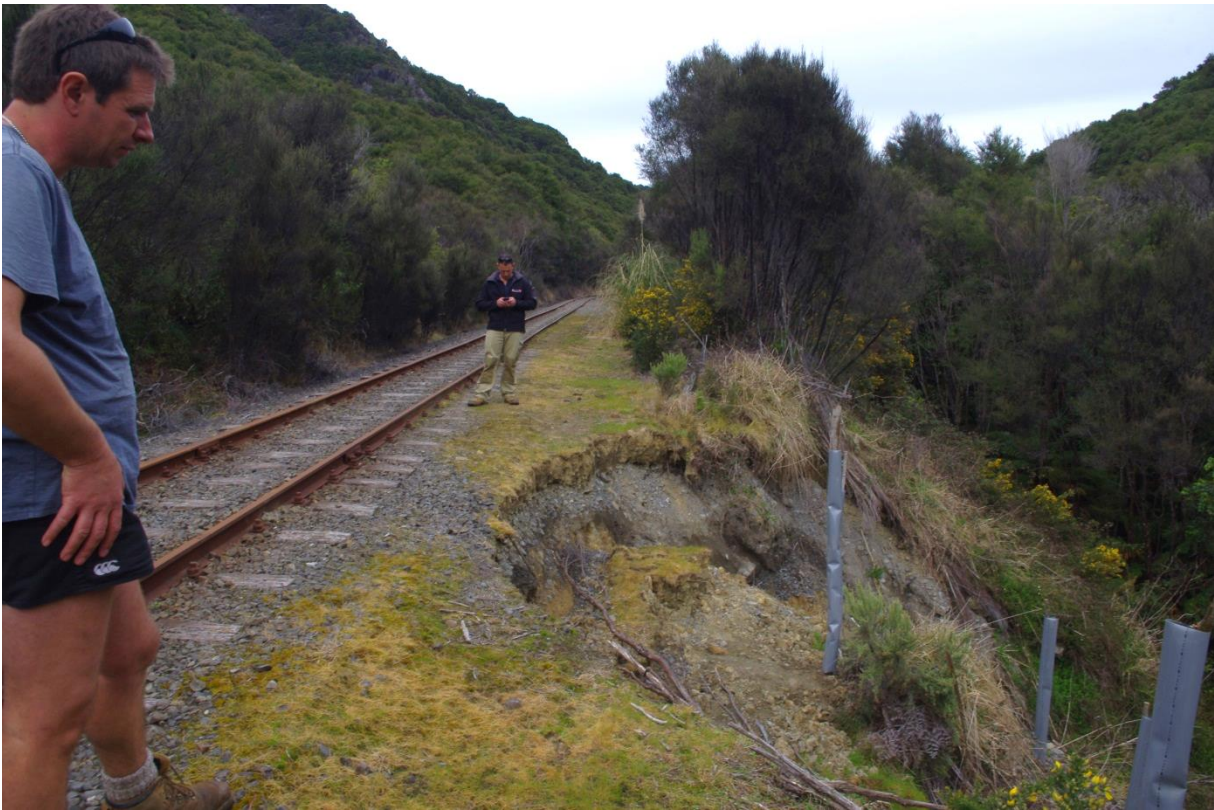
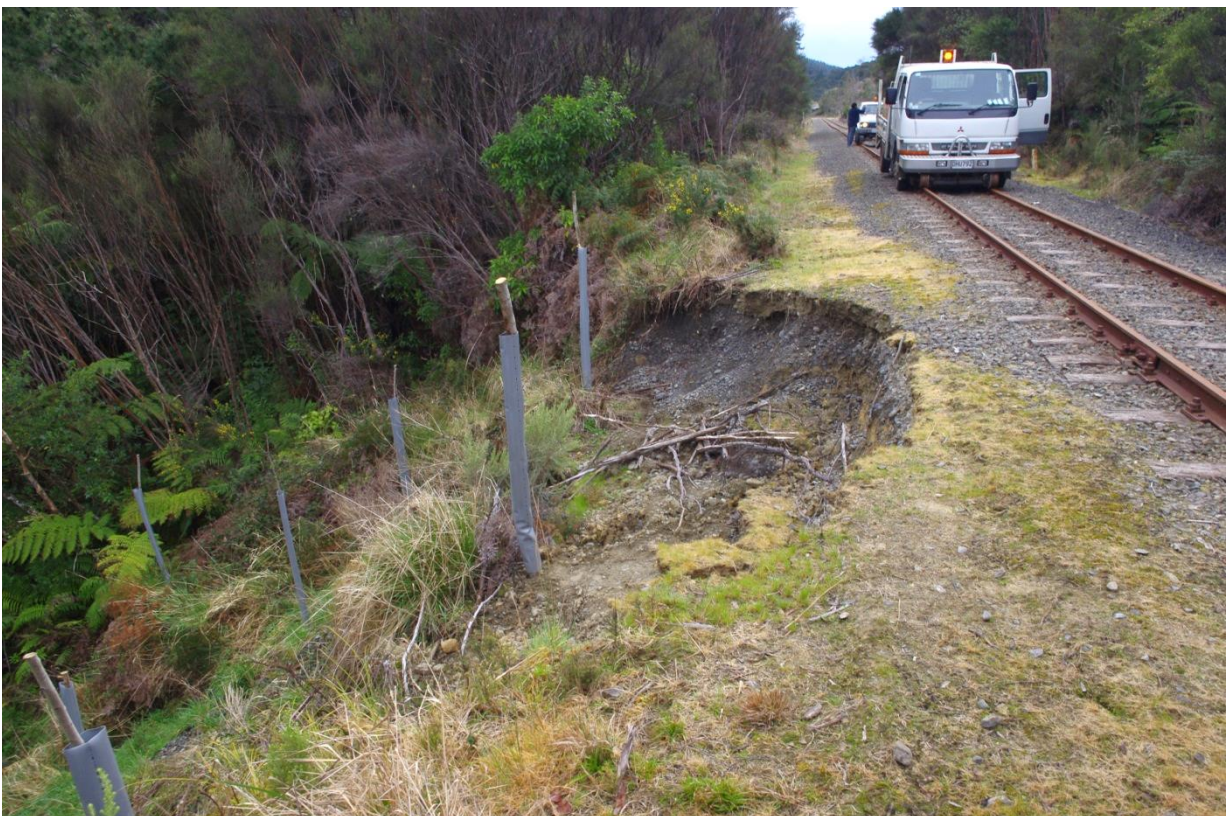
Embankment Slip 2 - 2013 Photos

Task 2 – Embankment Slip 2
Track Location:	Rail Chainage 361.11km
Description:	Short washout on embankment edge approx. 300m south of logging road level crossing off SH2 @ 361.40
Required Works	Driven H pile repair wall nominal 15m long, with timber lagging
Scale/ Scope/Volumes:	Driven H pile repair wall nominal 15m long, with timber lagging Allow driven 250UC73 @ 800 centres, 9m deep with 200*50 H5 timber lagging installed behind rear flange. Nominal trackside retained height 2.5m with sloping embankment toe.
Construction Comment:	Design TBC - steel section sizing to be confirmed. Driven pile design adopted on basis of driving into embankment filling and avoiding drilling works and concrete supply into corridor. Note causes of slope failure to be assessed - considered to be due to combination of over topping surface runoff and toe erosion but TBC
Designer Comment:	Alternative drill & concrete (600mm with temporary casing) as well as walers & tiebacks if required. Timber lagging as required – retention is primarily from arching between steel uprights at close driven centres however significant dropout volume will require backfilling with GAP65 Steel sections not galvanised

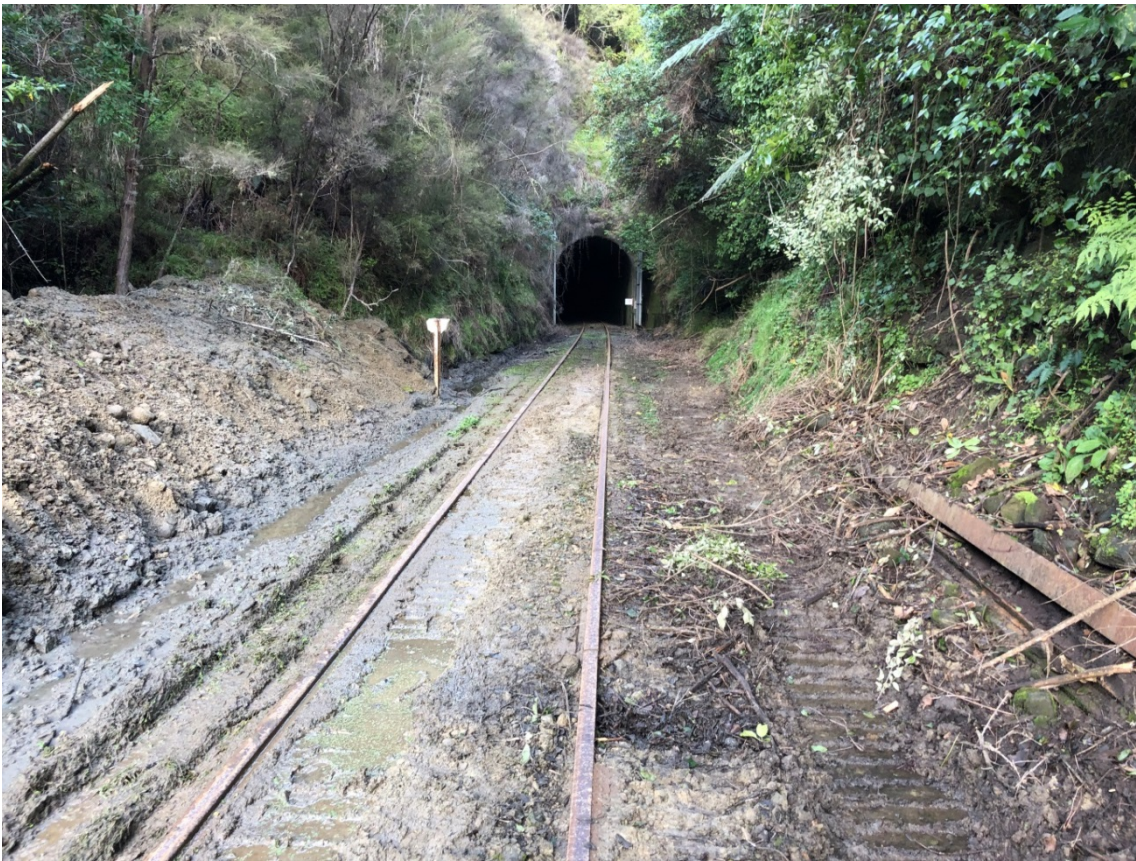
Temporary drainage works undertaken in week of 15 July 2019 – open up tunnel drainage, stockpile spoil against stream to confine sediment to channel and stop water flooding over track. Note significant groundwater drainage flowing out of exposed ballast.

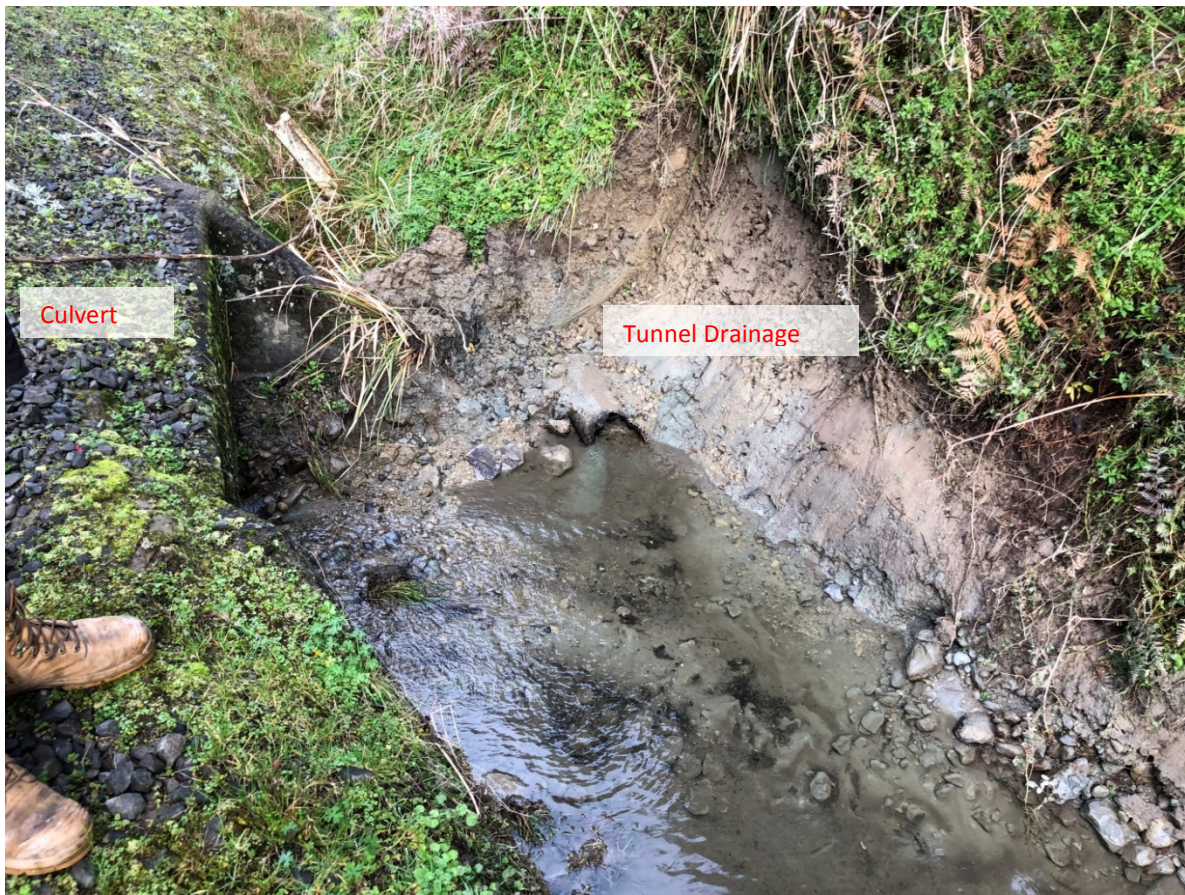
Uncovered tunnel drainage on western side of formation, plus flow through culvert under track.

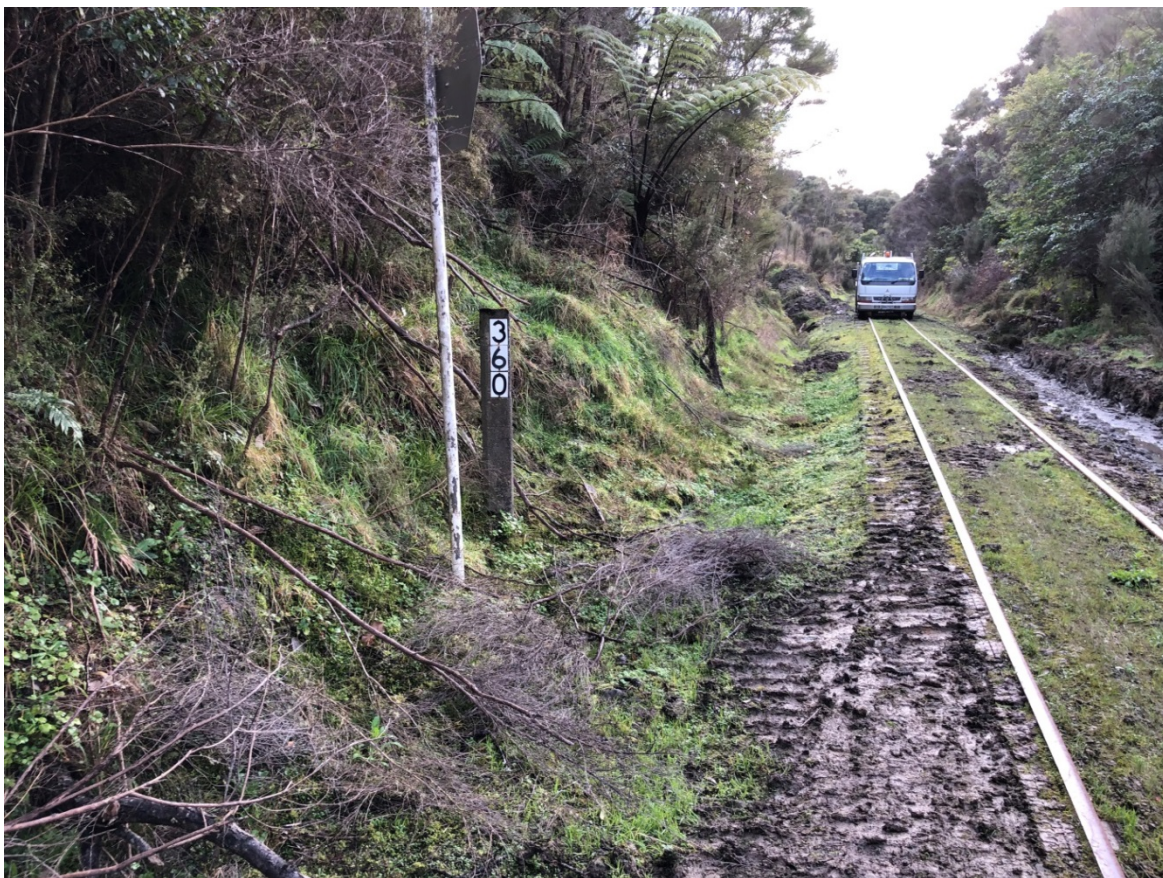
Designer Comment:	Existing culvert @360.03km logged as 1.2* 1.2 box - this is 50% blocked with sediment, swales require deepening. Max capacity 5.1m ³ /s at track level surcharge flows.
Rail Operations:	Work trains past site, including deliveries for Beach Loop dropouts.

View looking north, existing culvert crossing in front of truck, new culvert immediately downstream of this

Repair Task:	Task 3 – Wharekakaho Tunnel 26 North Portal
Track Location:	Rail Chainage 359.93km
Description:	Northern Tunnel Portal Drainage Works
Required Works	Northern Tunnel Portal Drainage Works
Scale/ Scope/Volumes:	<p>Excavate out and reinstate swales coming out from tunnel portal. Nominal 60m of swale deepening & widening required to accommodate existing culvert depth.</p> <p>Install larger secondary culvert where stream crosses under track - allow new 1350mm diameter culvert nominal 10 m long (TBC)</p> <p>Extend and deepen bypass and overflow swales down both sides of formation.</p> <p>Widen stream channel on eastern side and dig back into slope to provide more sediment catch area.</p>
Construction Comment:	<p>Inspect ground above tunnel - there is around 1.8km² of area to west of tunnel and not clear on site where the drainage for this runs - possibly over top of tunnel or approx. 50m to north of track alignment.</p> <p>May require access track to be constructed up onto western side of tunnel and clean out of areas.</p> <p>Existing culvert partially blocks with material coming down stream channel, larger / additional culvert required.</p>

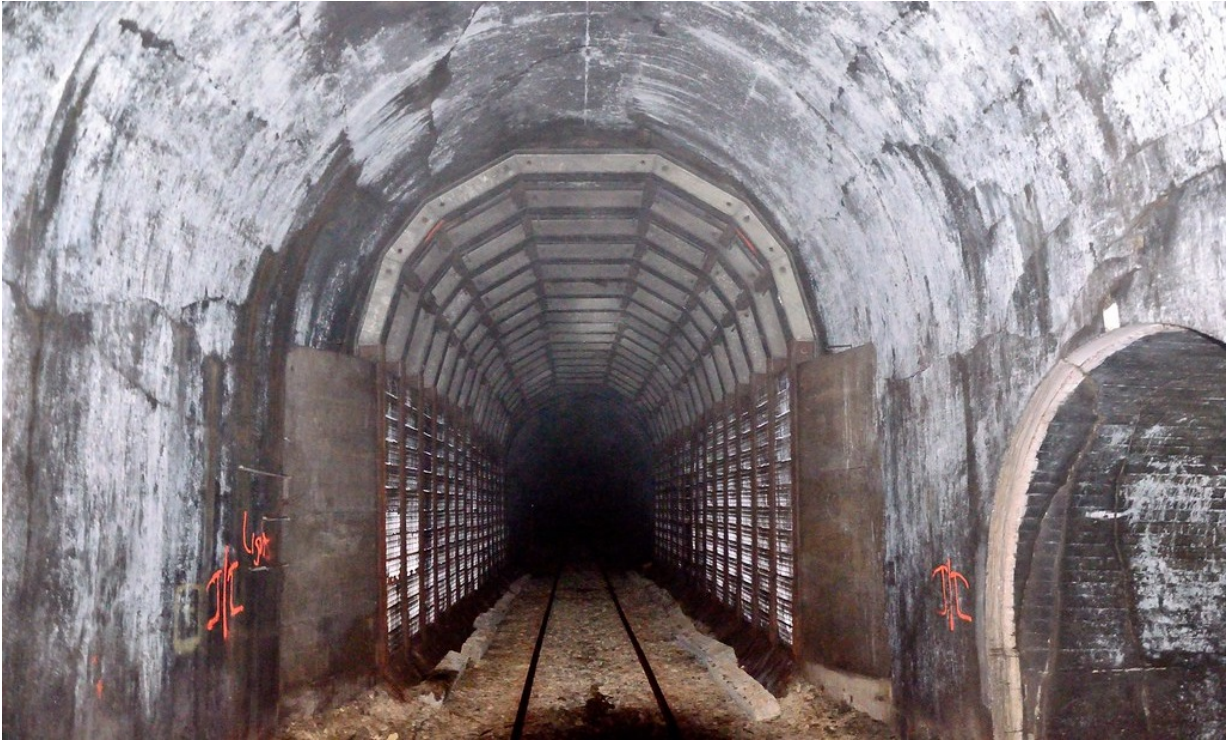
Photo showing lining support at approx. track meterage 359.4km (TBC). Track has also been lowered to allow passage for high cube containers at this location.

Repair Task:	Task4 – Wharekakaho Tunnel 26 Lining
Track Location:	Rail Chainage 359.29km (nominal)
Description:	Crackling in concrete tunnel lining
Required Works	Allow for baseline lazer scan survey through tunnel (Woods Consultants) as part of track reopening works.
Scale/ Scope/Volumes:	Assess concrete lining cracking - has been in place for nearly 80 years, in good condition for age. No physical works anticipated
Construction Comment:	Assess concrete lining cracking - has been in place for nearly 80 years, in good condition for age. No physical works anticipated
Designer Comment:	
Rail Operations:	Survey works early in program – no work trains expected during survey operations.

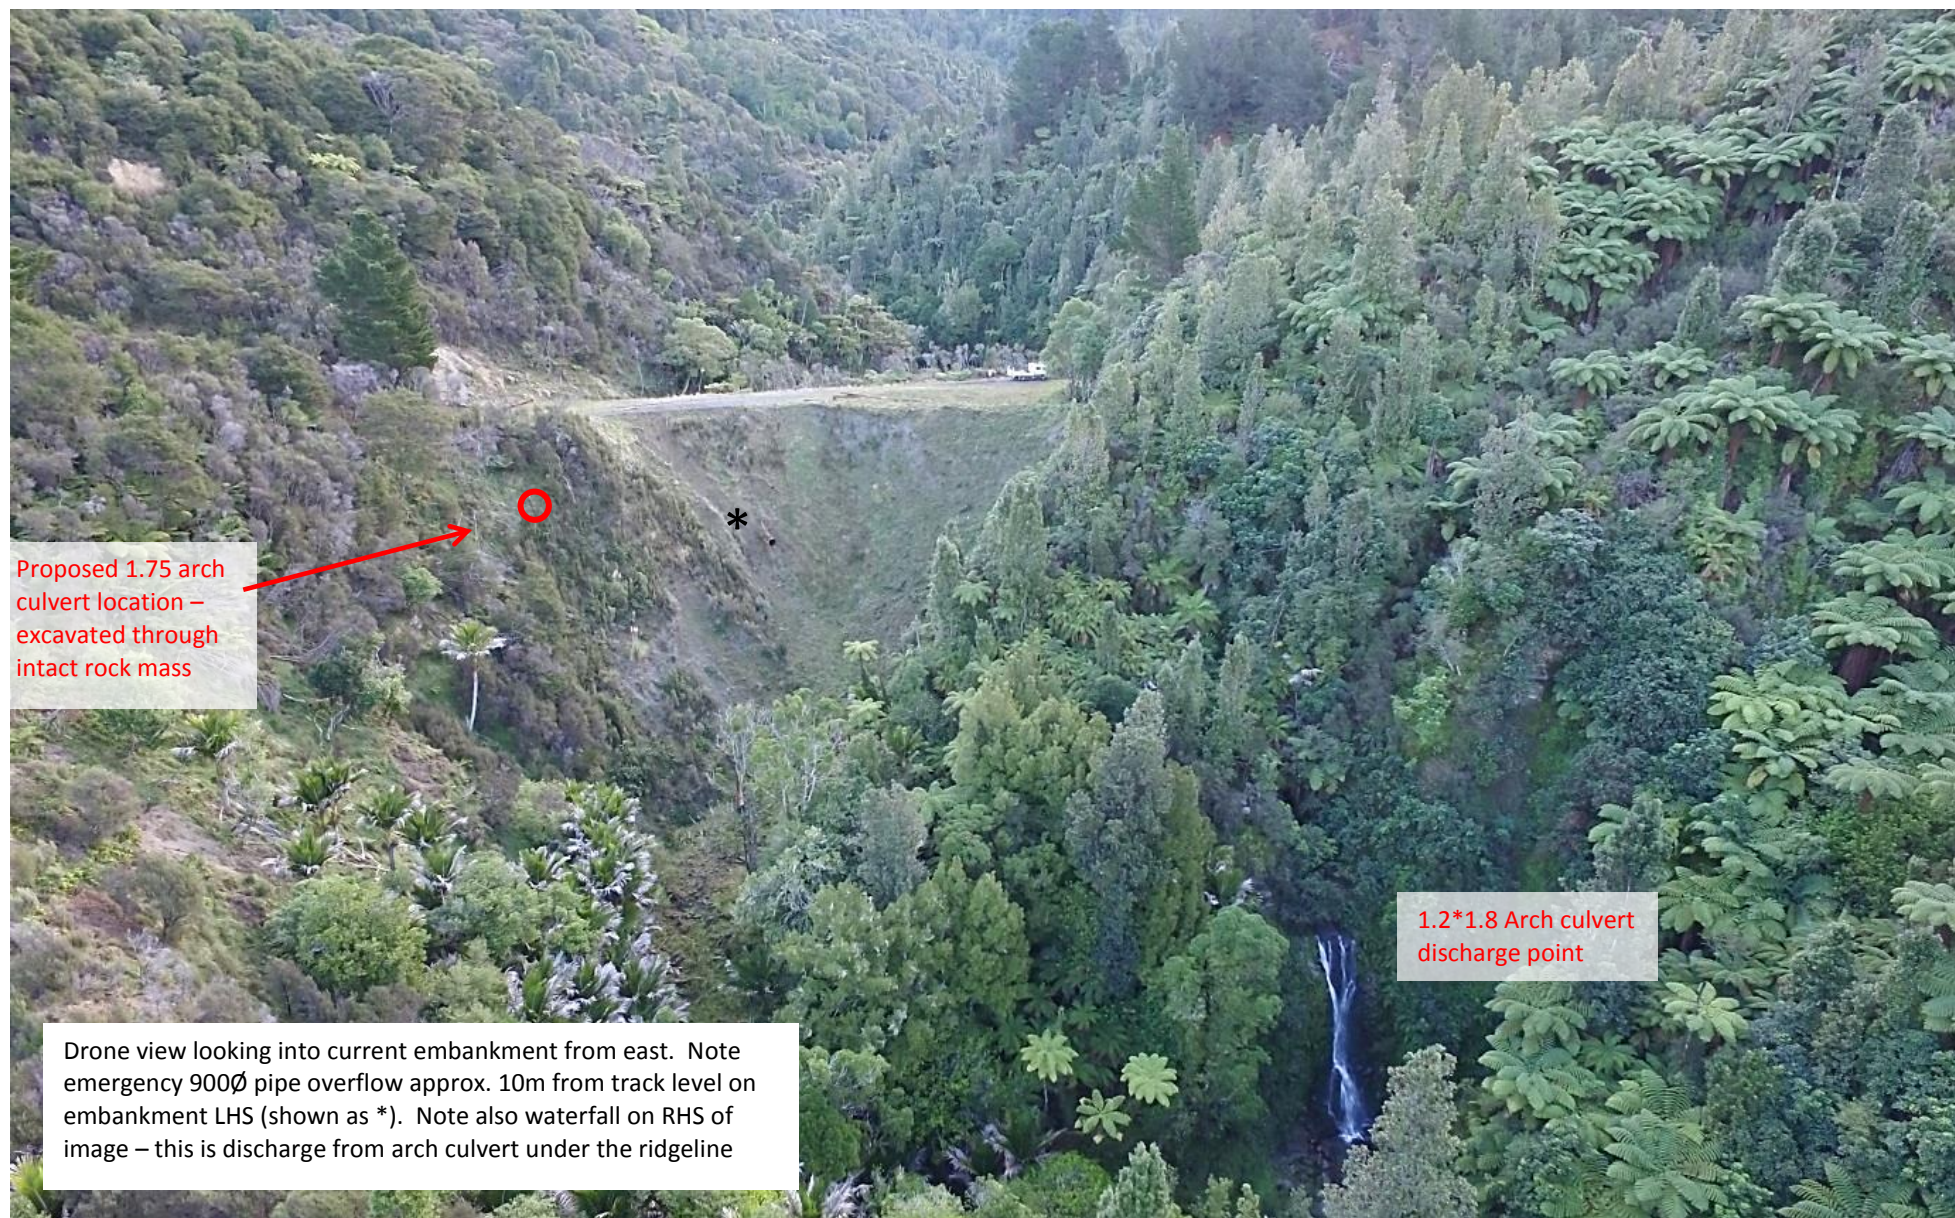
Proposed 1.75 arch
culvert location –
excavated through
intact rock mass

1.2*1.8 Arch culvert
discharge point

Drone view looking into current embankment from east. Note emergency 900Ø pipe overflow approx. 10m from track level on embankment LHS (shown as *). Note also waterfall on RHS of image – this is discharge from arch culvert under the ridgeline

Construction Comment:	Rebuild buttress fill against pinnacle embankment using Paragrid reinforced MSE slopes. Setup area as spoil dump site for surplus materials from Beach Loop and material excavated from northern end of Wharekakaho tunnel - use DBM side tip wagons Allow to slew track westward (1-3m) to ease tight radius curve on top of current embankment. Allow to excavate cutting slopes on southern end of site to allow for track slew and supply buttress fill material. Allow for new high level secondary inlet on existing 1.2*1.8 tunnel drainage under ridge line (1500/1800Ø vertical manhole drilled down onto tunnel or similar). Allow for repair of emergency 900 Ø overflow works -recover pipes in downstream washout and reinstate with additional rip rap outlet protection. Allow for additional high level 1750Ø arch culvert for balance of Q ₁₀₀ flood capacity as well as additional flow capacity in event of partial base flow blockage.

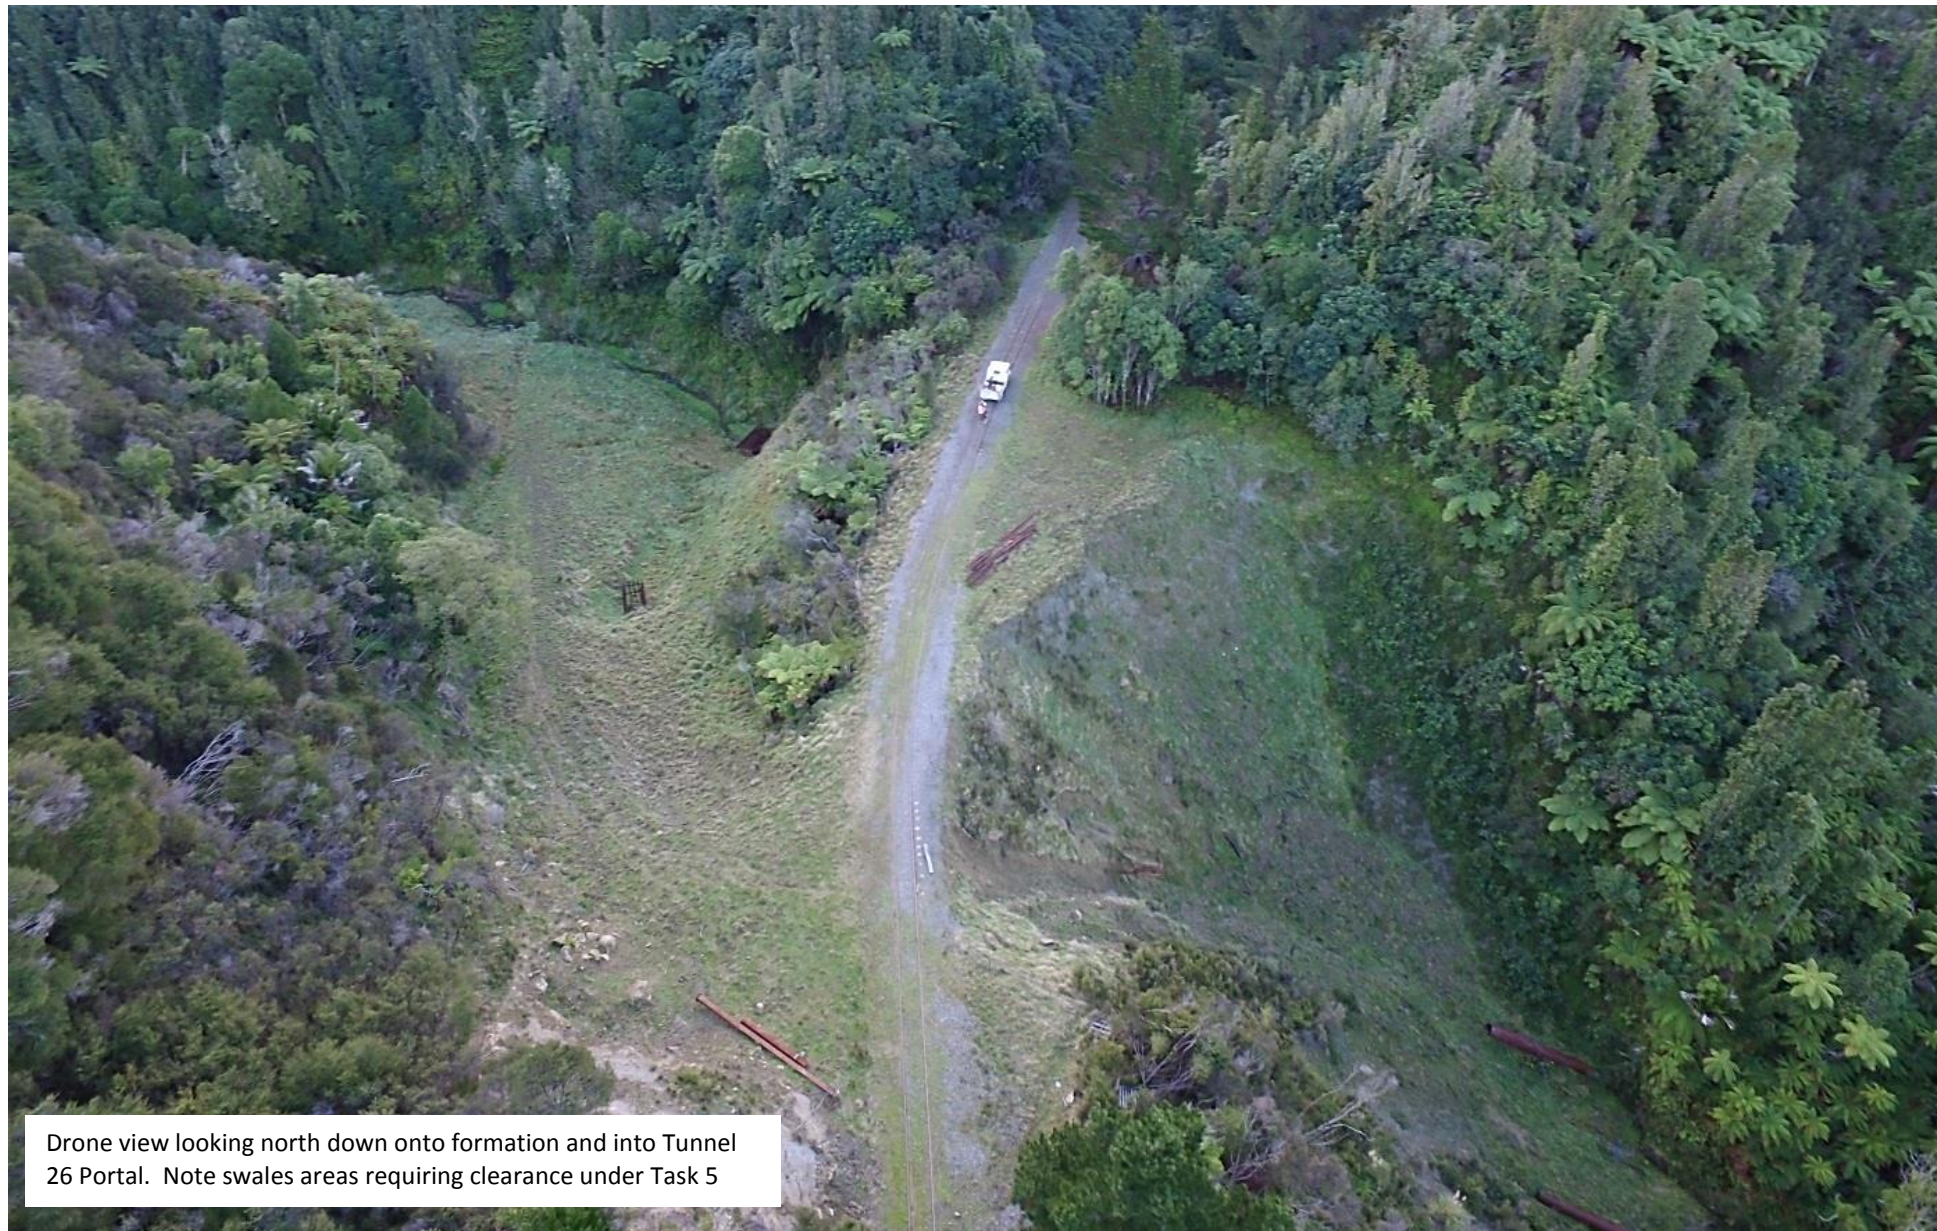
Drone view looking north down onto formation and into Tunnel 26 Portal. Note swales areas requiring clearance under Task 5

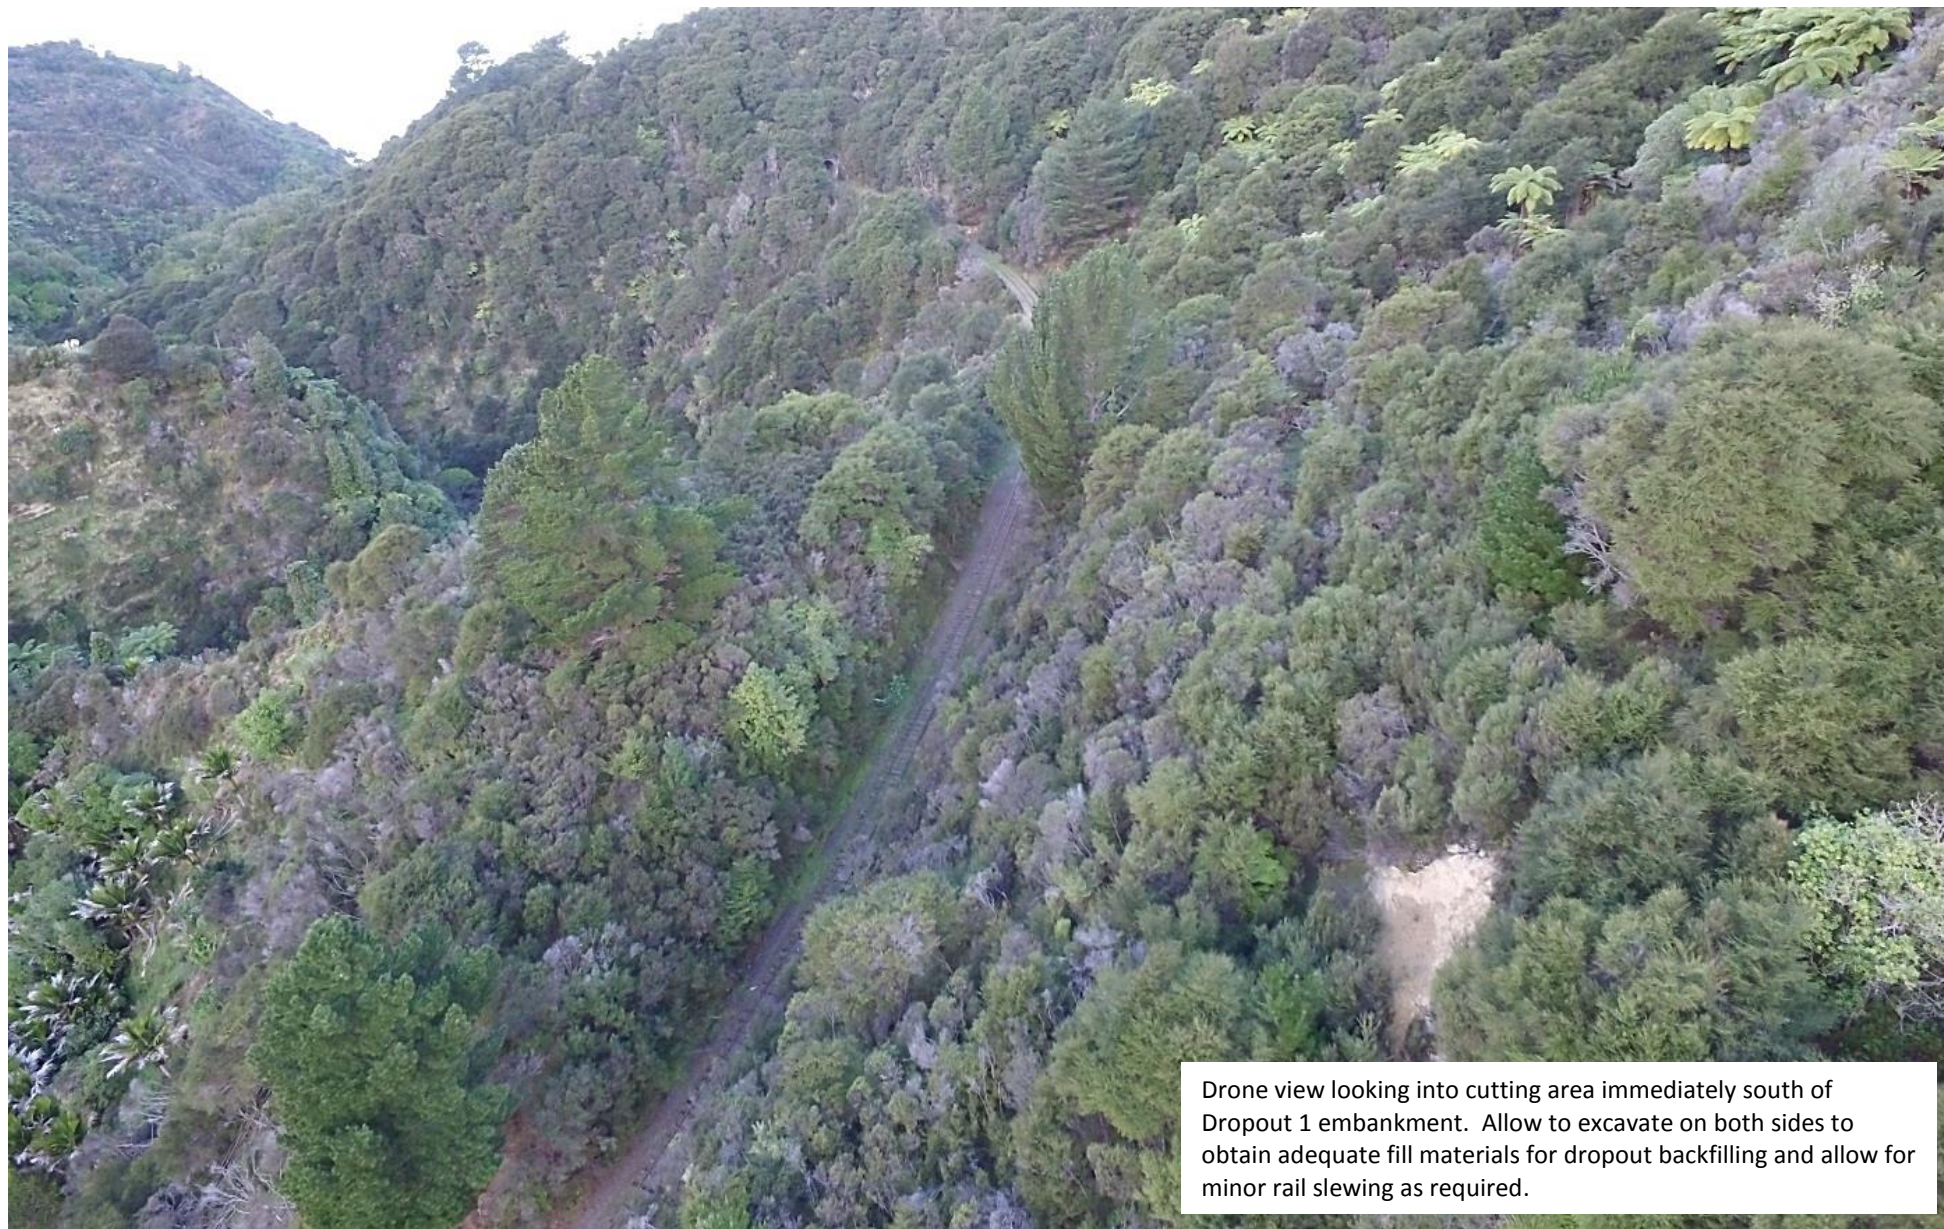
Drone view looking into cutting area immediately south of Dropout 1 embankment. Allow to excavate on both sides to obtain adequate fill materials for dropout backfilling and allow for minor rail slewing as required.

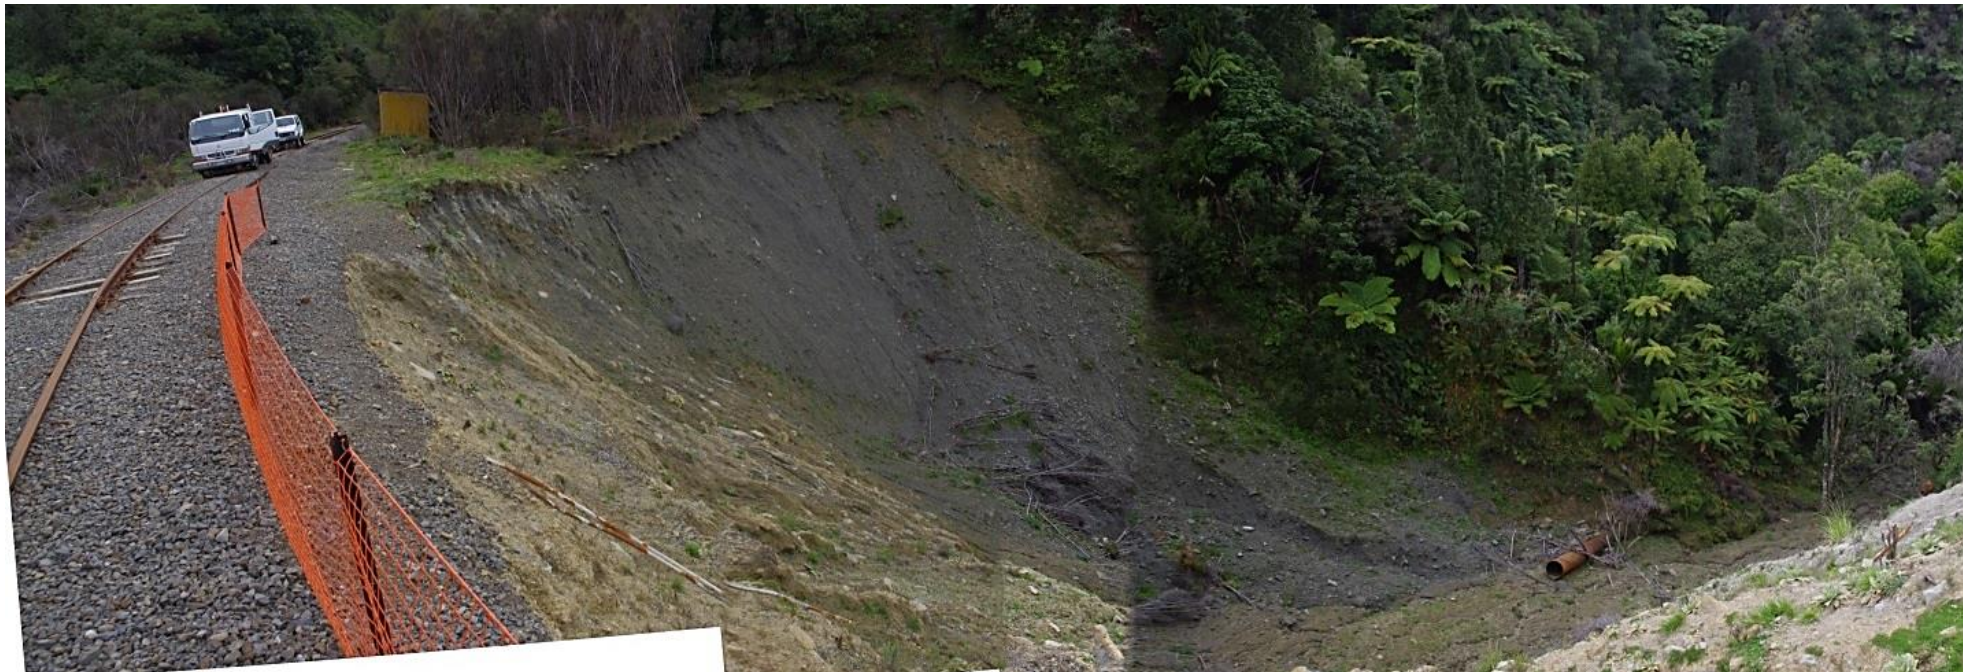
2013 photos stitched together looking into northern side face. Note washed out 900Ø pipe sections in base washout, substantial volumes of spoil washed away in 2012 event and evidence that multiple overtopping events have occurred based on vegetation growth on ridge facing

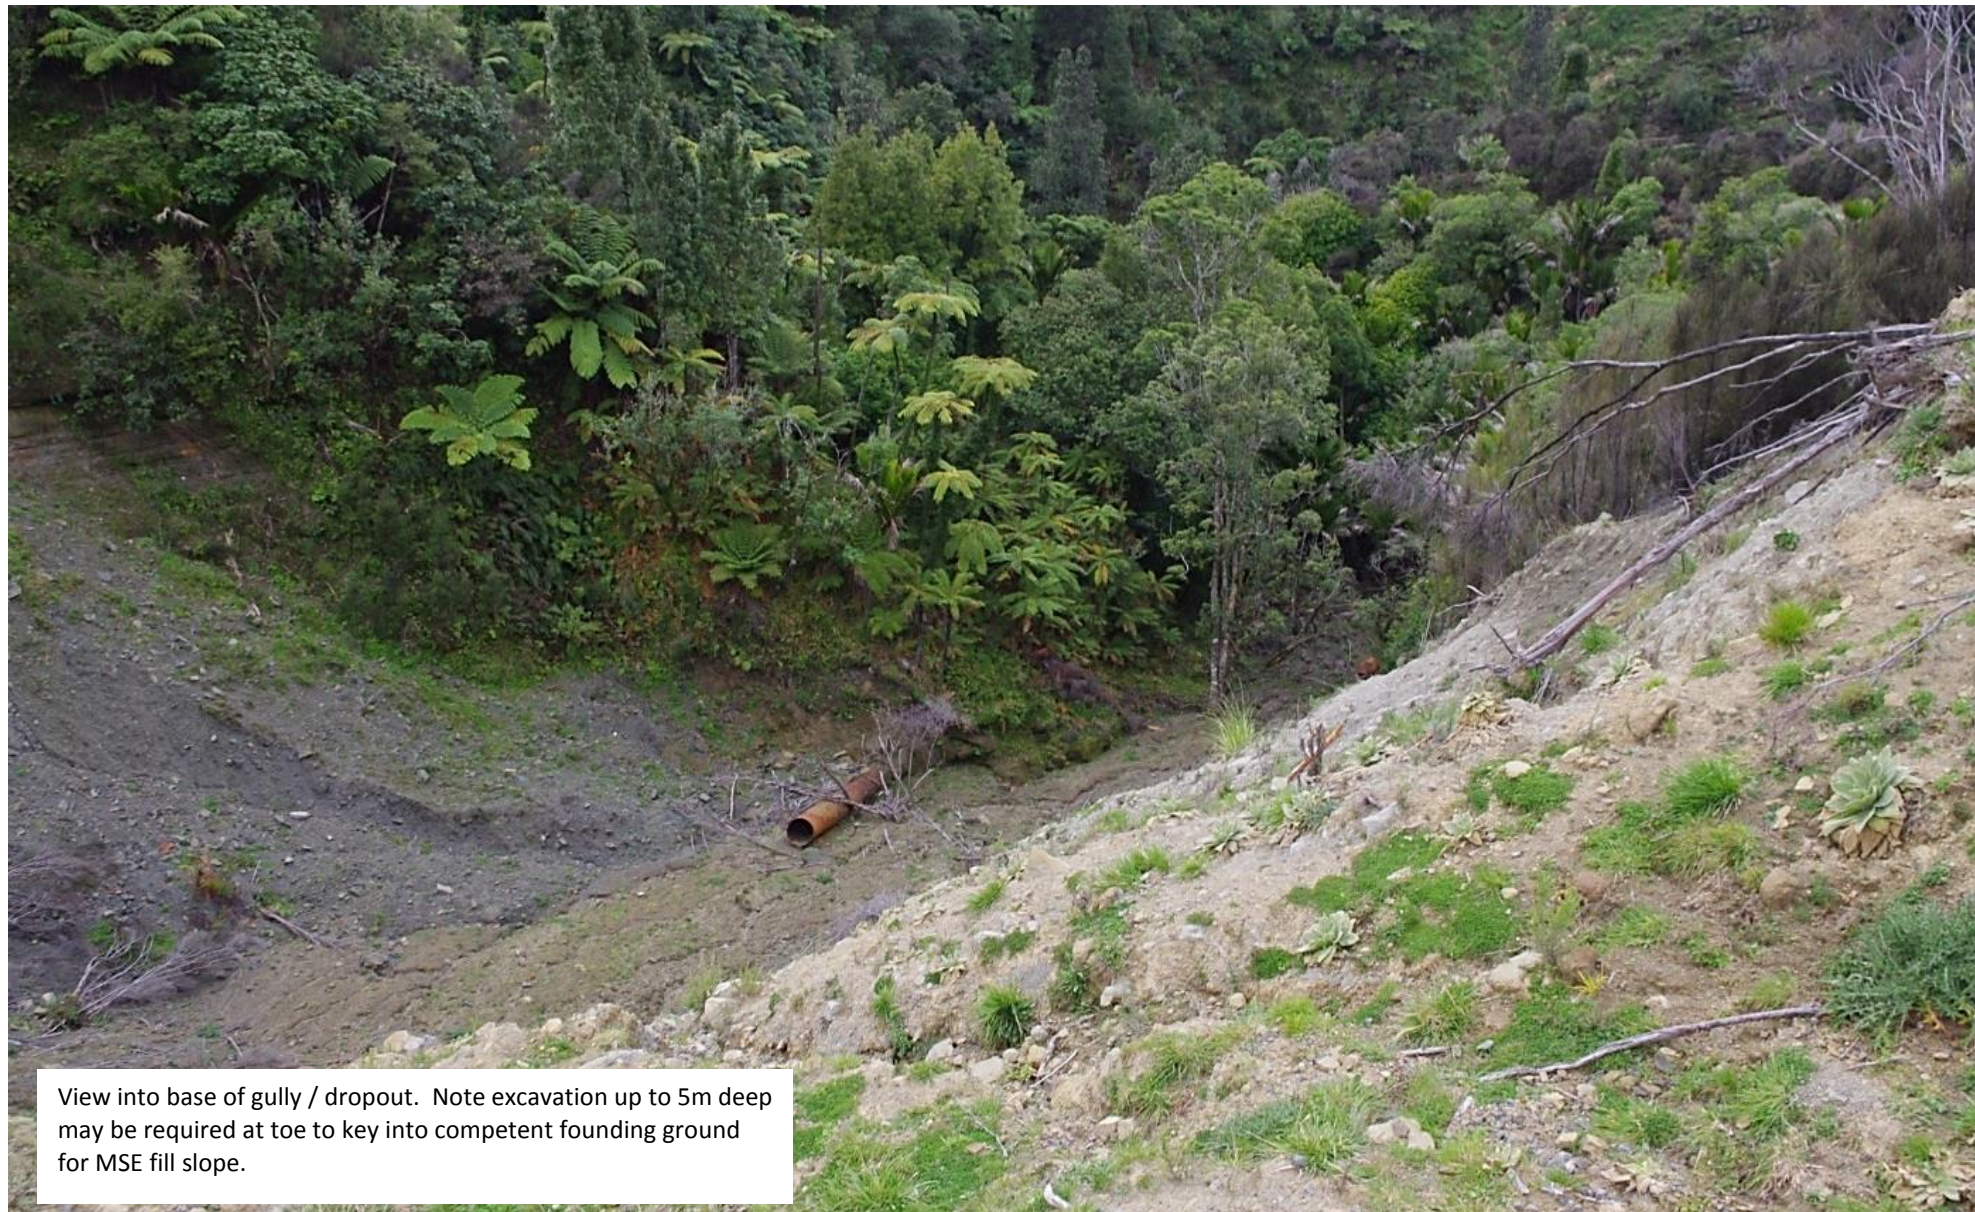
View into base of gully / dropout. Note excavation up to 5m deep may be required at toe to key into competent founding ground for MSE fill slope.

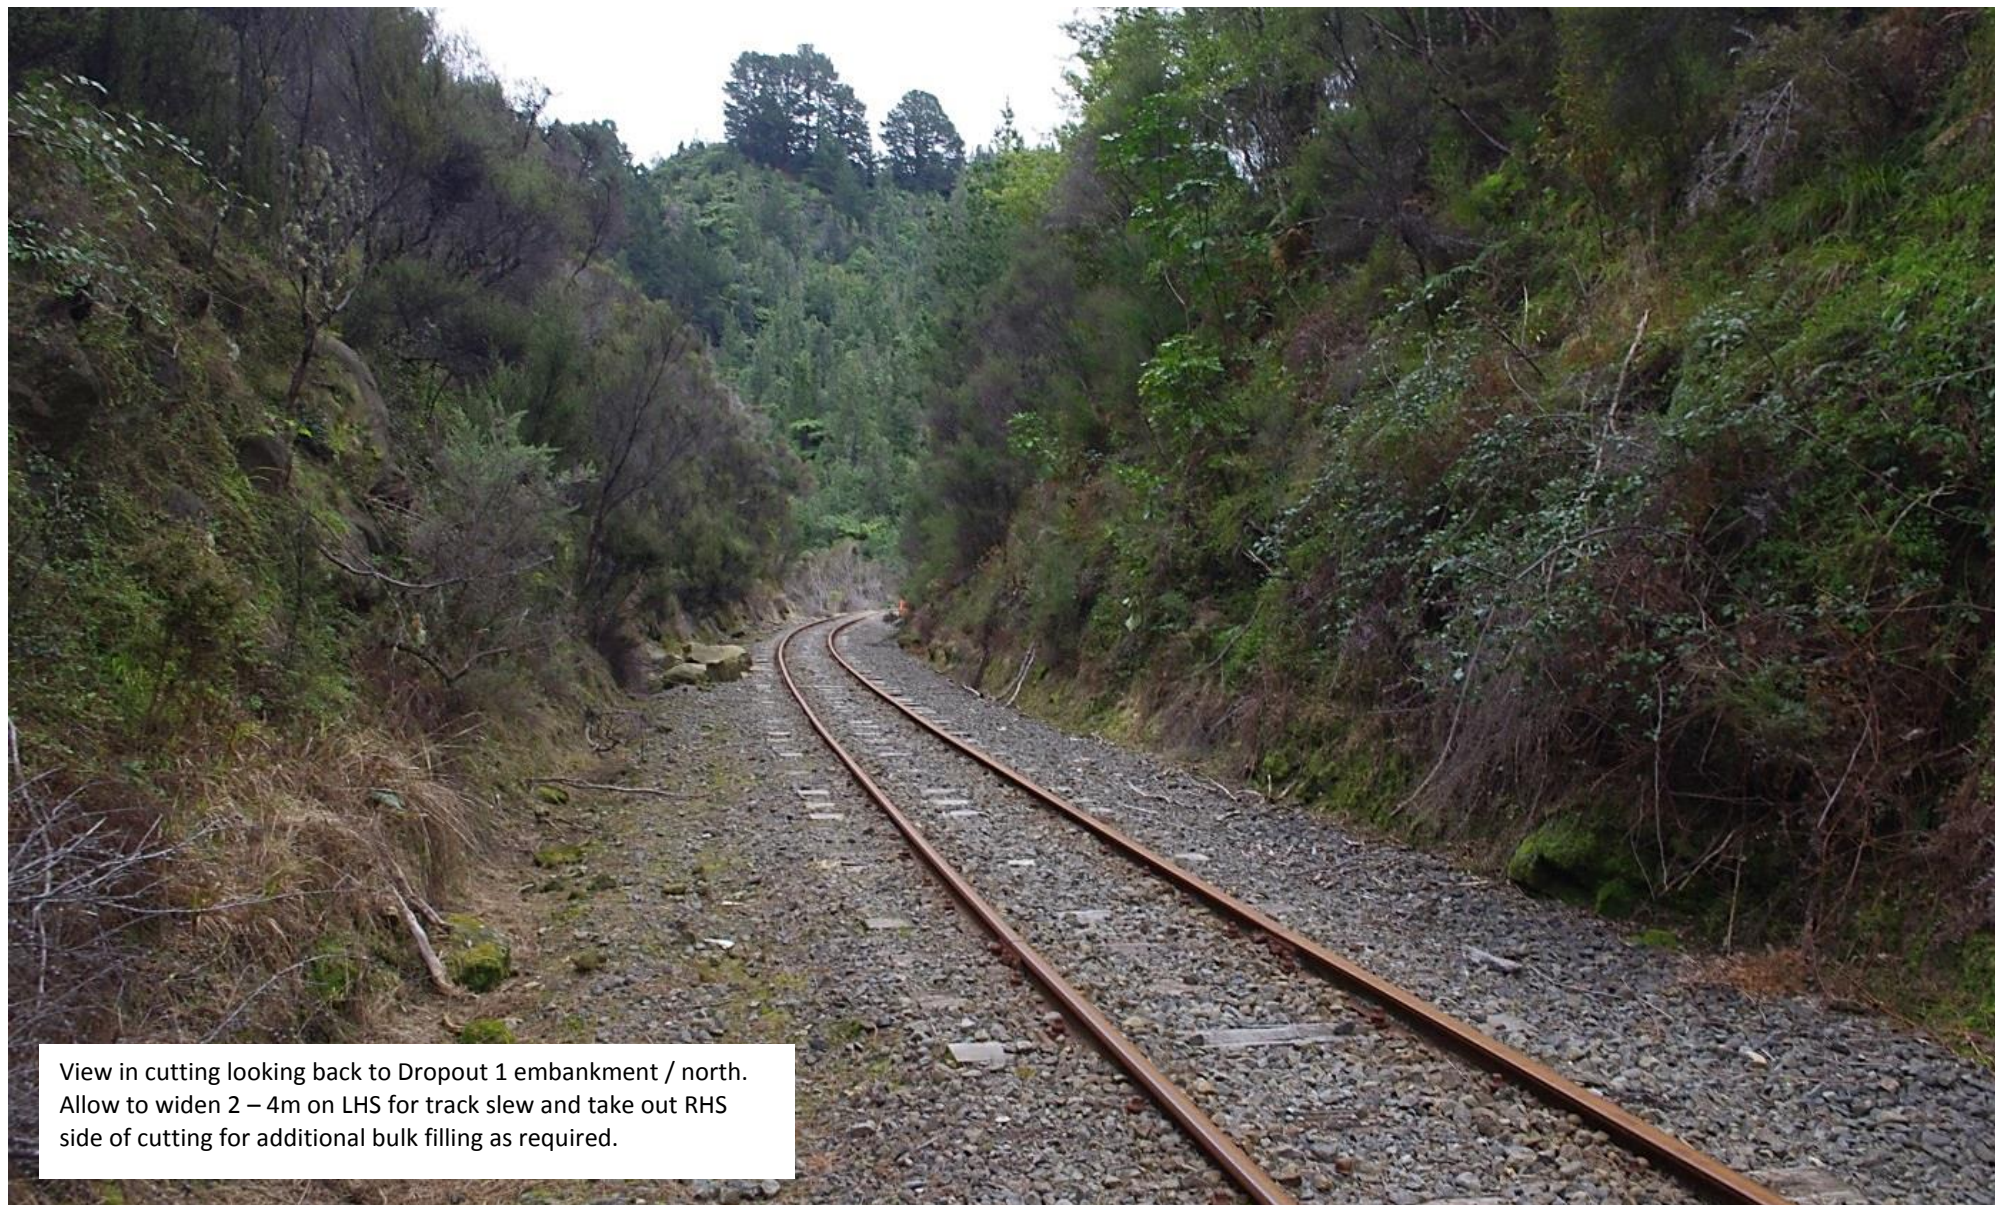
View in cutting looking back to Dropout 1 embankment / north.
Allow to widen 2 – 4m on LHS for track slew and take out RHS
side of cutting for additional bulk filling as required.

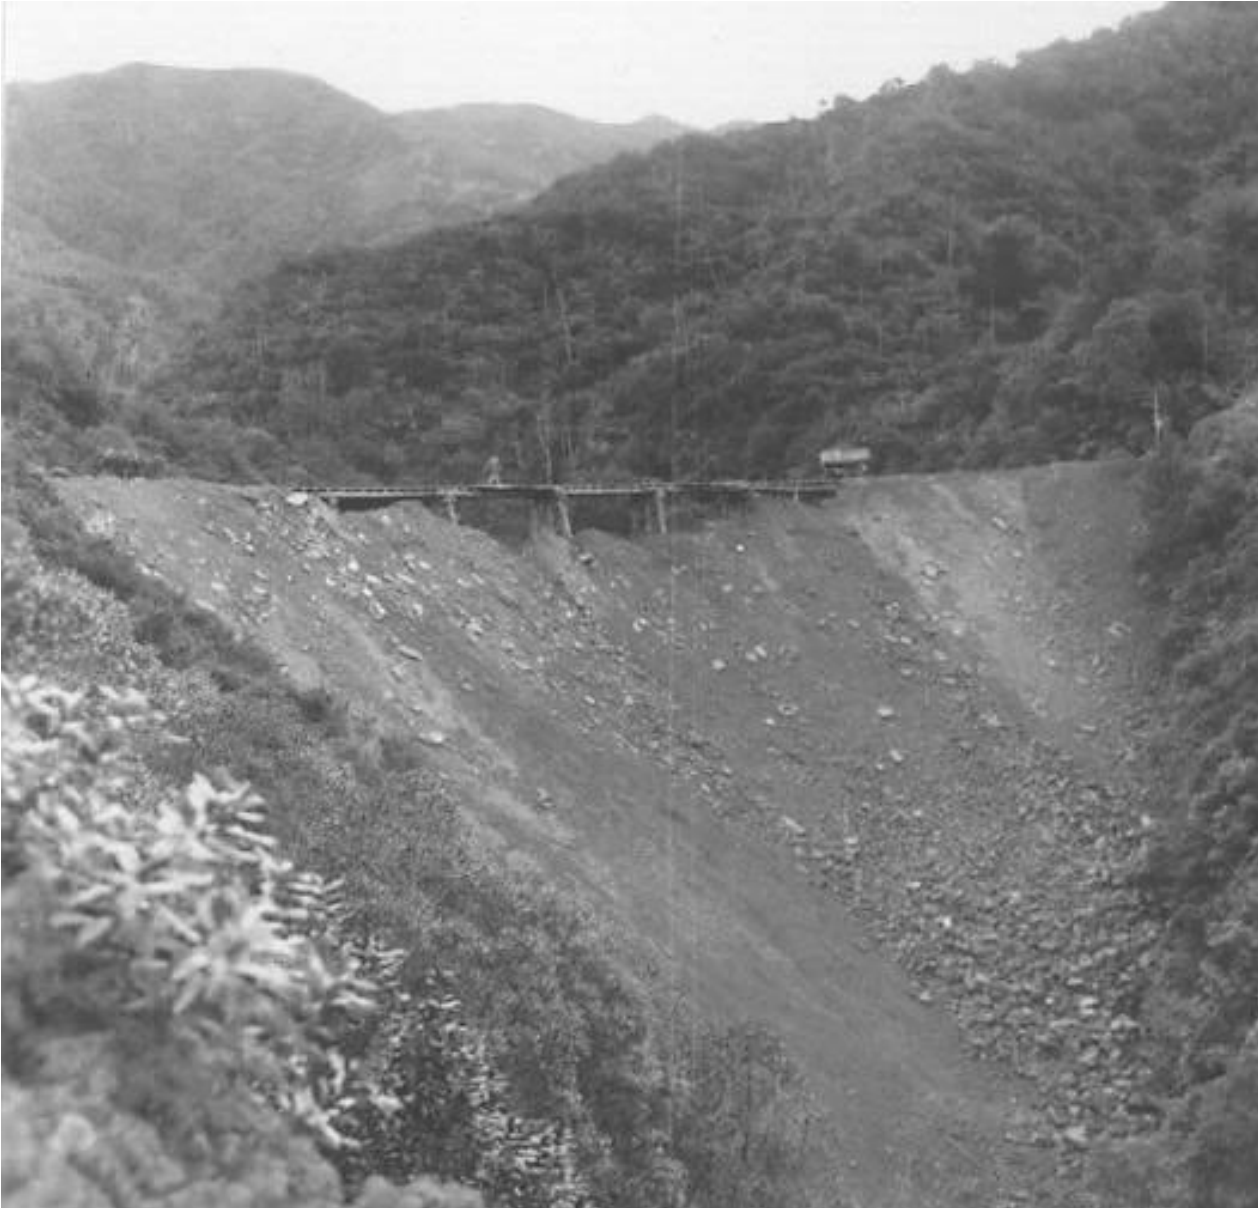
1936 historical photo during Wharekakaho Tunnel 26 construction – tunnel spoil was railed out over gully and then either bottom or side tipped to form unconsolidated embankment. Note photo is also good indication of typical excavated rockmass materials in other embankments and fills in Beach Loop and Kopuawhara Valley areas.
