PNGL Wairoa – Gisborne 296.3 - 390.5km Track Formation Repair Works Civil Construction Work Packages 30%Design & Pricing – October 2019

Date: 10th October 2019

Project: FGL 1331

Prepared by: Maurice Fraser - Fraser Geologies Ltd

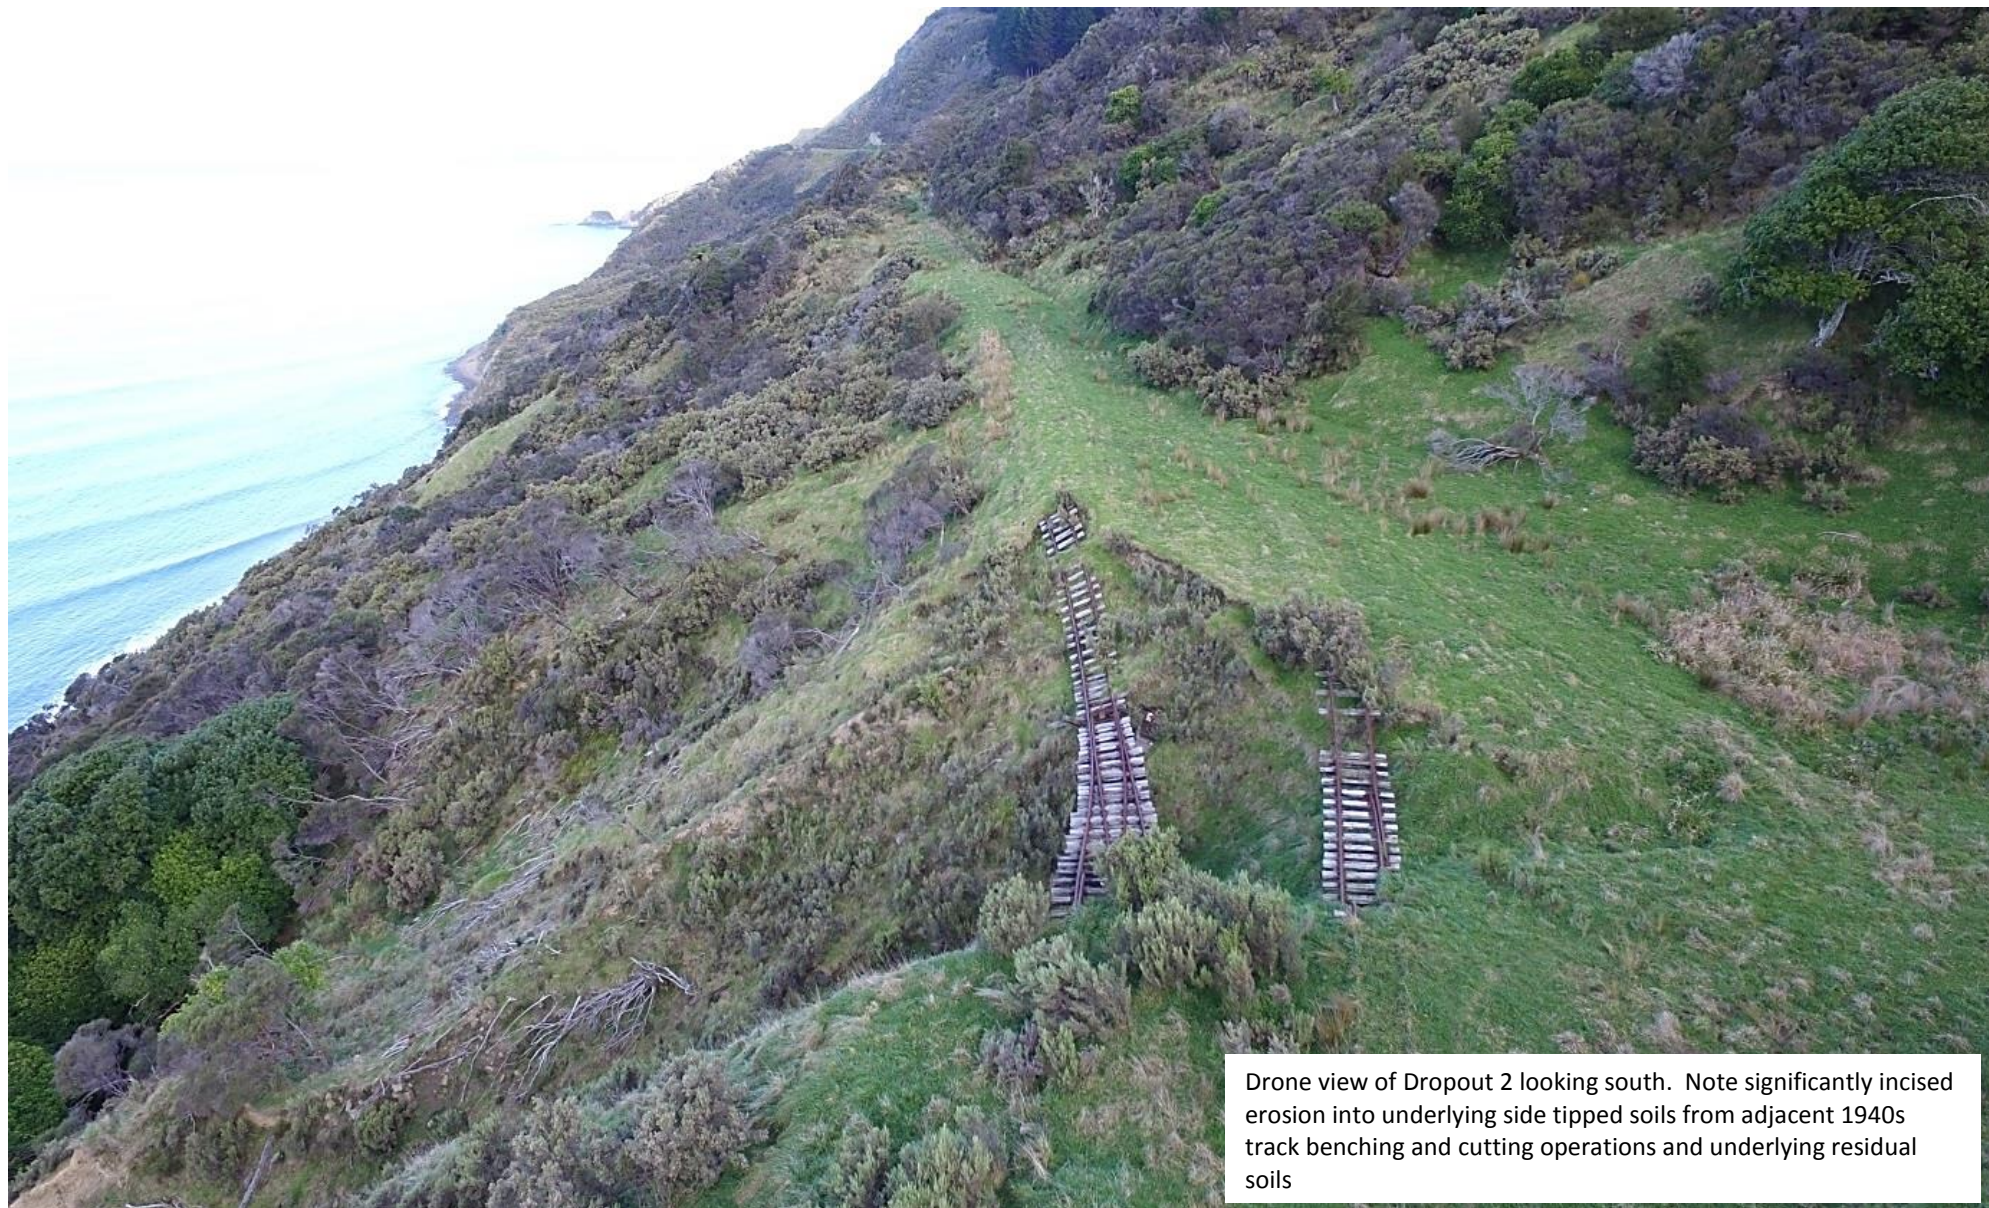
Drone view of Dropout 2 looking south. Note significantly incised erosion into underlying side tipped soils from adjacent 1940s track benching and cutting operations and underlying residual soils

Repair Task:	Task 7 - Dropout 2 Beach Loop
Track Location:	Rail Chainage 357.14km
Description:	Reshape and bench out the washout area prior to installing either a 2V:1H (63 degree) sloping Paragrid reinforced MSE slope faced off with hybrid 0.5m high gabion baskets filled with local site soils or a vertically faced retaining wall structure backfilled with Paraweb reinforced GAP 80/ 100 greywacke derived hardfill.
Required Works	As per description above
Scale/ Scope/Volumes:	Indicative MSE fill volumes are in the order of 5600m ³ for the retaining wall option and nominally 16000m ³ for the site fill option. (main difference is engineered fill performance under seismic shaking) Installation of a high level culvert inlet (nominal 1500/1800mm manhole riser with a scruffy dome top) set several metres downstream to provide a high level inlet into the base culvert Excavation of a pondage area to provide for some future spoil volume from periodic culvert maintenance and cleanout , improved entrance into the swale drain including cutting back of the ridgeline and some short culverting.

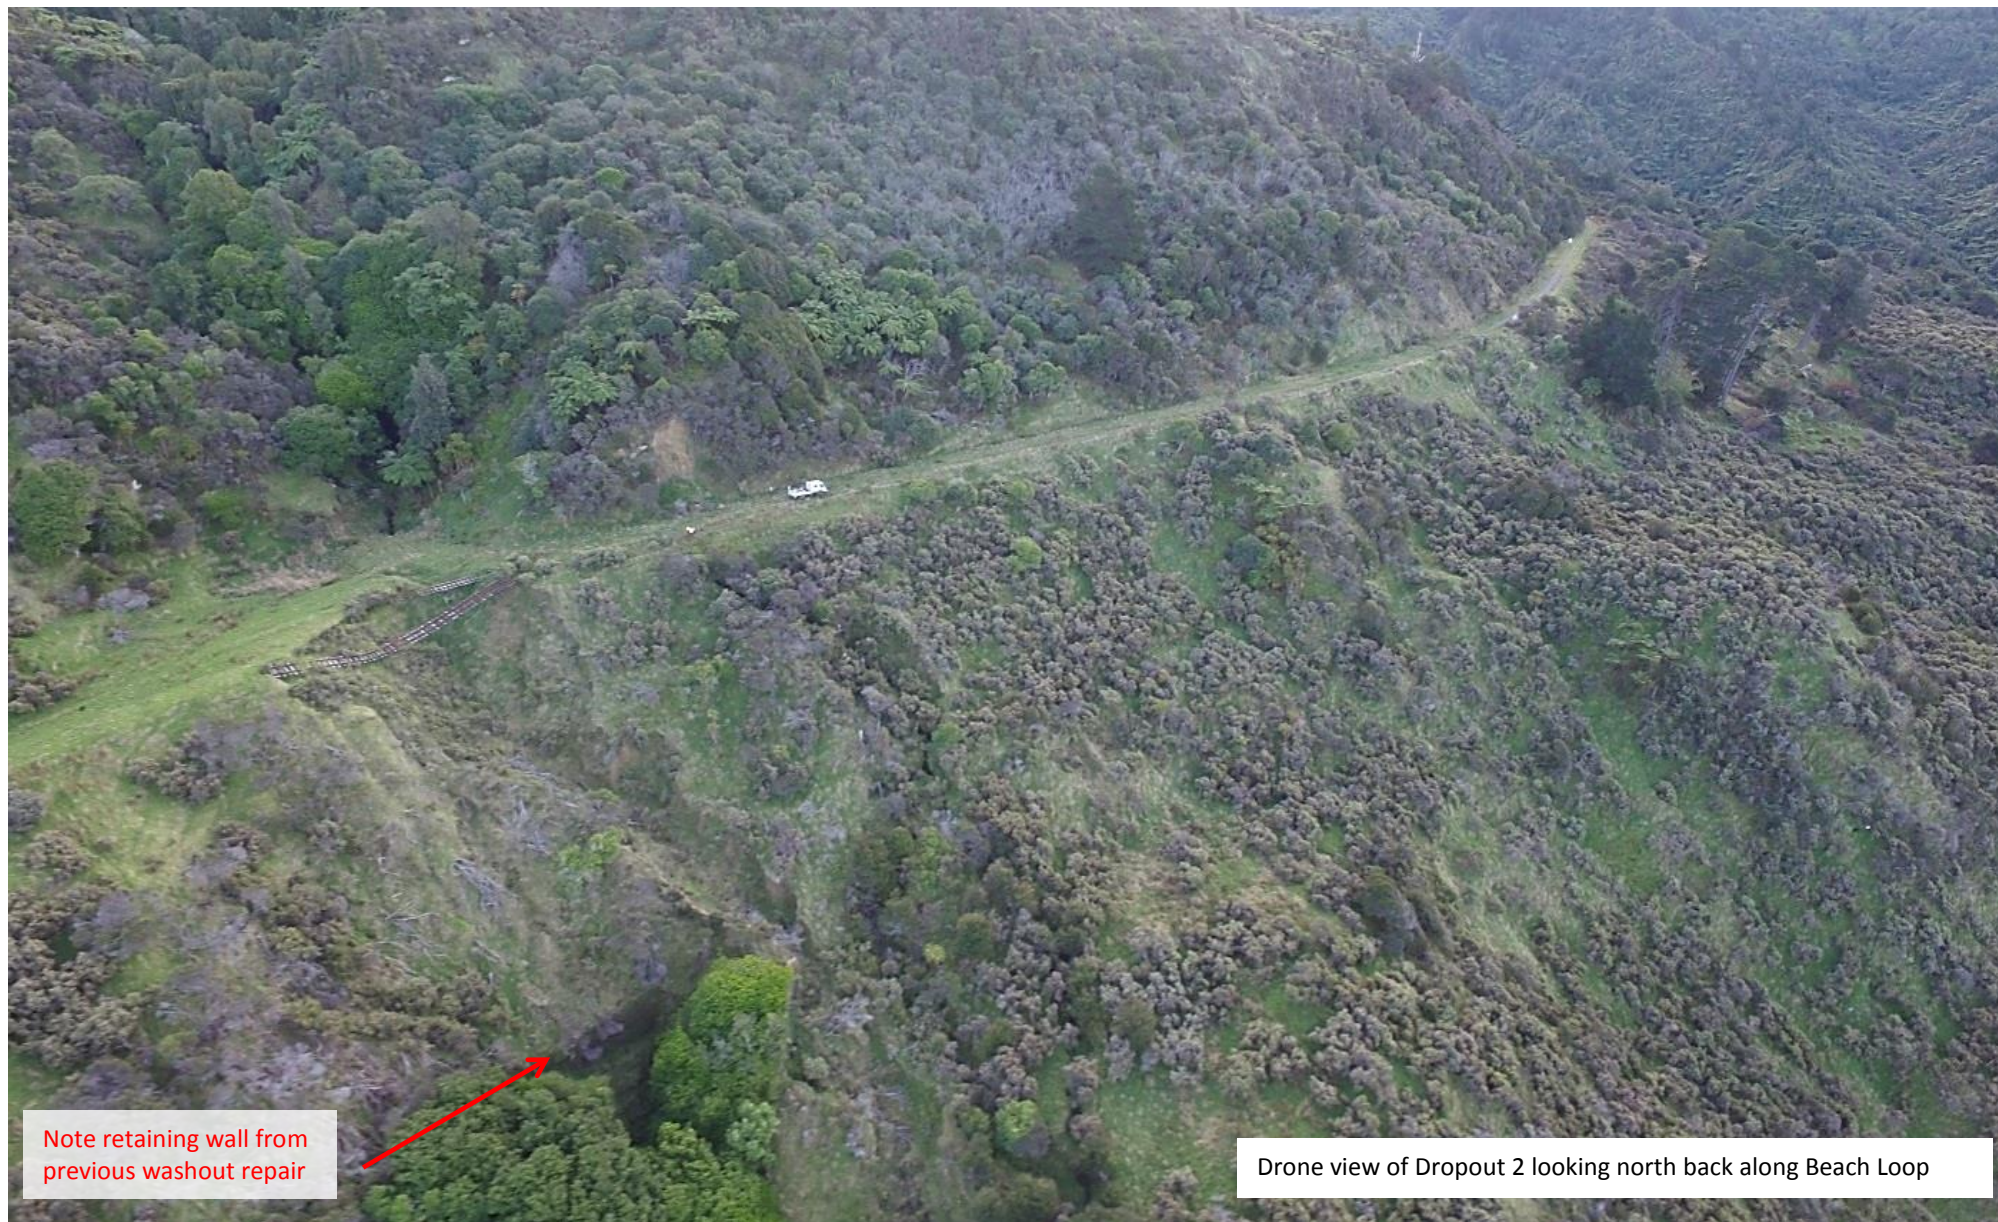
Note retaining wall from
previous washout repair

Drone view of Dropout 2 looking north back along Beach Loop

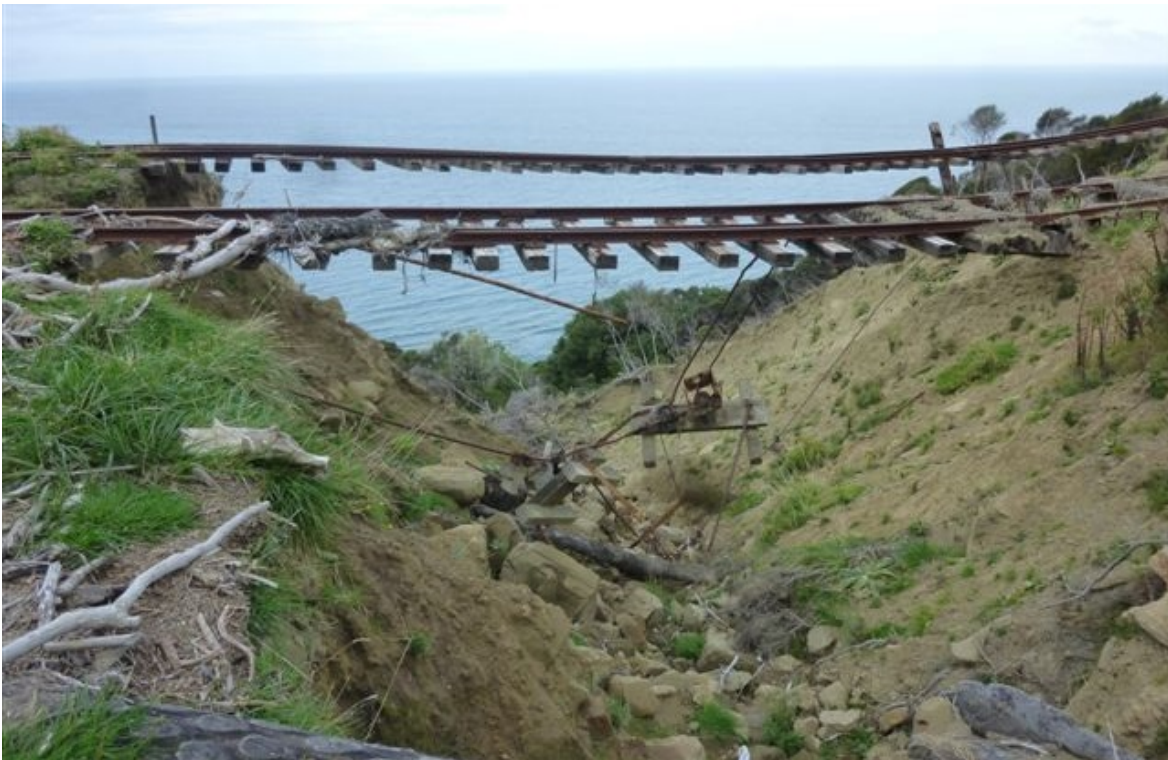
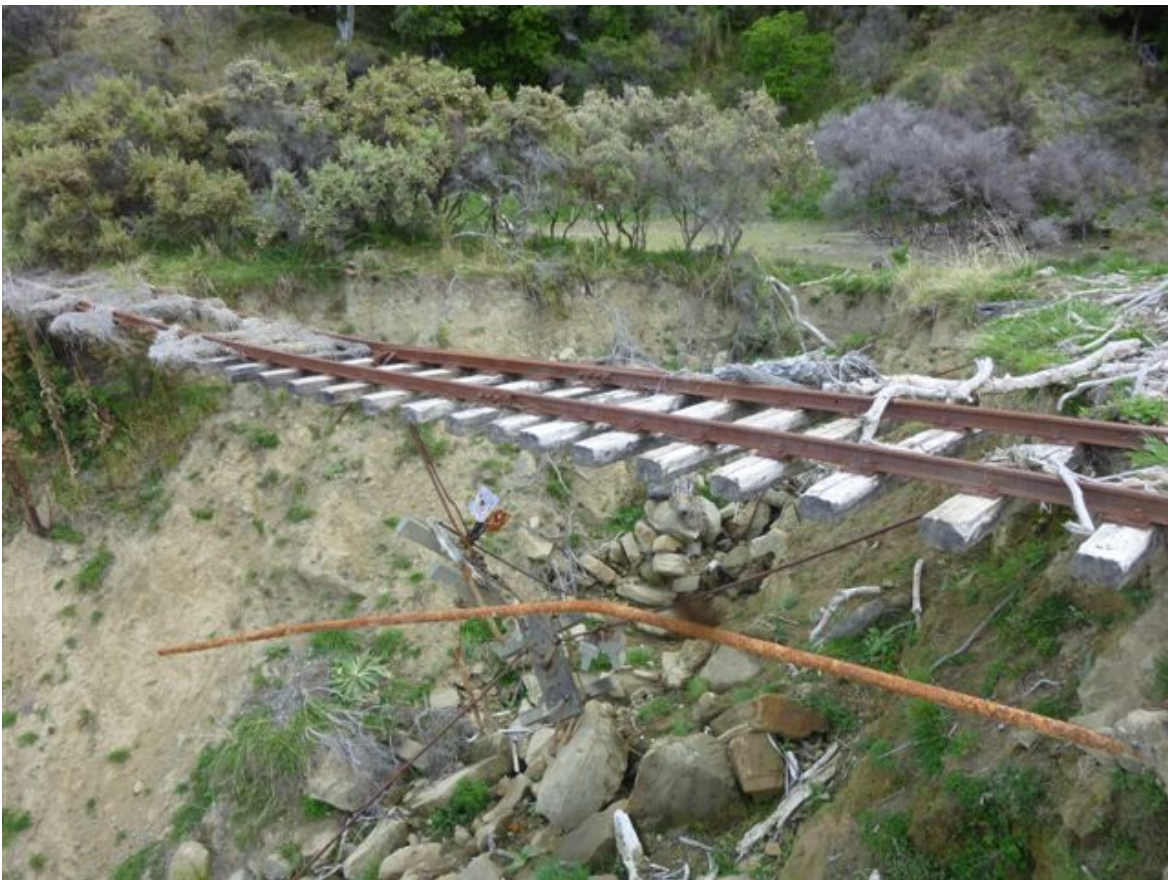
2013 photographs – extent of washout and track formation damage. Base of dropout is still in spoil - no hard rock visible in photographs or during inspections.

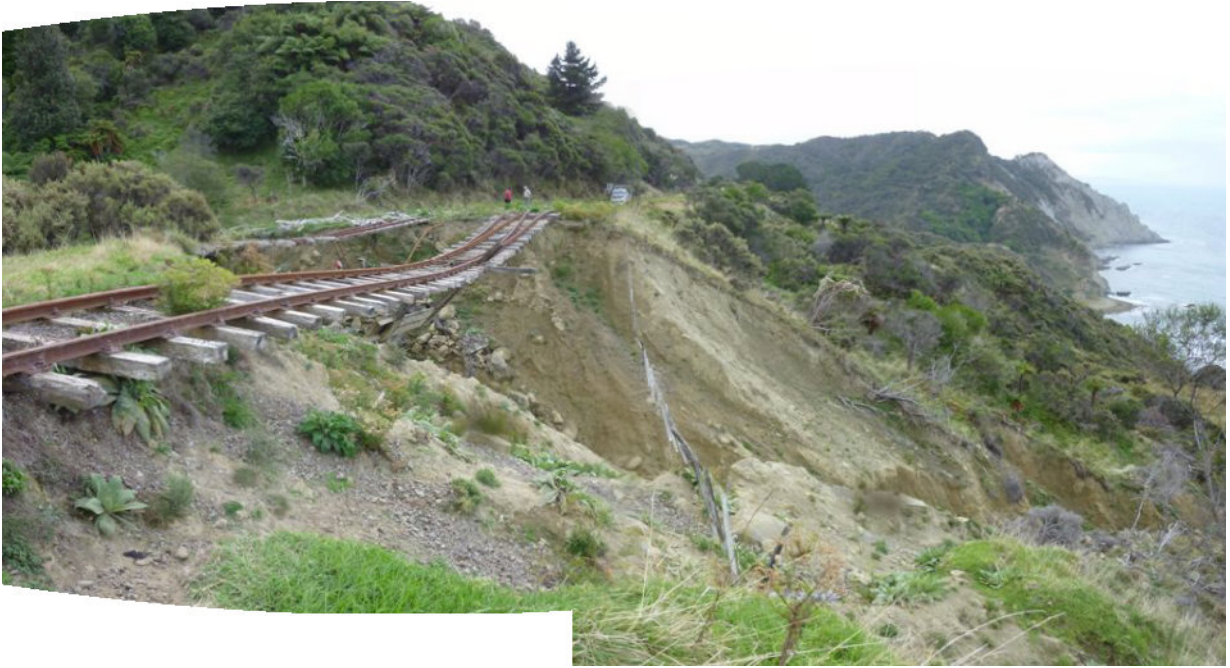
Stitched photo view looking north - note extensive spoil depths on far facing, no intact rockmass visible.

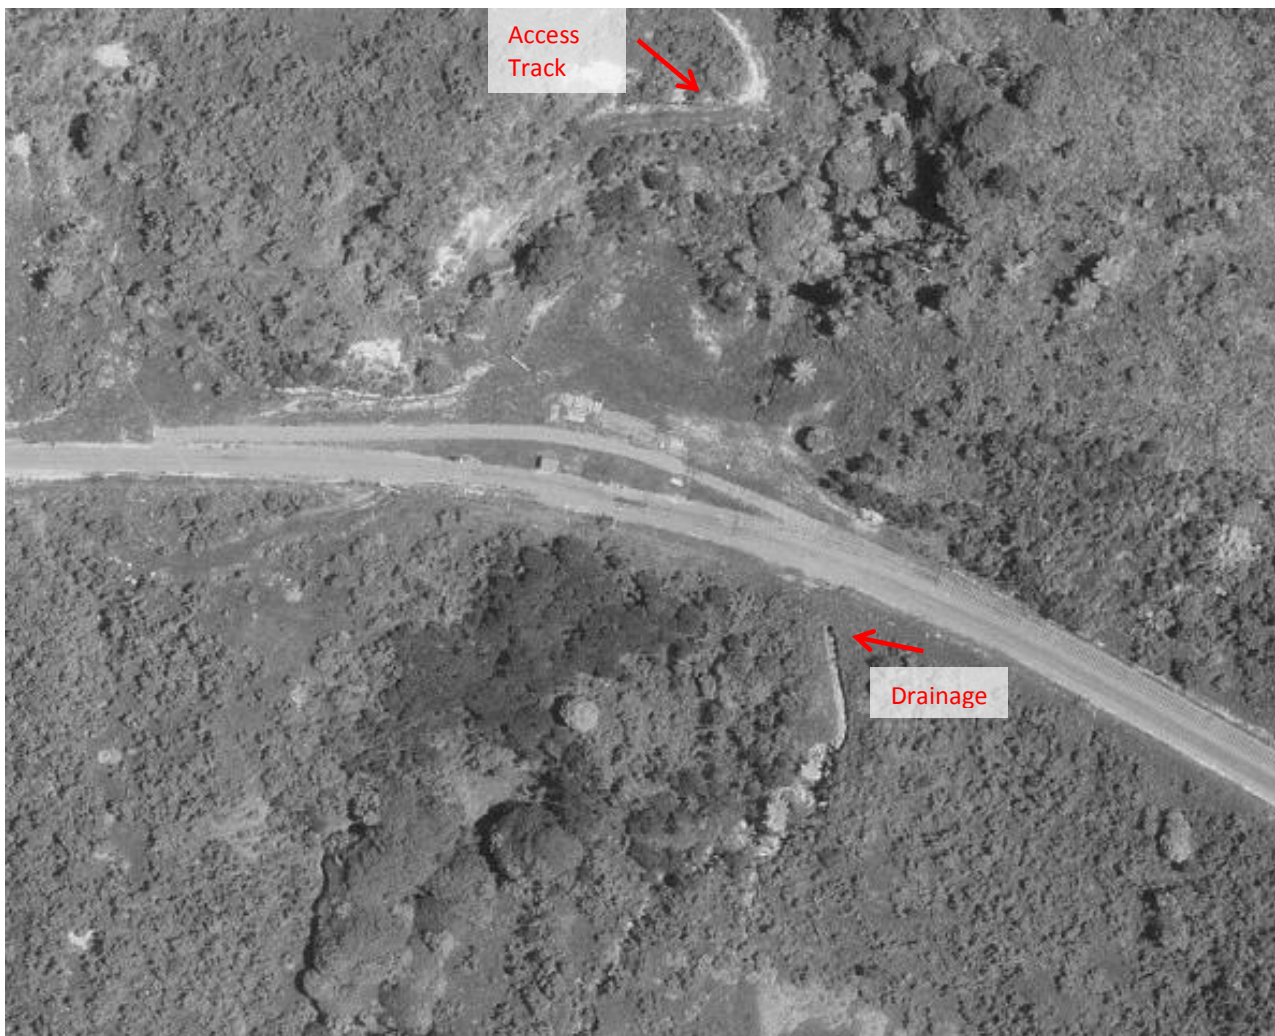
1986 NZR aerial photograph showing Dropout 2 prior to failure - note significant fill material on slope below turnout and clear view of track drainage works on northern side. Note access track above loop area.

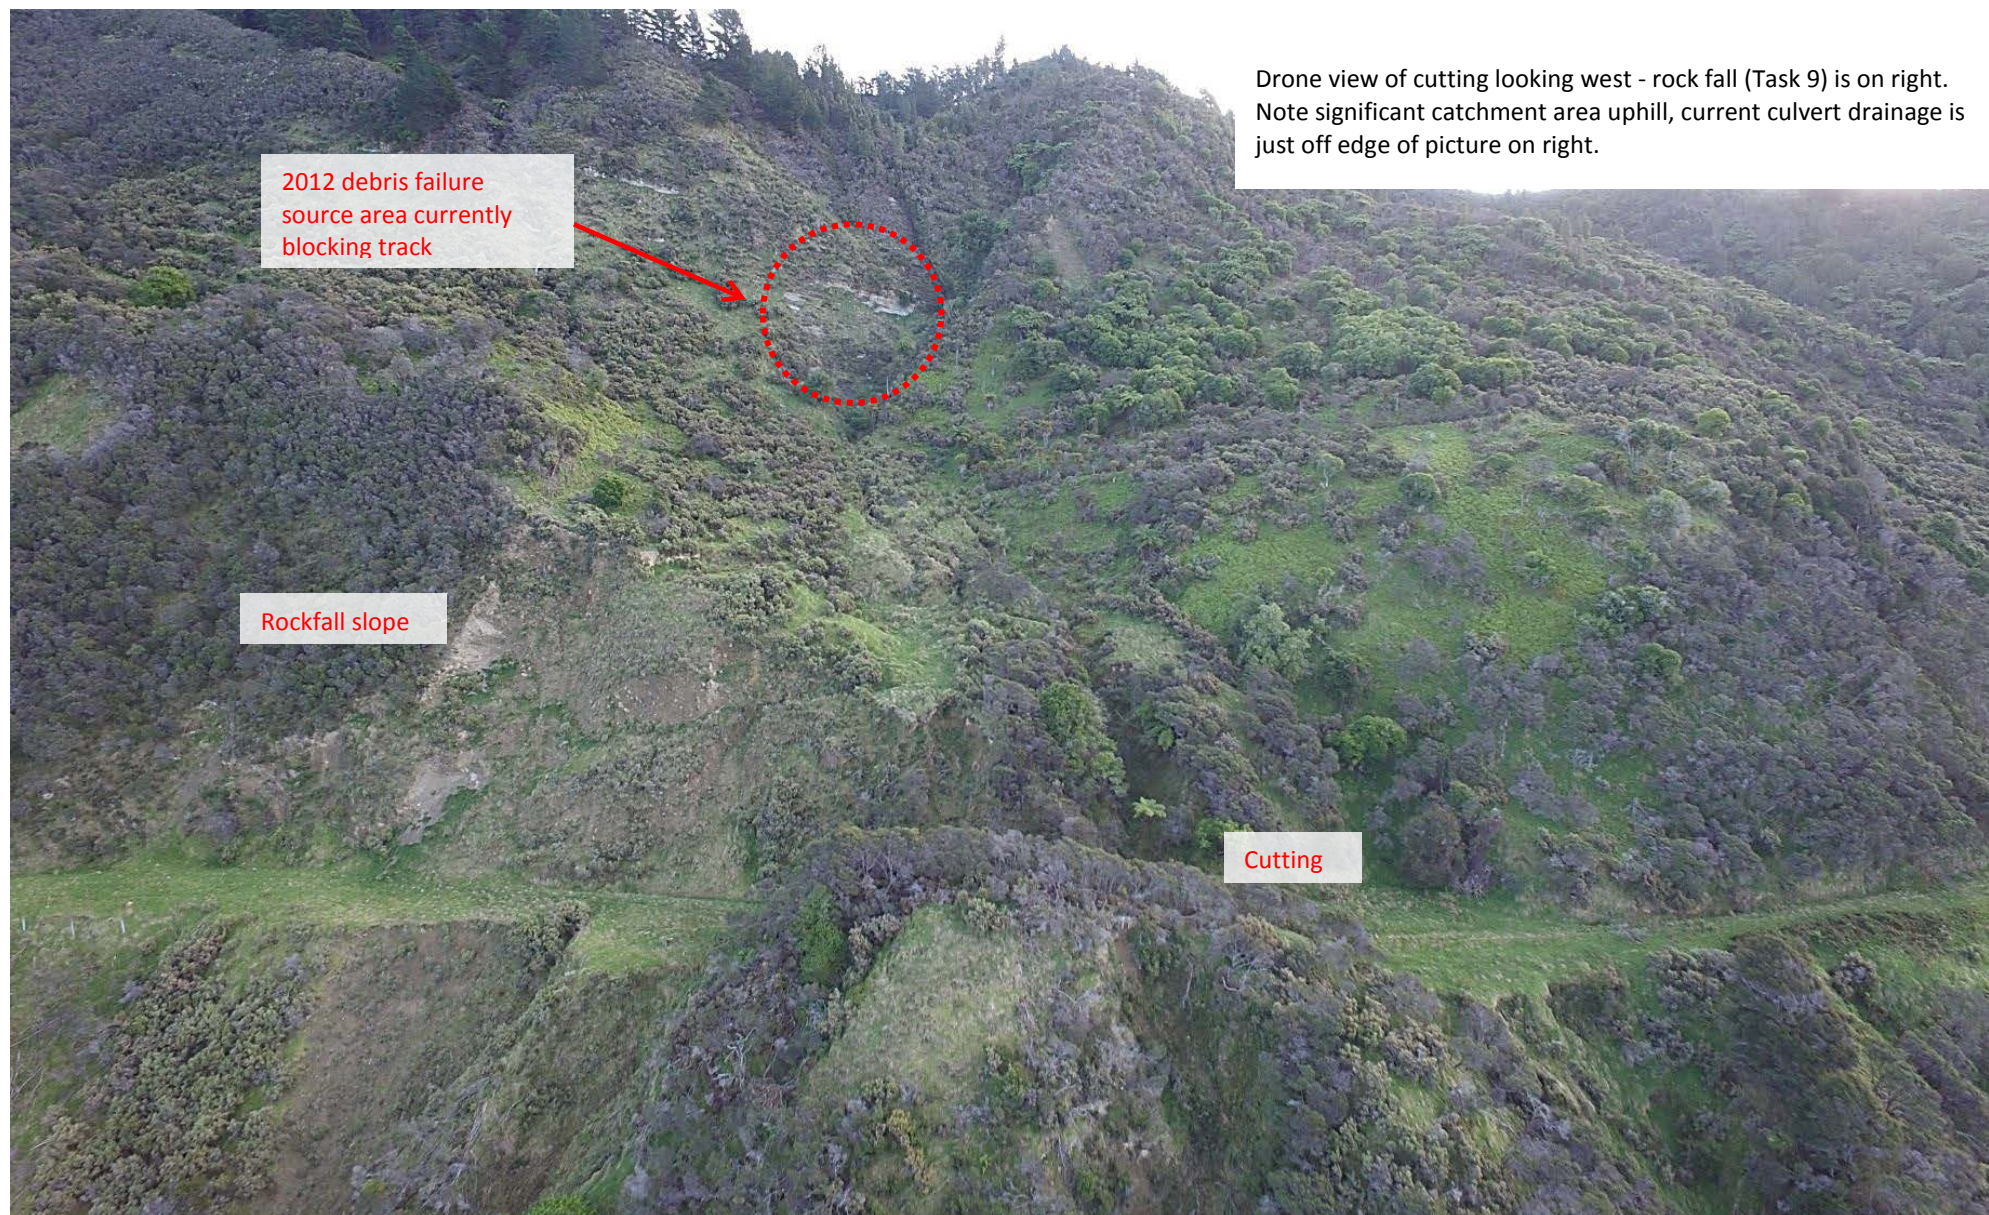
Drone view of cutting looking west. Note potential for new Beach Loop access track from upper right on photo

Repair Task:	Task 8 – Cutting Excavation & Reinstatement
Track Location:	Rail Chainage 356.83km
Description:	Excavate out slip material blocking track and reinstate stream drainage, install new culvert capacity under formation.
Required Works	Excavate out slip material blocking track and reinstate stream drainage, install new culvert under formation
Scale/ Scope/Volumes:	Estimated 2800m ³ excavation volume from cutting area Excavated material to go to dropout 2 as MSE fill (estimated 4300m ³ incl. Task 9 volumes) Install new drainage outlet from stream - deepen swale next to track - install additional culverts under track to take stream overflows.
Construction Comment:	Establish where slope debris has come from and consider any uphill works required - install new access track up slope and undertake benching or drainage redirection works above site. Existing culvert(s) may be buried under fill, current culvert and deep swale drainage leading north looks impractical - additional concrete wall required under track formation to better direct water to north?

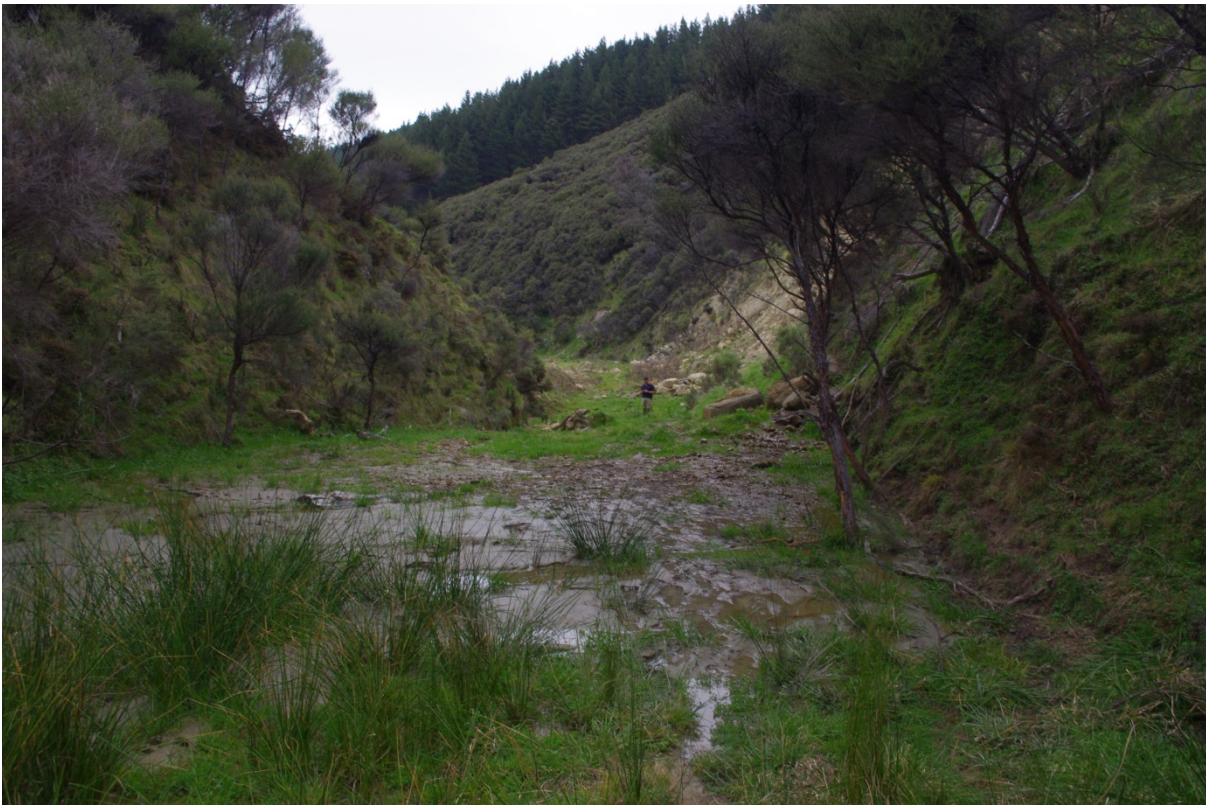
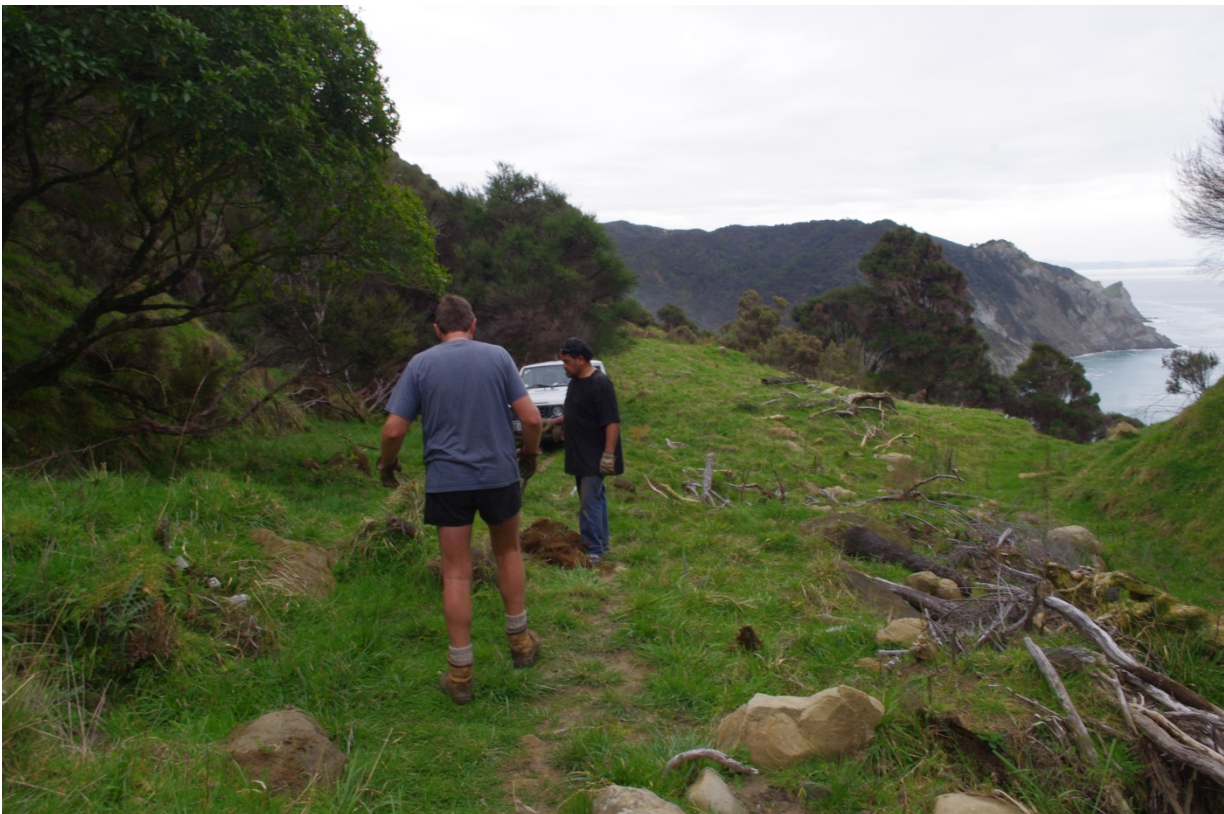
2013 photographs showing washed out spoil across formation

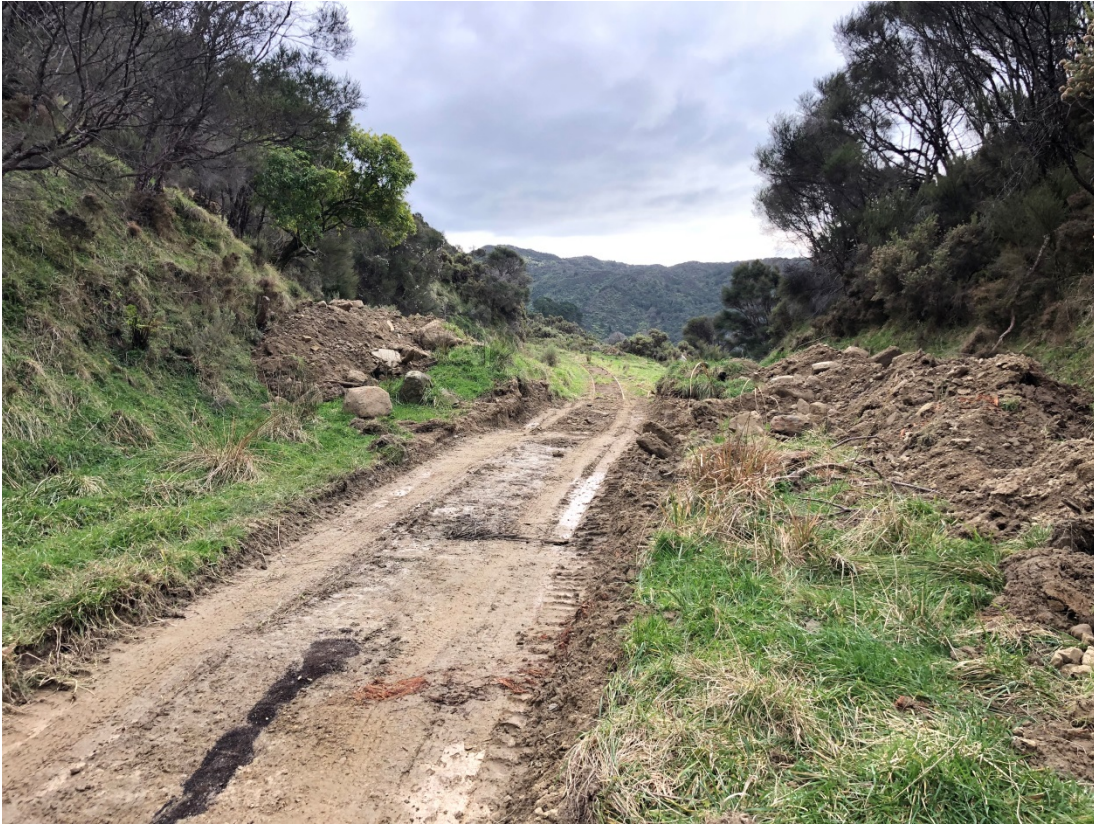
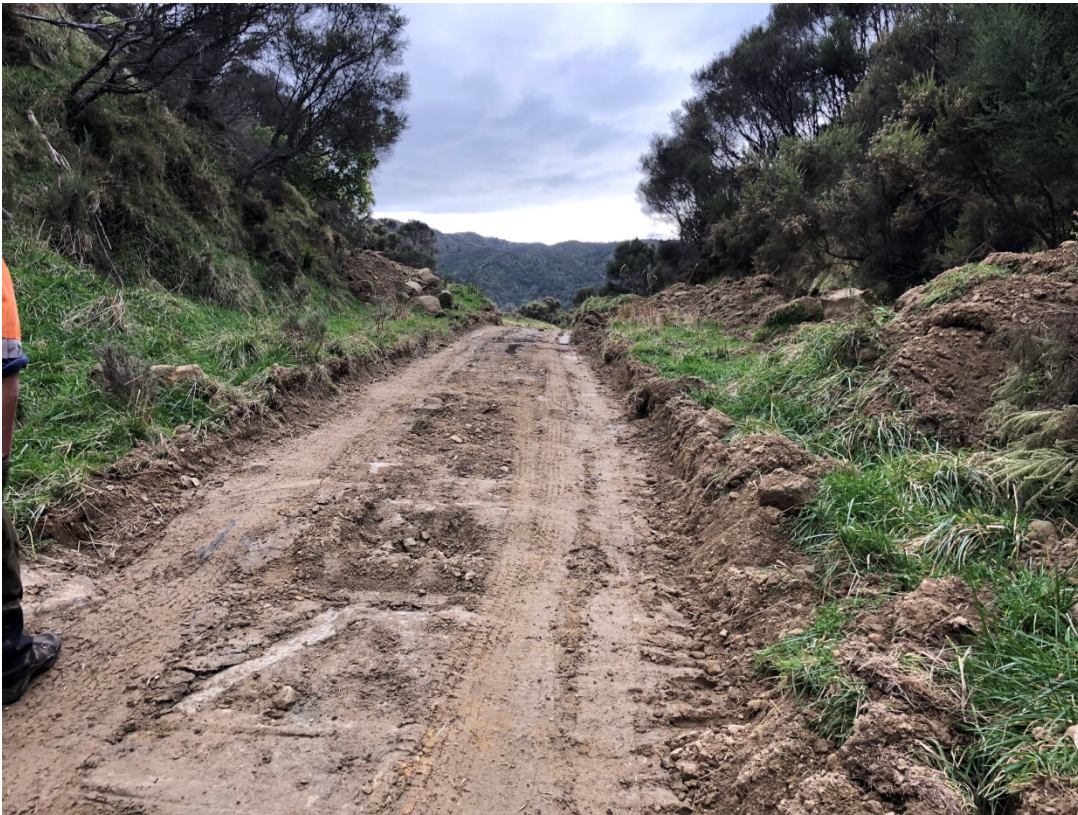
2019 Photos showing temporary access track across top of spoil (note large spoil volume)

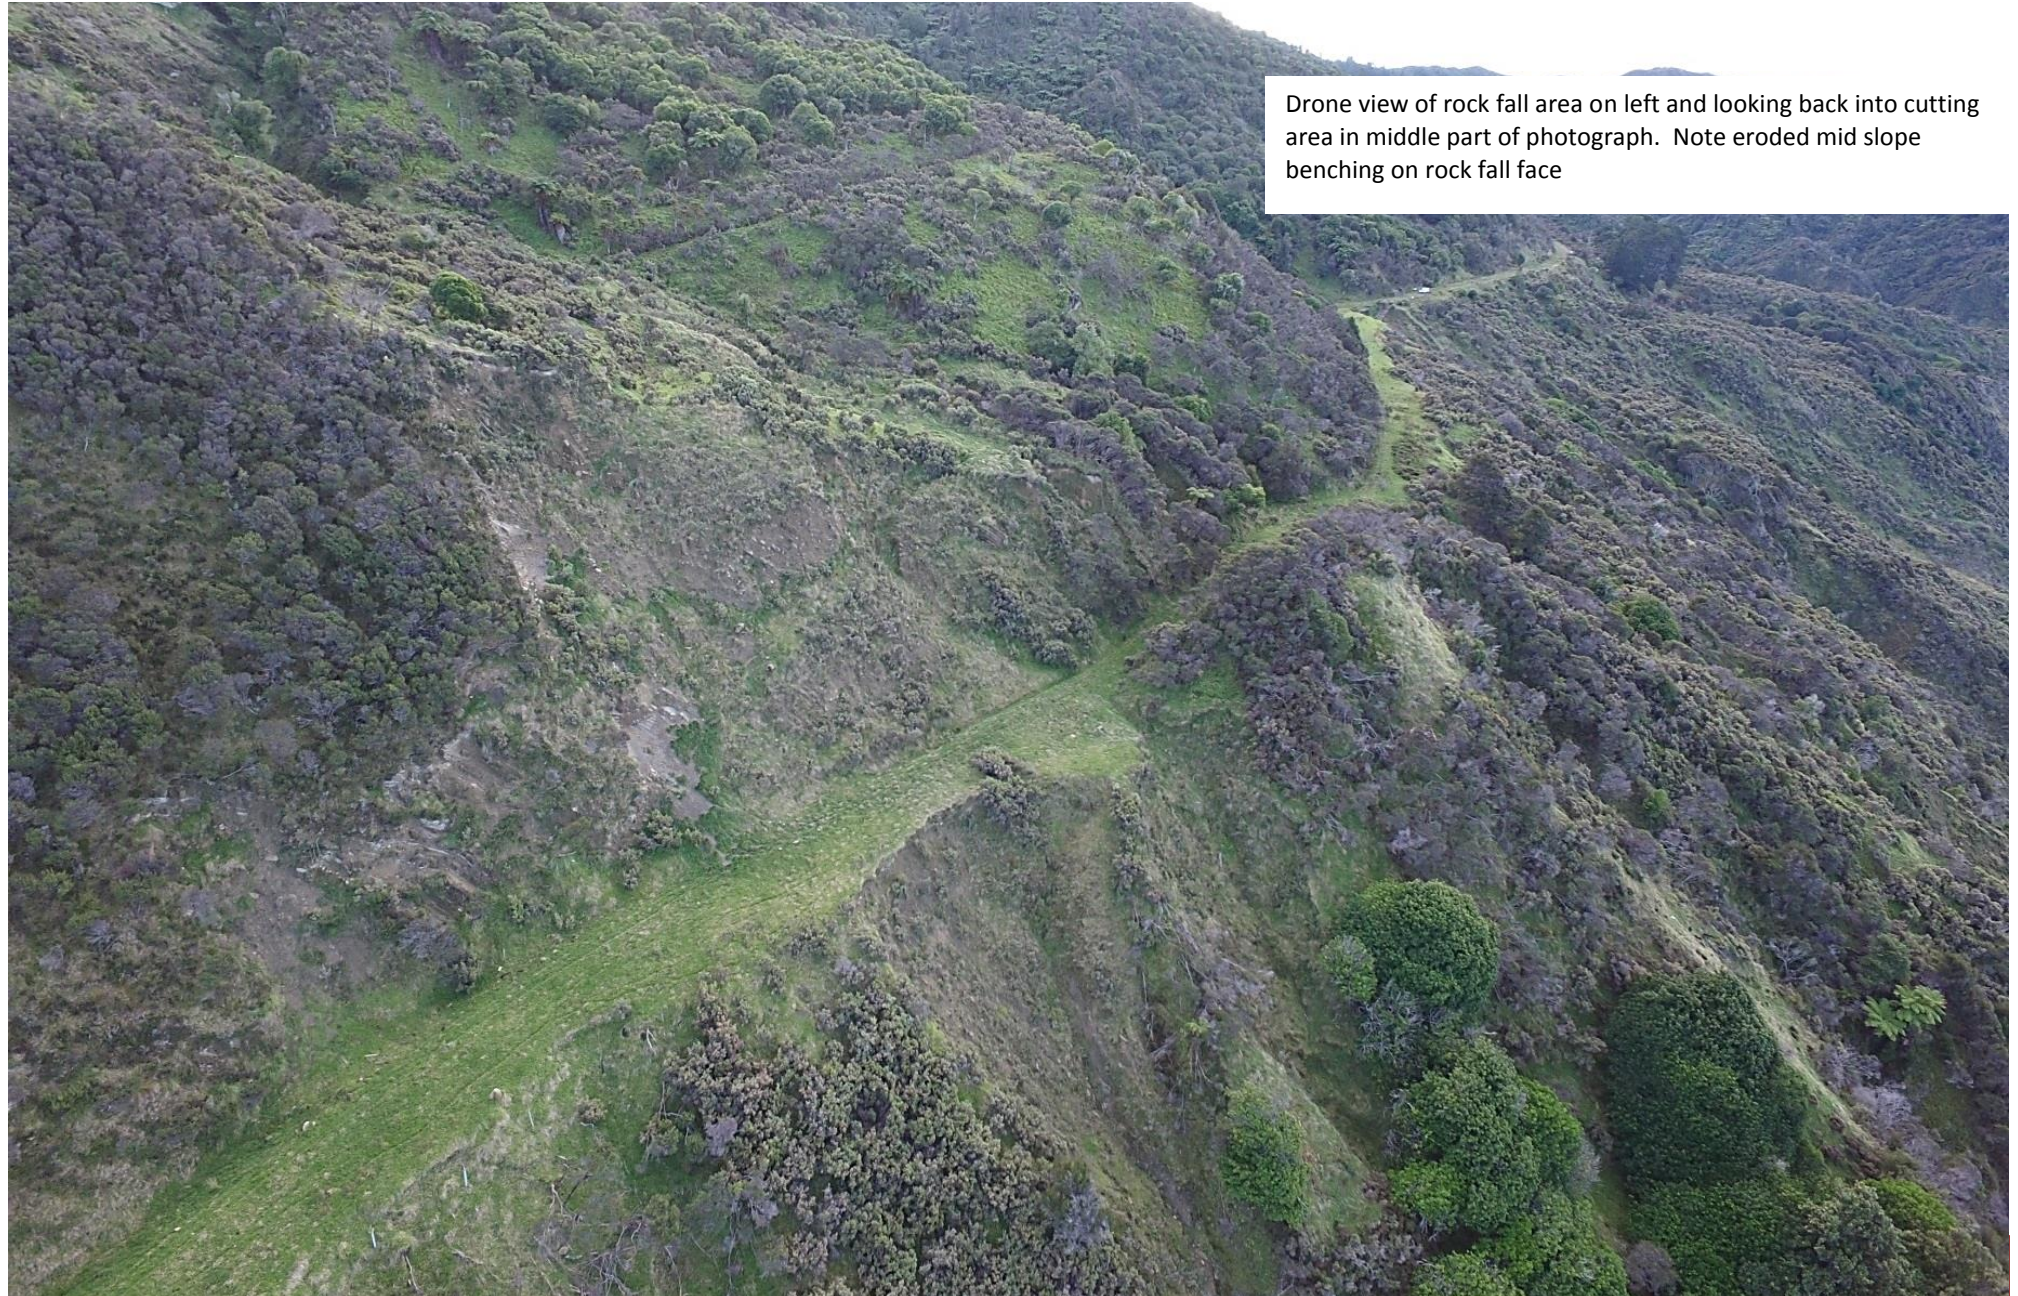
Drone view of rock fall area on left and looking back into cutting area in middle part of photograph. Note eroded mid slope benching on rock fall face

Repair Task:	Task 9 – Rock Fall Batter Slope
Track Location:	Rail Chainage 356.76km
Description:	Regrade slope, reinstate excavated benches
Required Works	Regrade slope, reinstate excavated benches
Scale/ Scope/Volumes:	Excavate out failing material and large boulders - use boulders as rock toe for dropout 1 and 2 with backup fill material for dropout 3 – estimated 1500m ³ volume, tbc Reinstate existing benches and tidy up internal slope drainage. Excavate out swale at bottom of slope adjacent rail, improve rock catching ability, rework culvert inlets and outlets
Construction Comment:	Rock slope looks unstable but has generally performed reasonably well since 2013. Some material failing into swale at southern end, will require additional assessment. Significant failure 2010 – 2011. Has been ongoing issue since construction in 1940s.
Designer Comment:	Site of large landslide in mid 2000s. Consider loss of ground on downstream side of site - any precautionary H piles needed for track support? Drilled or driven pile design? (Currently not allowed for in pricing schedule)

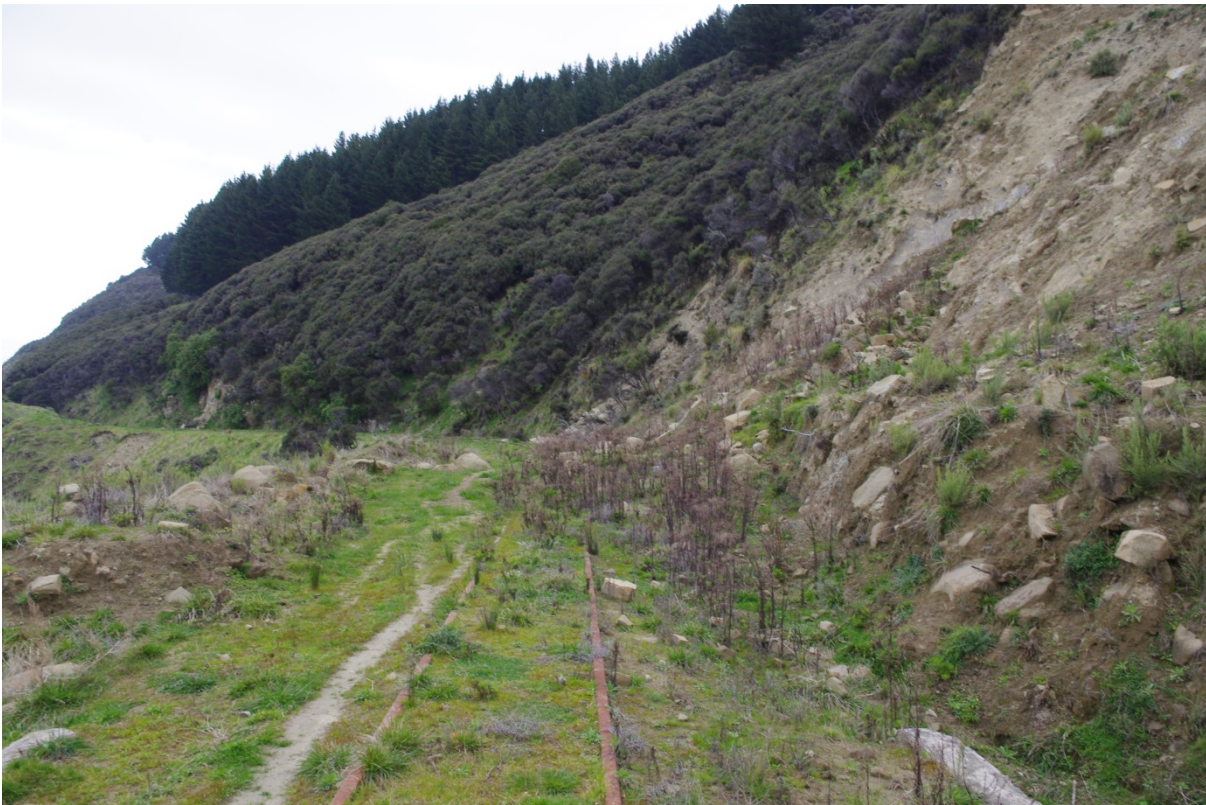
2013 photographs rock fall area – note large rocks on batter slope.

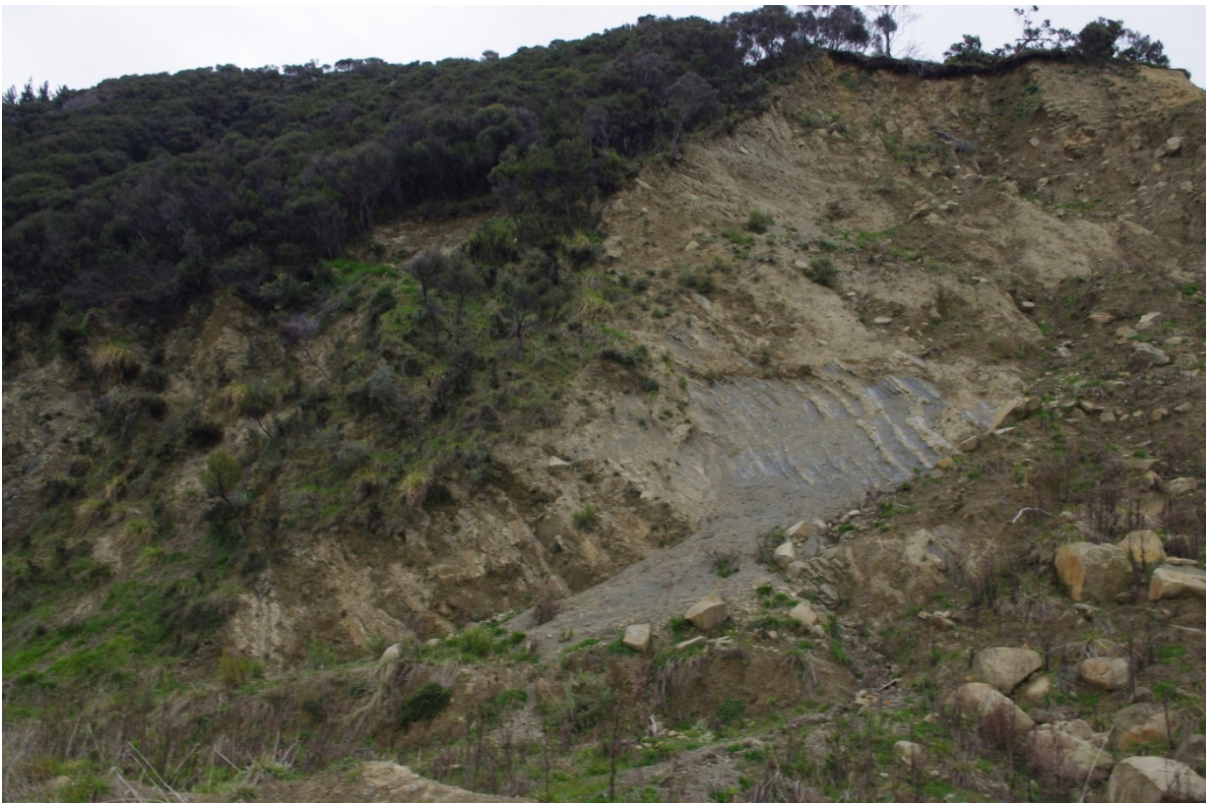
Exposed rockmass on southern side of landslide area acting as side release zone.

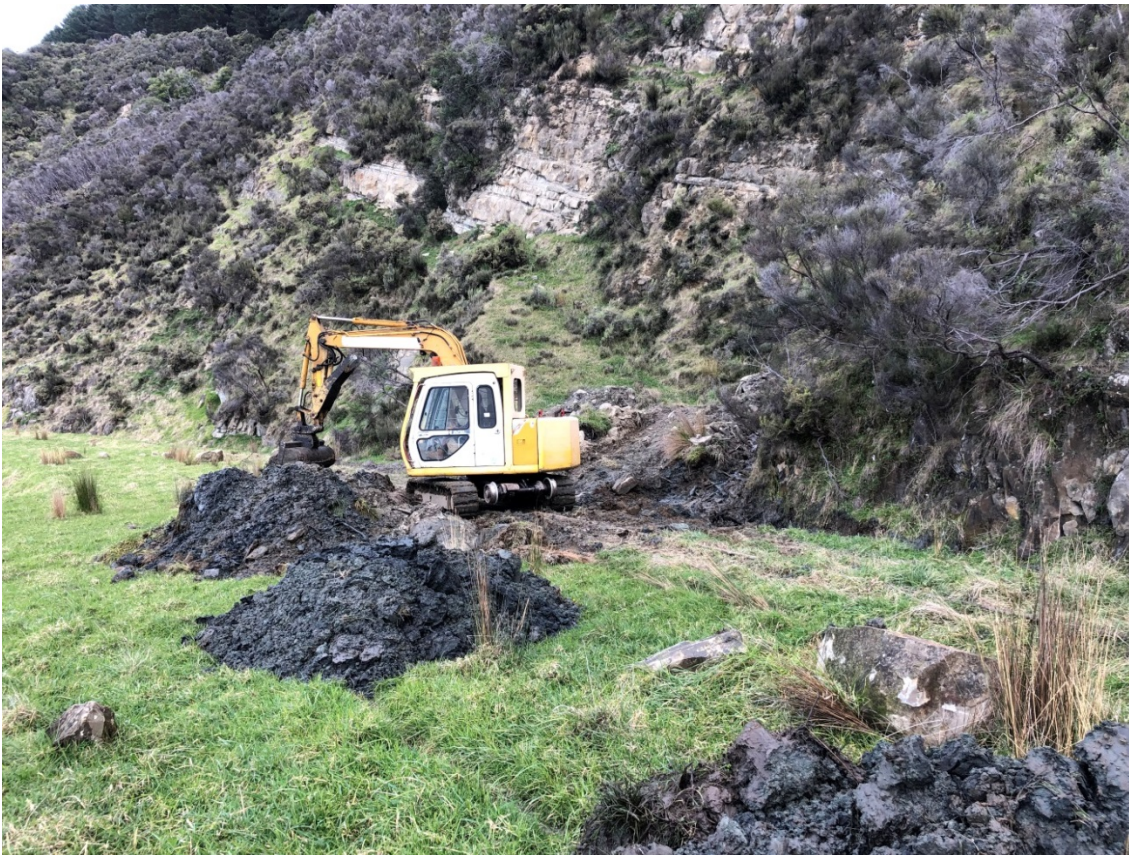
Swale clearance works July 2019 to prevent water flooding across track and destabilising slope on outside edge of track formation.

Repair Task:	Task 10 – Stream Works @ 356.23
Track Location:	Rail Chainage 356.23km
Description:	Reinstate swale drainage, clean out entrance area, create additional sediment catch area.
Required Works	Excavate out slip material blocking swale drainage - clean out concrete headwall swale back to splash wall
Scale/ Scope/Volumes:	Slip partially excavated out by DBM in week of 15 June as emergency works Additional excavation works and removal of spoil to dropout 1 required.
Construction Comment:	
Designer Comment:	Additional slope protection where stream enters top of debris fan down to swale drain should be considered. Additional excavation and removal of fan drainage to be assessed further.
Rail Operations:	Work trains past site, including deliveries for dropout 3 & 4.
