PNGL Wairoa – Gisborne 296.3 - 390.5km Track Formation Repair Works Civil Construction Work Packages 30%Design & Pricing – October 2019

Date: 10th October 2019

Project: FGL 1331

Prepared by: Maurice Fraser - Fraser Geologies Ltd

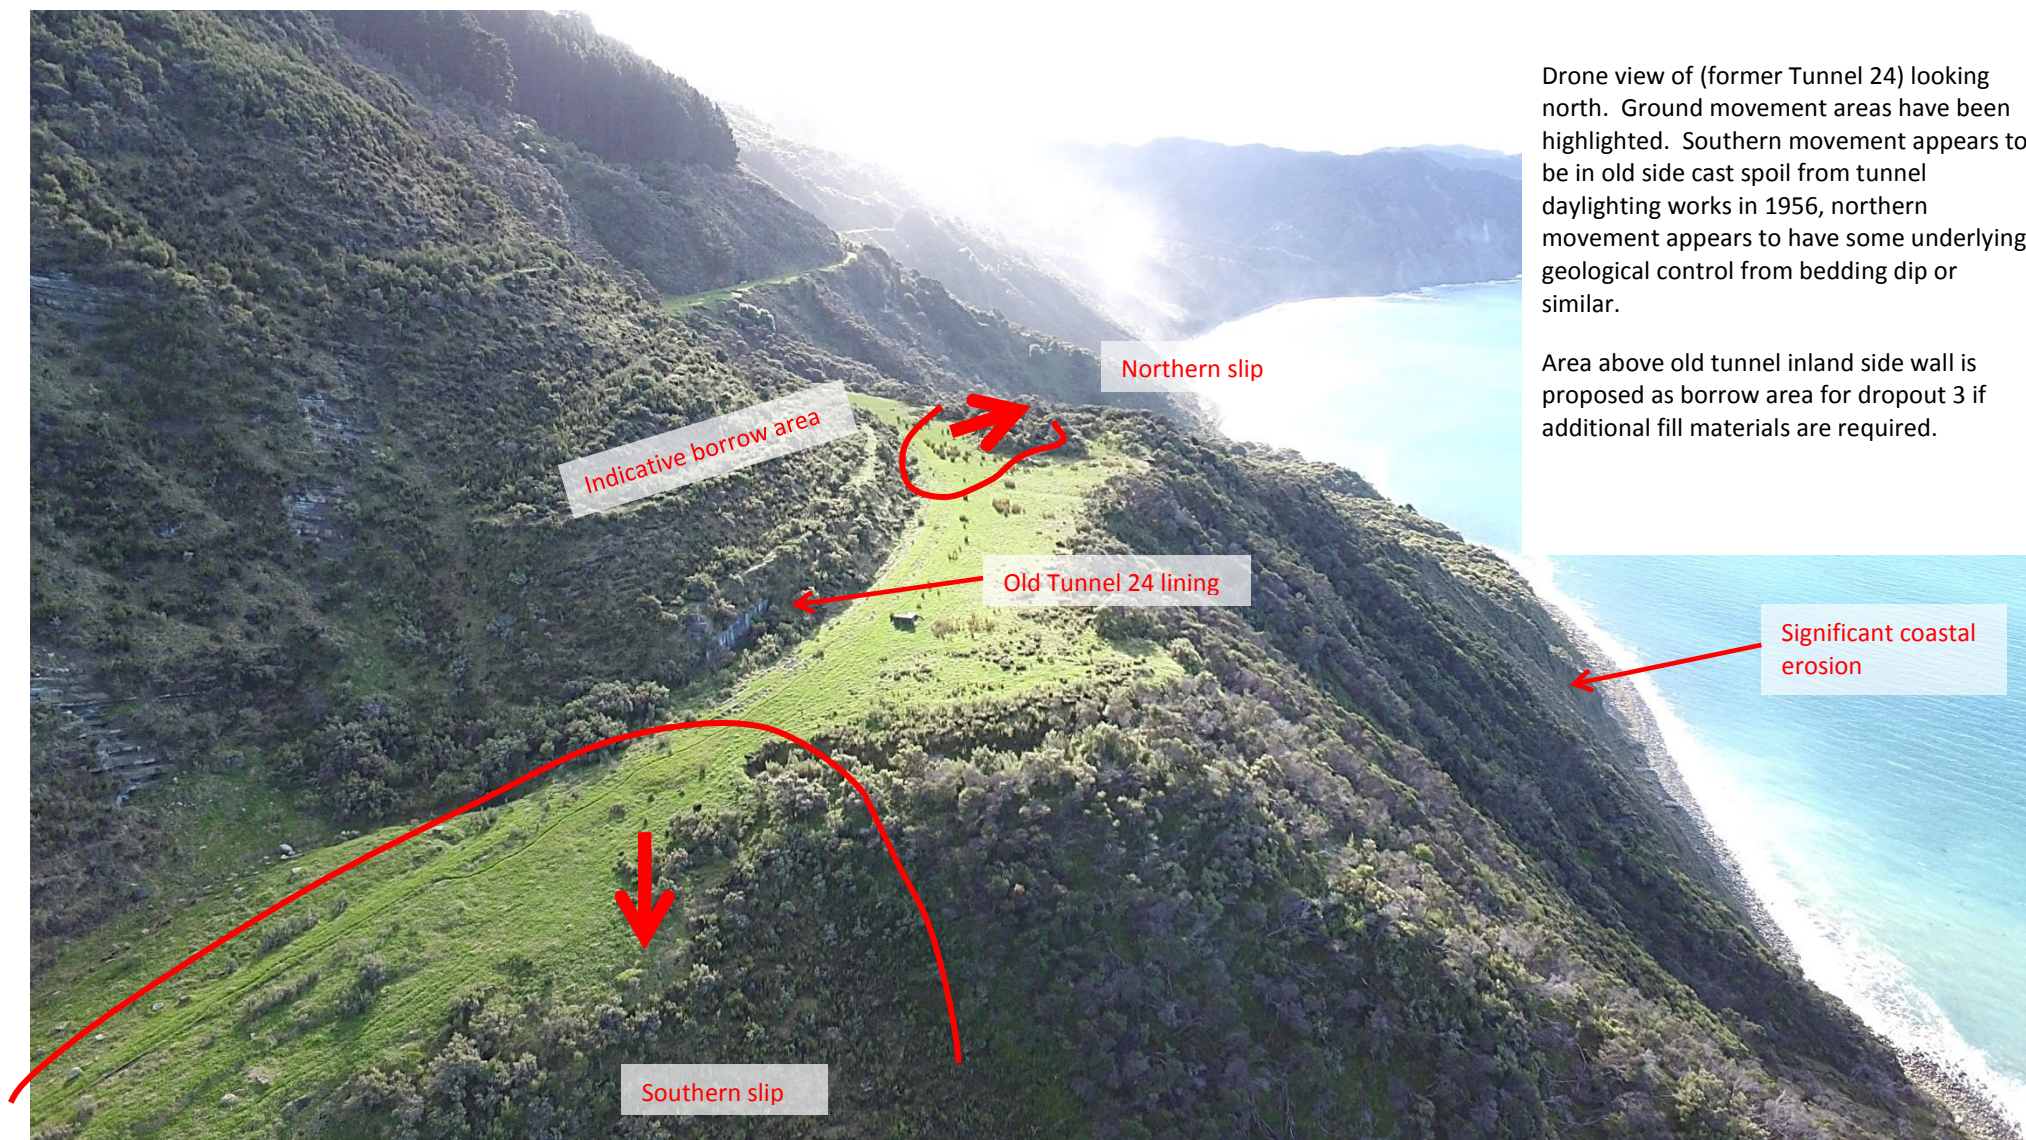
Drone view of (former Tunnel 24) looking north. Ground movement areas have been highlighted. Southern movement appears to be in old side cast spoil from tunnel daylighting works in 1956, northern movement appears to have some underlying geological control from bedding dip or similar.

Area above old tunnel inland side wall is proposed as borrow area for dropout 3 if additional fill materials are required.

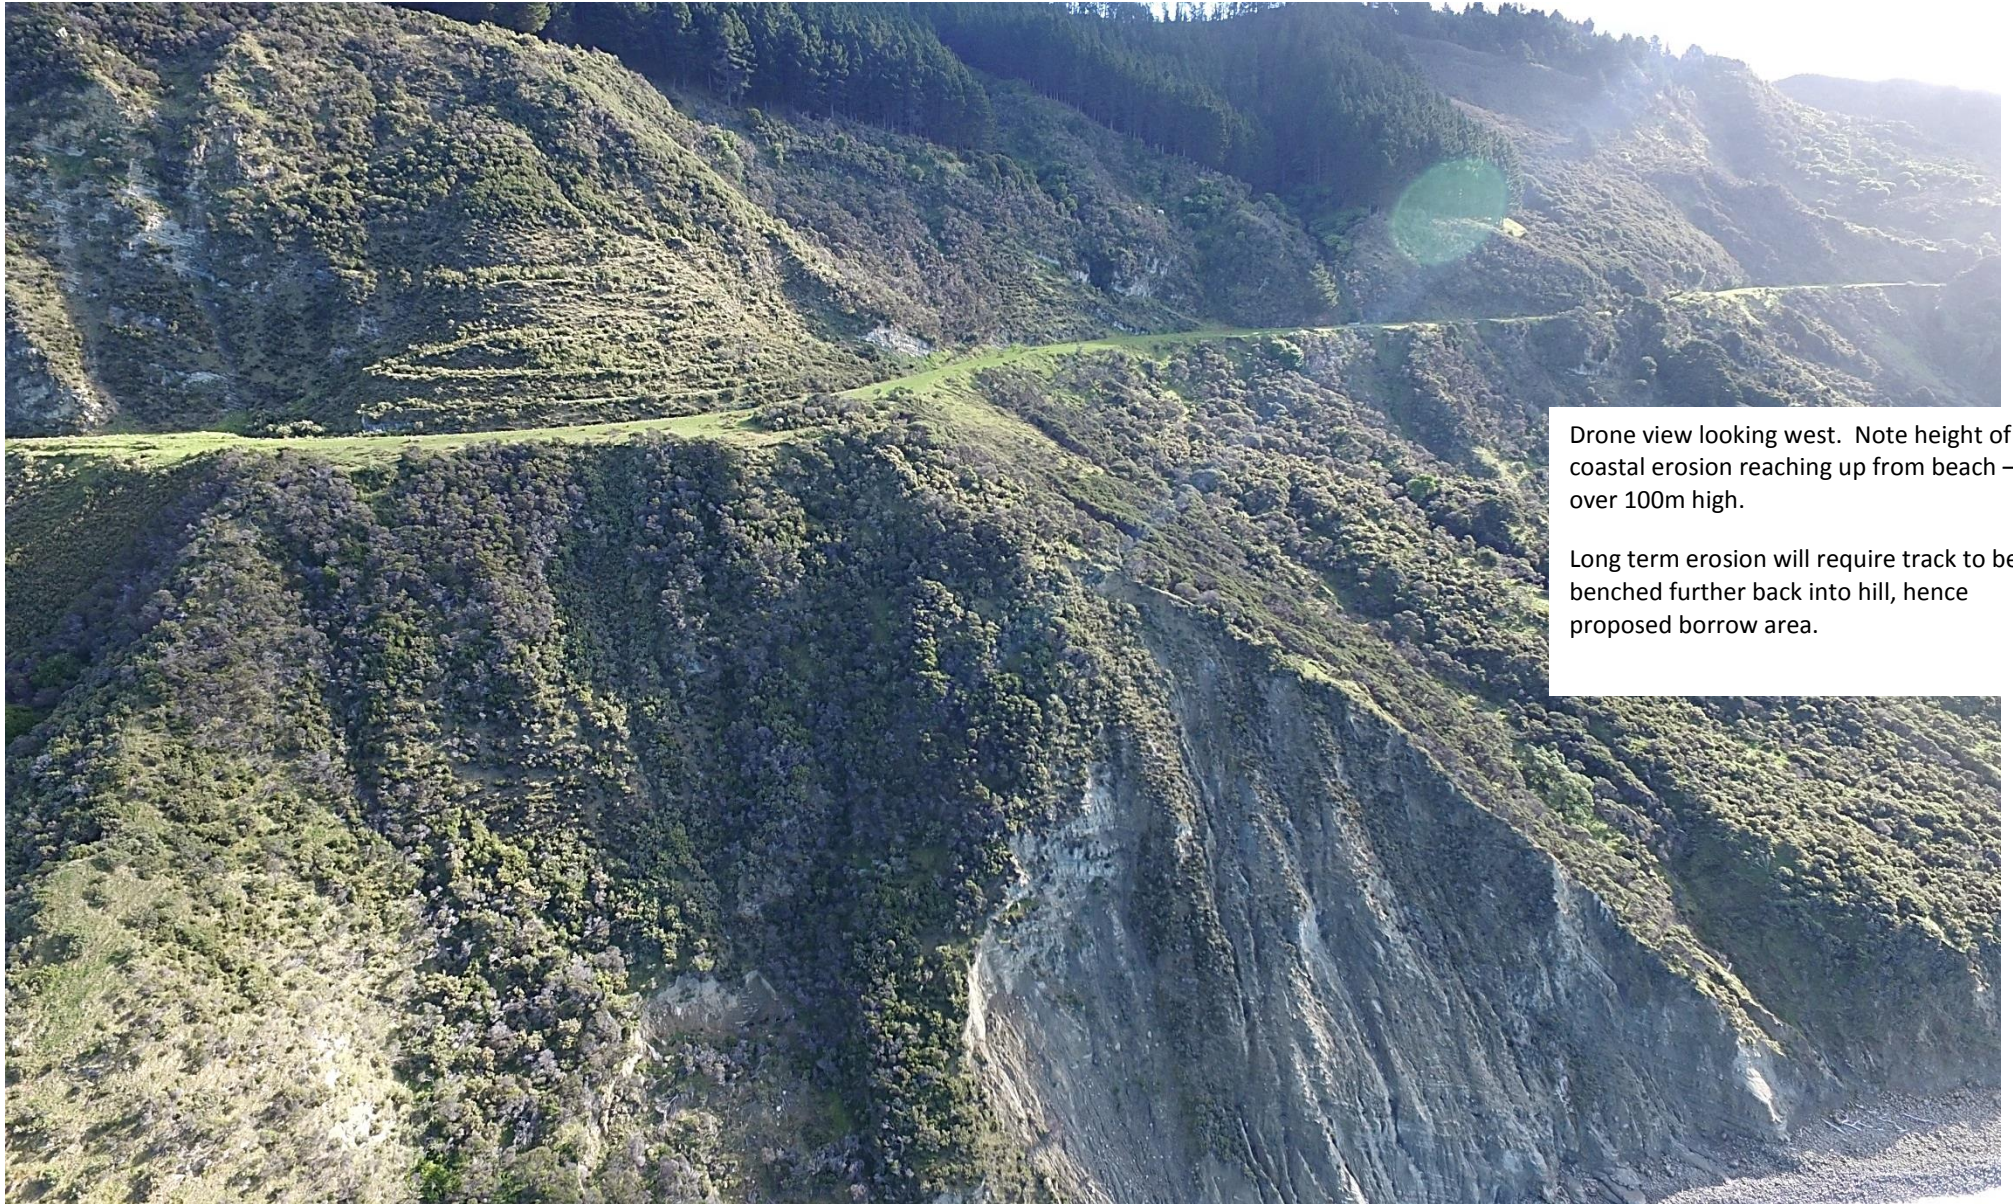
Drone view looking west. Note height of coastal erosion reaching up from beach – over 100m high.

Long term erosion will require track to be benched further back into hill, hence proposed borrow area.
