<b>Repair Task:</b>	<b>Task 12 – Rock Scaling 355.42 - 355.79</b>
<b>Track Location:</b>	Rail Chainage 355.42-355.79
<b>Description:</b>	Cliff face areas require scaling to remove significant rock fall hazard.
<b>Required Works</b>	
<b>Scale/ Scope/Volumes:</b>	Allow to scale cliff face Allow to put 20 tonne excavator up on bench and remove collected rocks - push out onto formation bench below. Remove track and sleeper sets prior.
<b>Construction Comment:</b>	Require expert assistance to define scale and scope of problem - prelim budget 12 days of actual abseil work on site.
<b>Designer Comment:</b>	Require expert assistance to define scale and scope of problem - prelim budget 12 days of actual abseil work on site.
<b>Rail Operations:</b>	Work trains past site, including deliveries for Dropout 3 & 4.

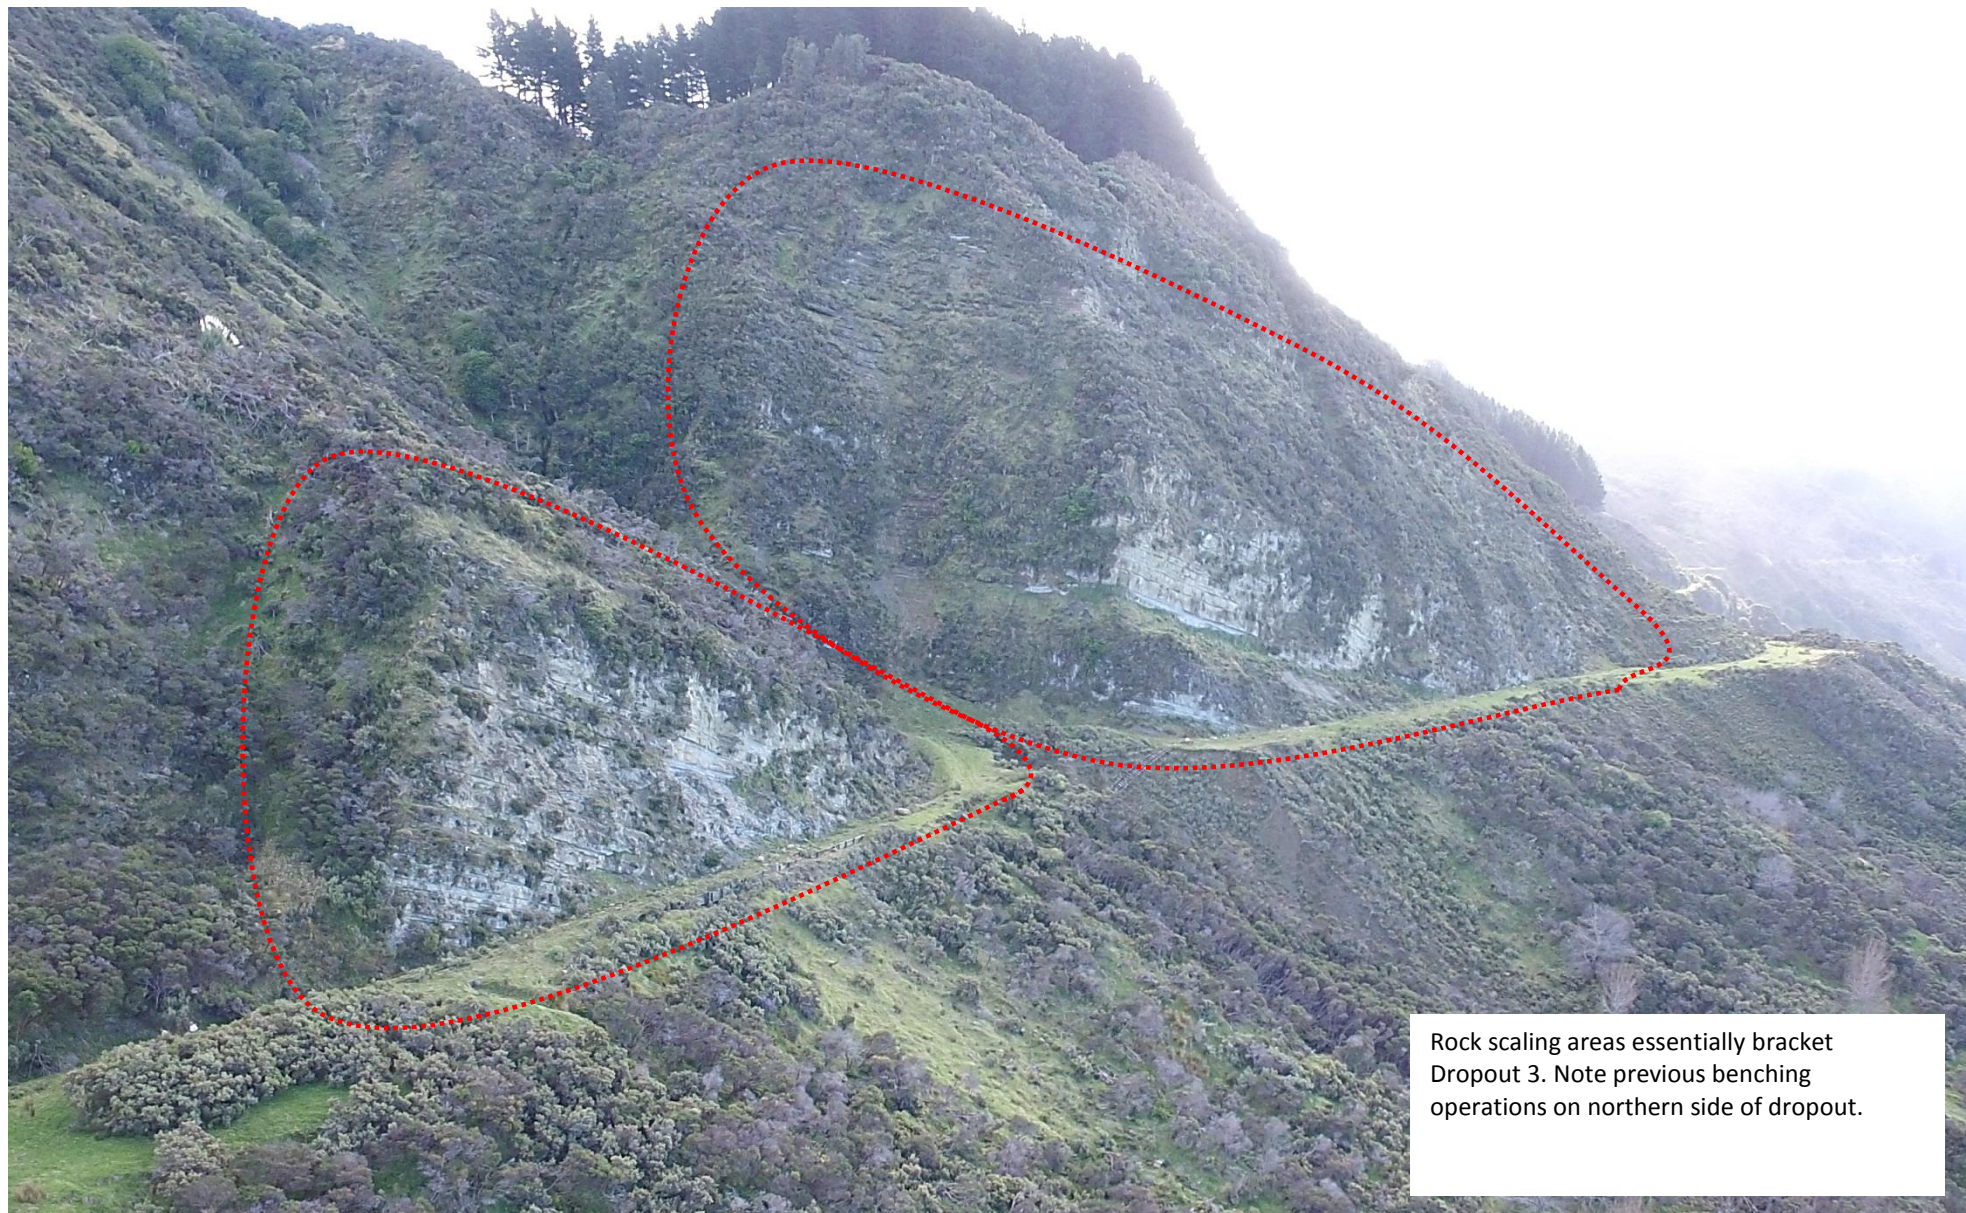
Rock scaling areas essentially bracket Dropout 3. Note previous benching operations on northern side of dropout.

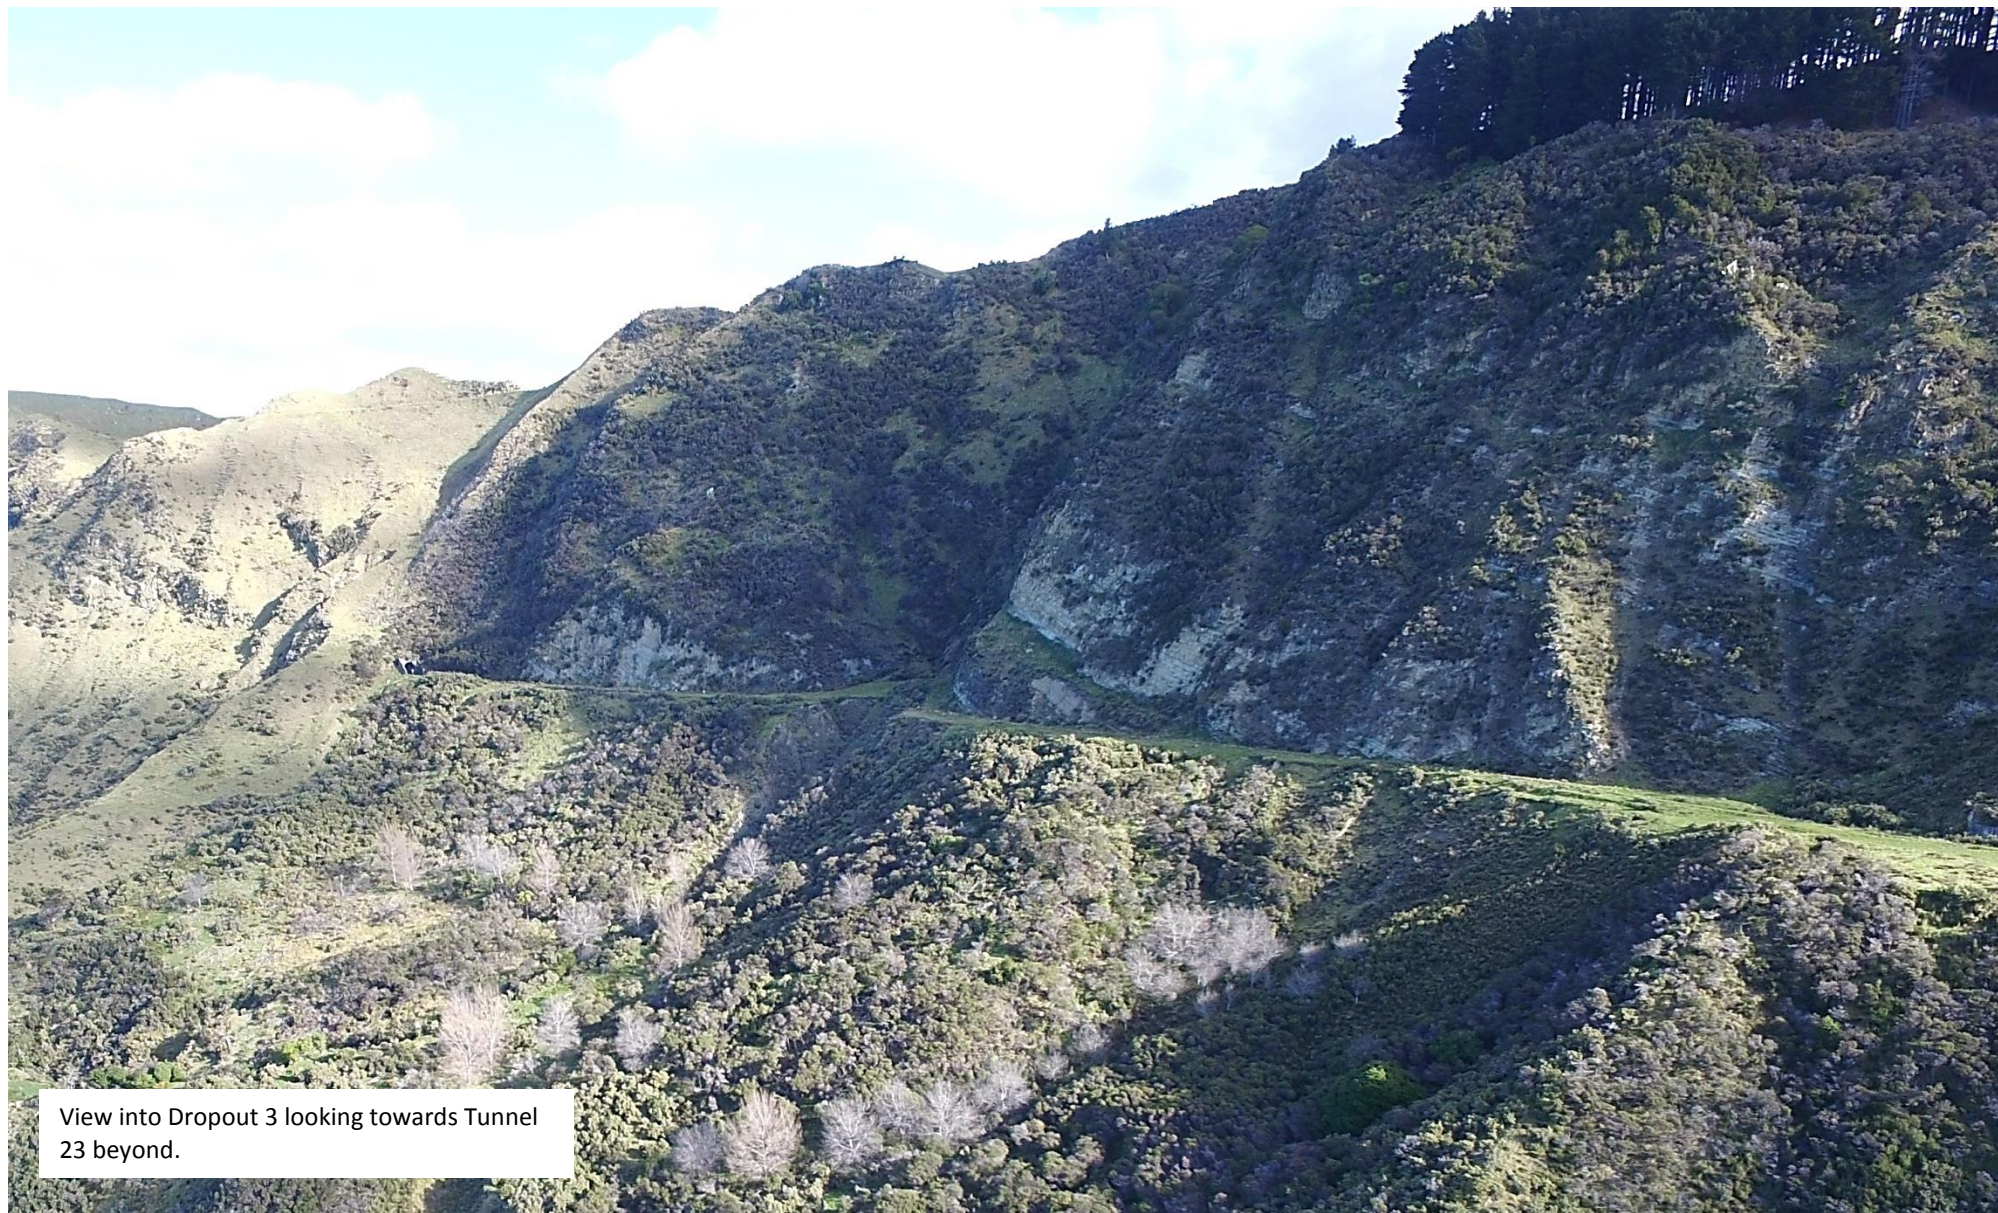
View into Dropout 3 looking towards Tunnel 23 beyond.

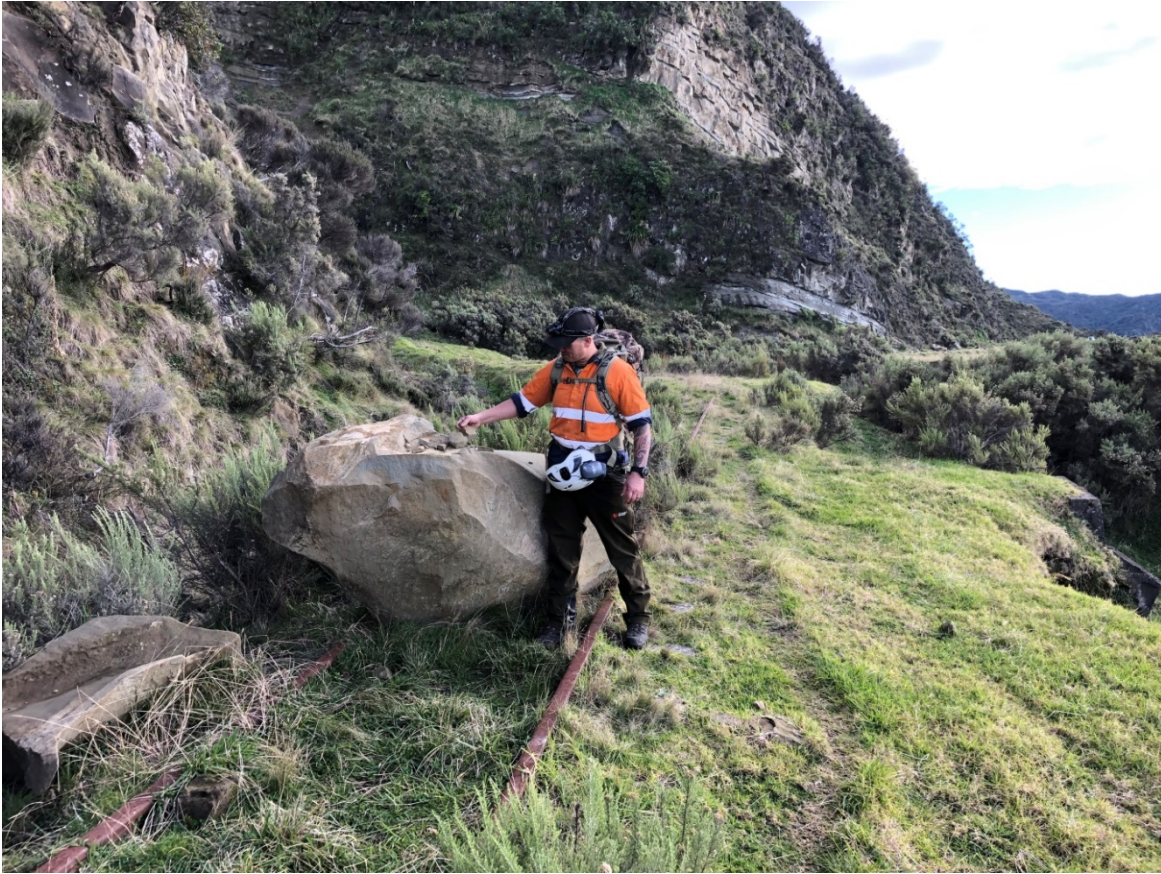
Typical rock fall debris between dropout and Tunnel 23 (note accumulated over 7 years)

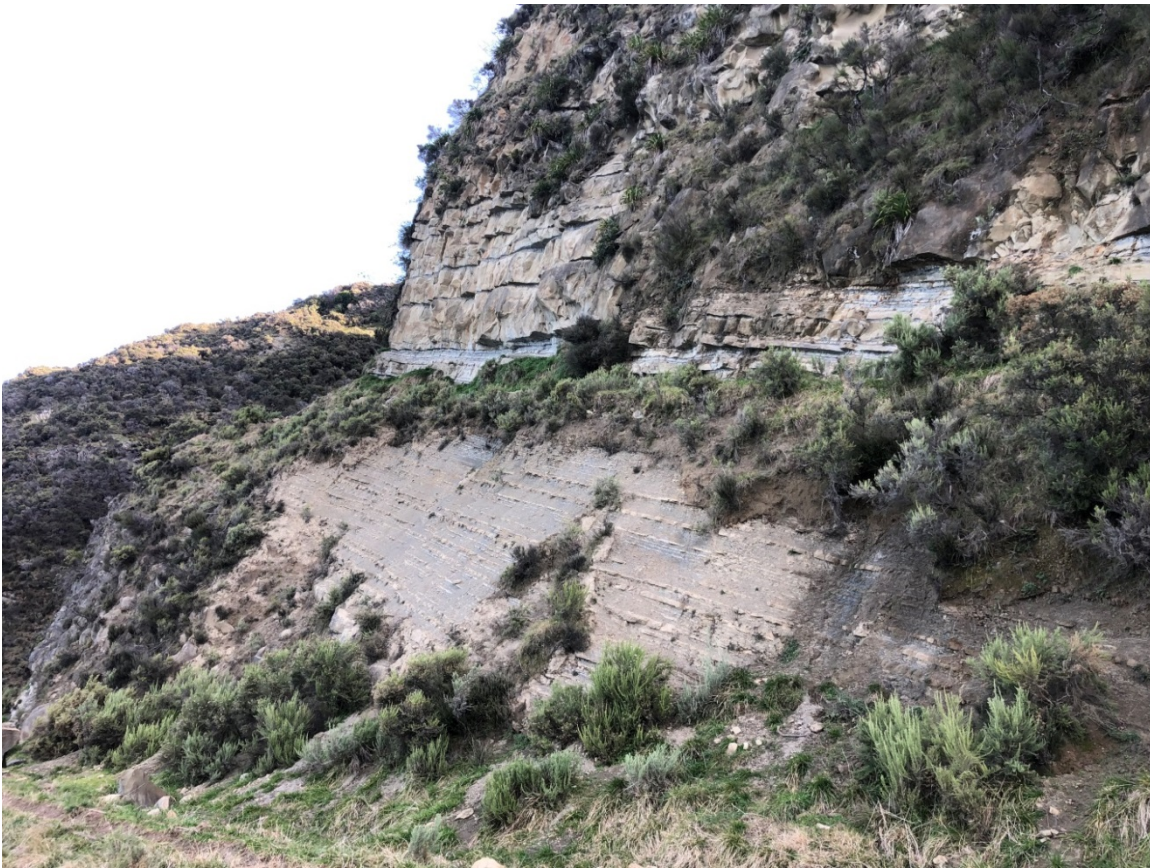
Views of rock face north of dropout 3 – note catch bench in above photo (requires clearance)-.

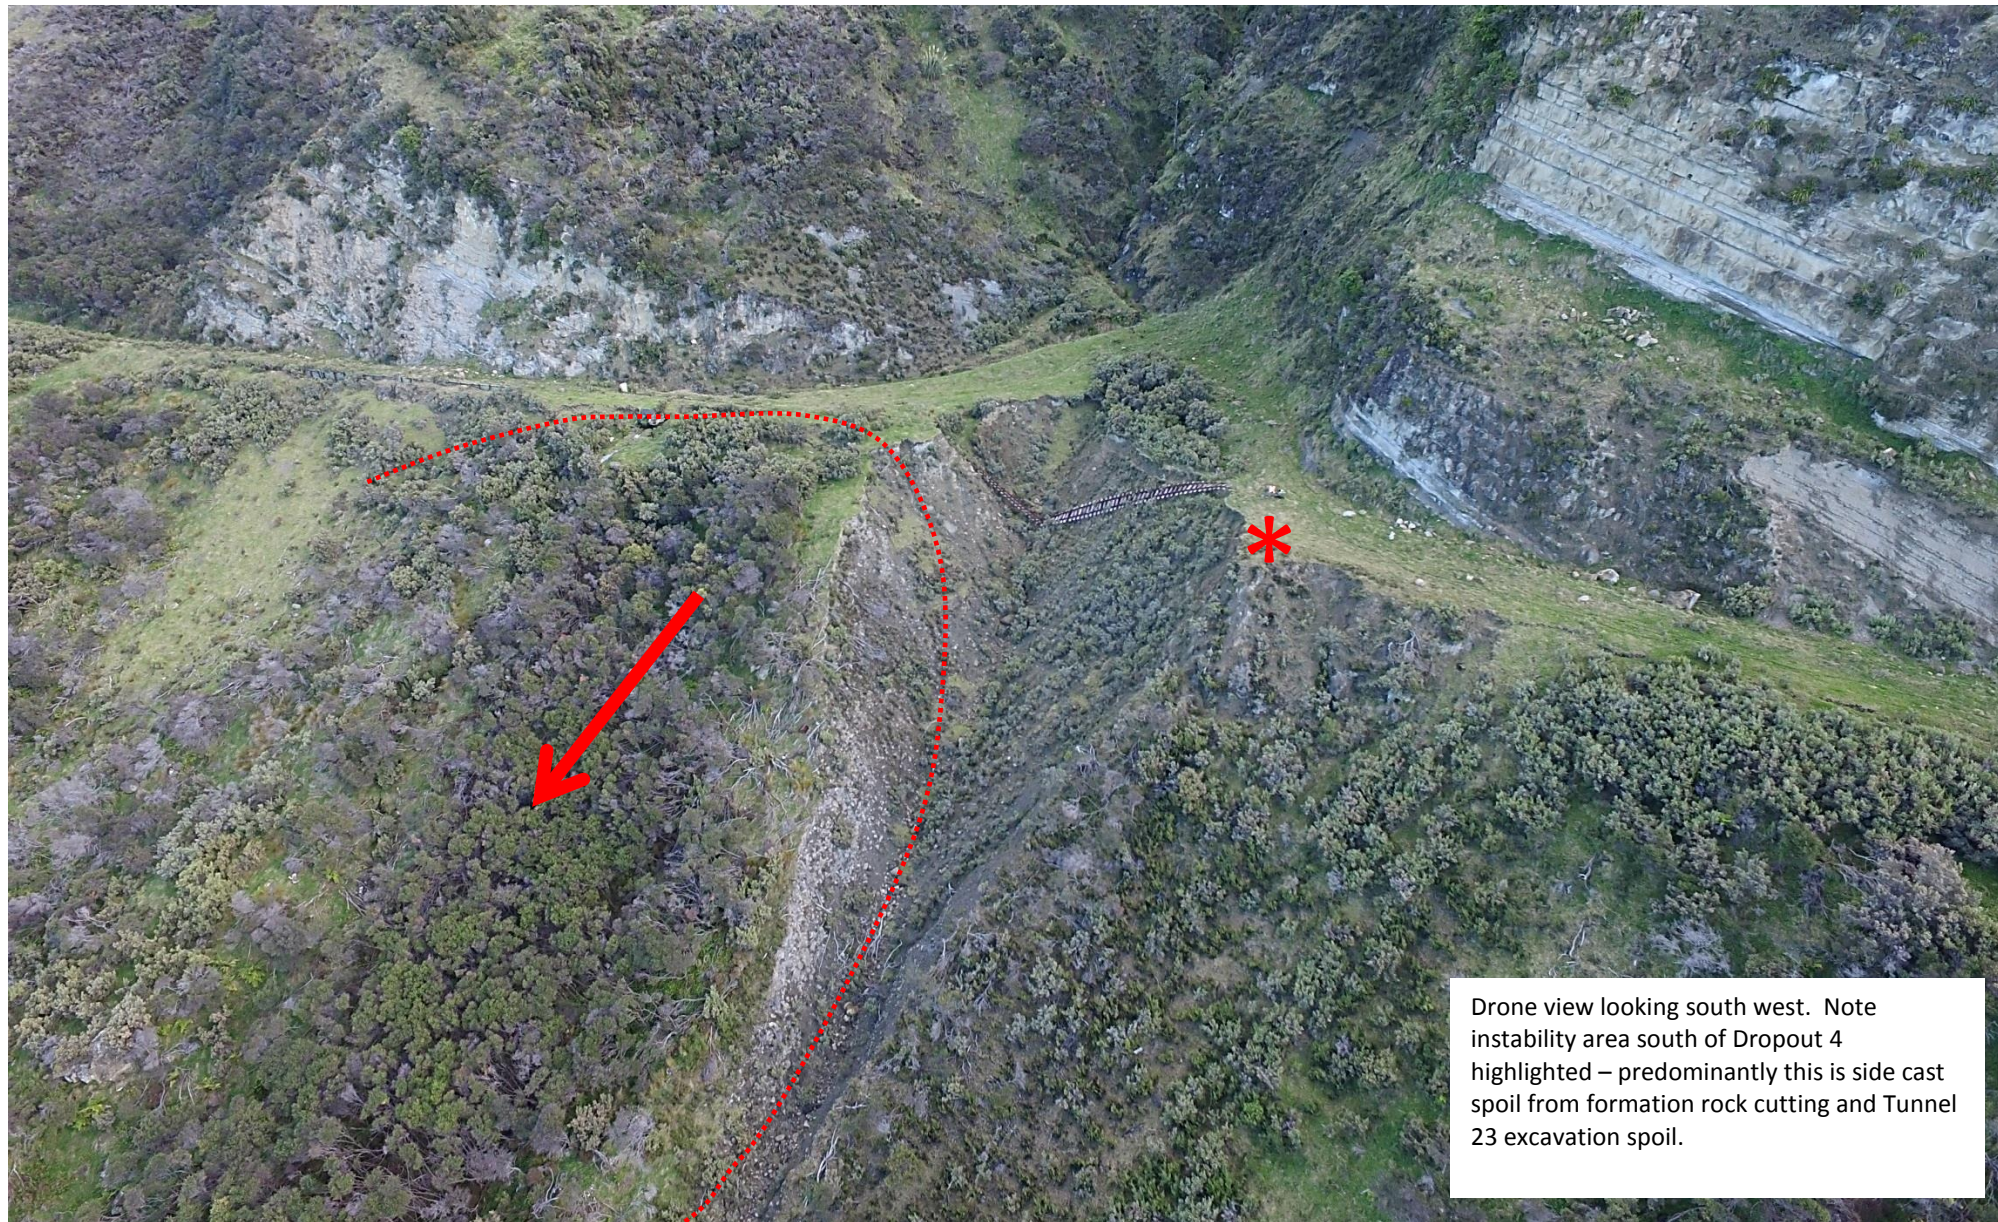
Drone view looking south west. Note instability area south of Dropout 4 highlighted – predominantly this is side cast spoil from formation rock cutting and Tunnel 23 excavation spoil.

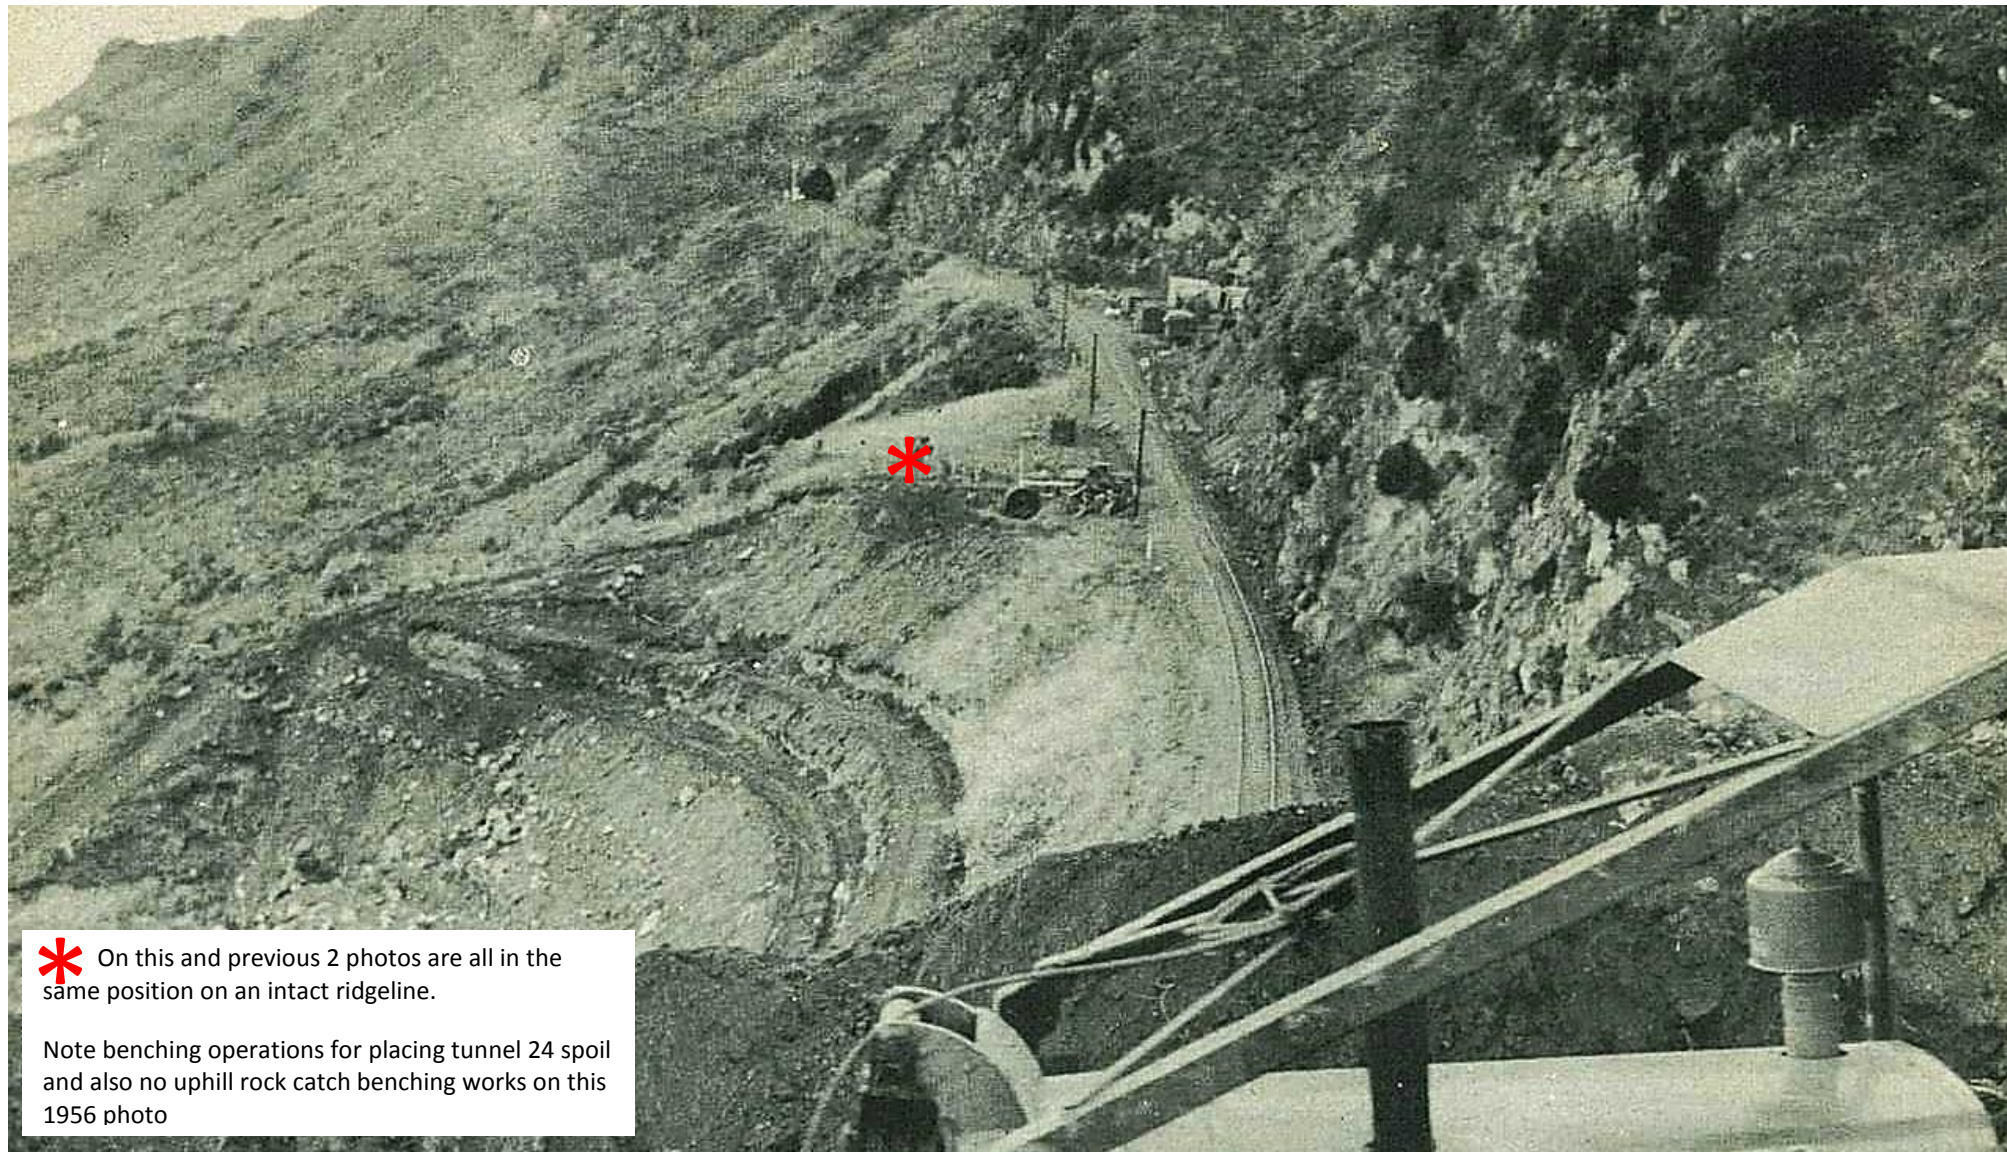
\* On this and previous 2 photos are all in the same position on an intact ridgeline.

Note benching operations for placing tunnel 24 spoil and also no uphill rock catch benching works on this 1956 photo

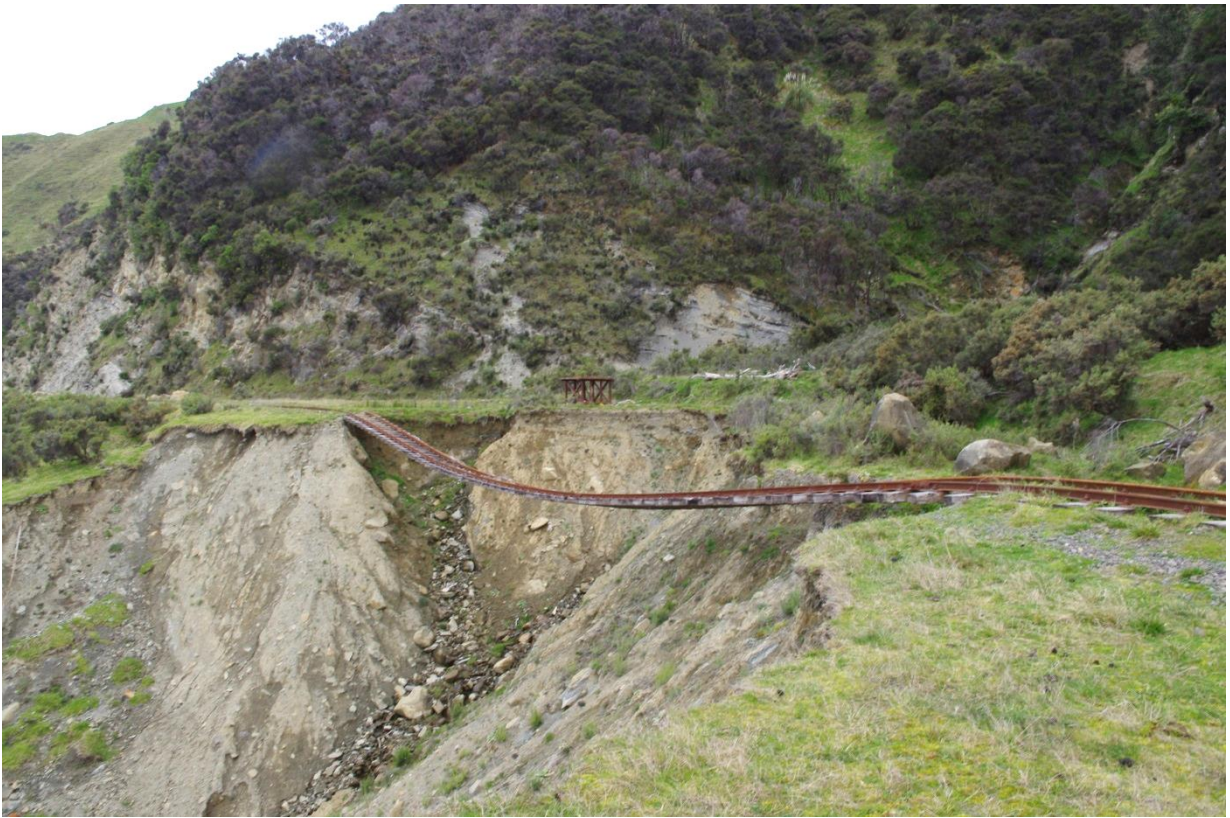
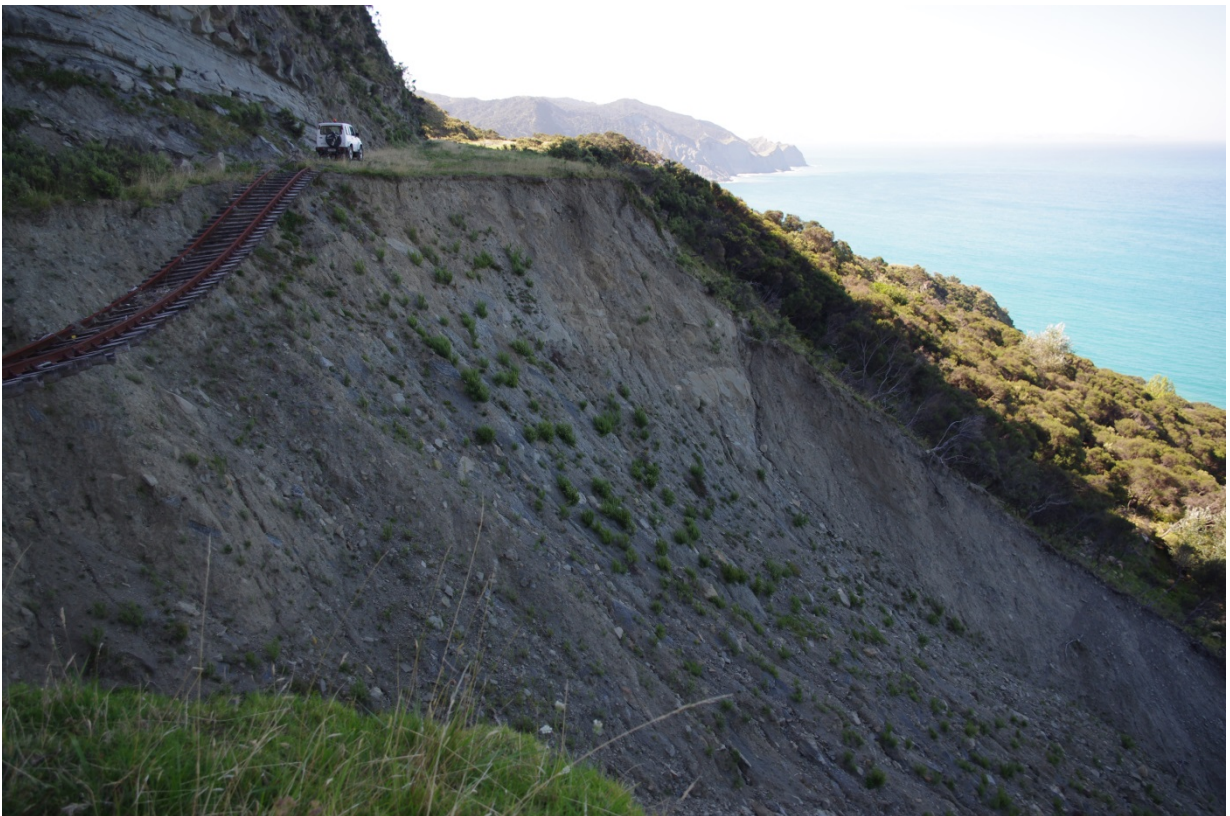
2013 photographs of dropout 3 - looking south (above), north (below)

<b>Repair Task:</b>	<b>Task 13 – Dropout 3</b>
<b>Track Location:</b>	Rail Chainage 355.57km
<b>Description:</b>	Reshape and bench out the washout area prior to installing either a 2V:1H (63 degree) sloping Paragrid reinforced MSE slope faced off with hybrid 0.5m high gabion baskets filled with local site soils or a vertically faced retaining wall structure backfilled with Paraweb reinforced GAP 80/ 100 greywacke derived hardfill.
<b>Required Works</b>	As per above
<b>Scale/ Scope/Volumes:</b>	<p>Dropout dimensions are in the order of 45m wide by 90m long and nominally 15 metres deep on the outer edge of track formation. Upstream catchment is some 0.3km<sup>2</sup> with relatively complicated and ineffective drainage system, destabilising the immediate downhill formation slope with potential for a significant landslide event to occur south of immediate dropout area. No secondary or emergency drainage system available.</p> <p>TOR is nominally RL 134m +/- . Base of the dropout on the outer formation edge is around RL120m +/- with the toe of the dropout at nominal RL90, some 60m to 70m downstream of rail centreline.</p> <p>Install new primary drainage system under track formation and discharge to north – current drainage is destabilising adjacent slope below rail formation. Consider use of 1750Ø arch box culvert set nominal 4m deep in intact rockmass, discharge onto Rip Rap or similar, on northern side of fill.</p> <p>Repair culvert outfall at 355.516km - extend outfall out and down to better discharge position, reconfigure as emergency system only.</p>

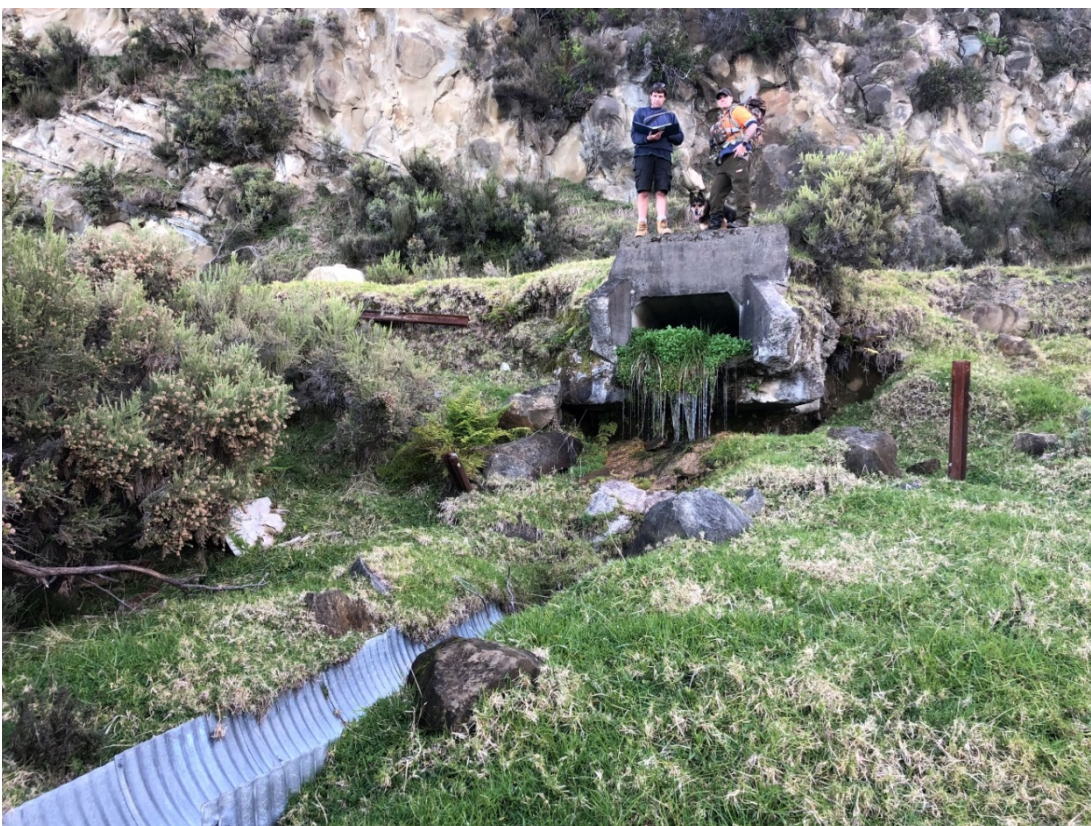
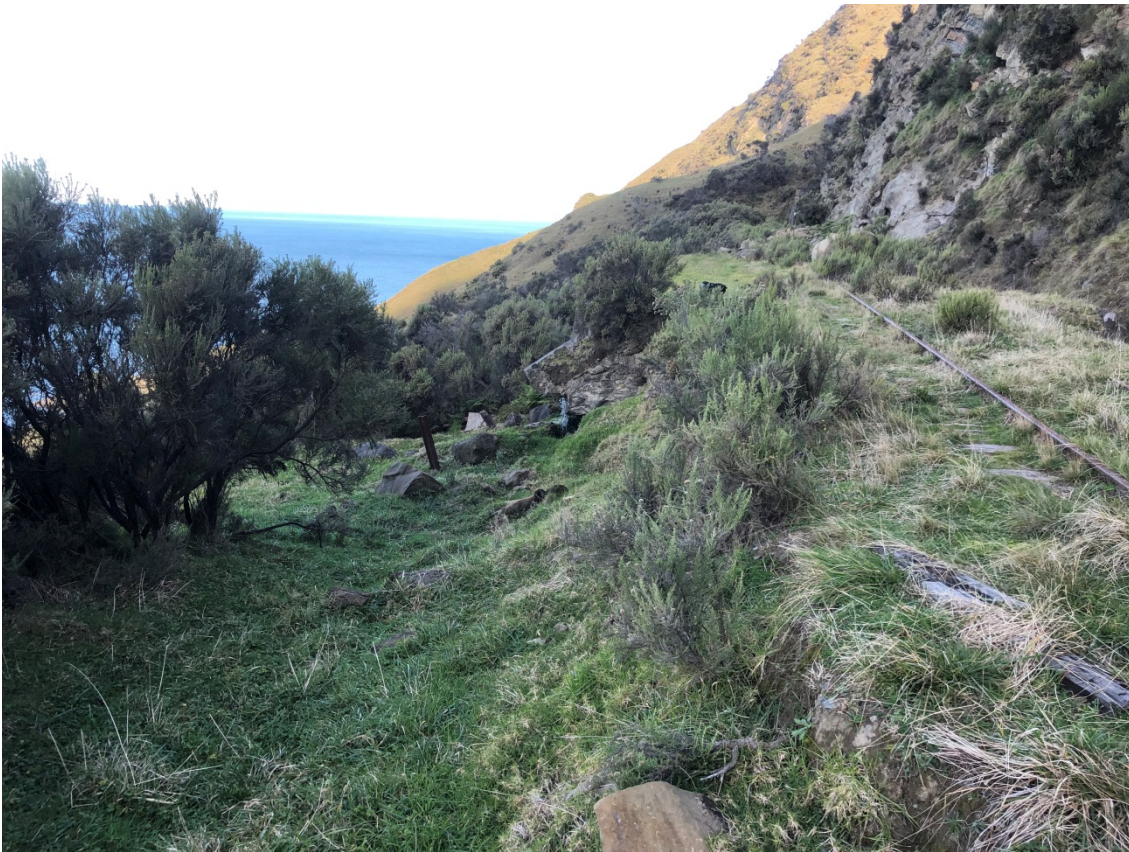
Outlet culvert@ 355.516km – 2013 photo above, 2019 photo below. Note slope movement / head scarp and ground pulling away from under culvert edge. Nominal 400mm downwards movement over 6 years due to water getting into slope from culvert discharge

<b>Construction Comment:</b>	Area uphill of old tunnel lining proposed as fill source for dropout 3
<b>Designer Comment:</b>	<p>Consider design with nominal Ru value for wet soils</p> <p>Consider subsoil drainage design, drainage aggregate, geotextile protection, megaflo Ultra 300 high strength pipe, benching works into underlying SST/ZST - rock breaker required?</p> <p>Culvert outfall extension – steel flume nominal 20m long plus 10m drop structure.</p> <p>Upstream catchment 0.3km<sup>2</sup>, Q100 flood design 5.4m<sup>3</sup>/s</p> <p>Base culvert:</p> <ul style="list-style-type: none"> <li>• New 1750Ø culvert has excess capacity with option to pass significant washed in sediment in flood event. Nominal 10m<sup>3</sup>/s @ 2.0m head – invert depth around 4m to allow sufficient granular backfill over top of arch.</li> <li>• Existing 0.9*1.2 arch culvert at 355.516km has 2.1m<sup>3</sup>/s @ 1.2m head - reconfigure for emergency bypass only.</li> </ul>

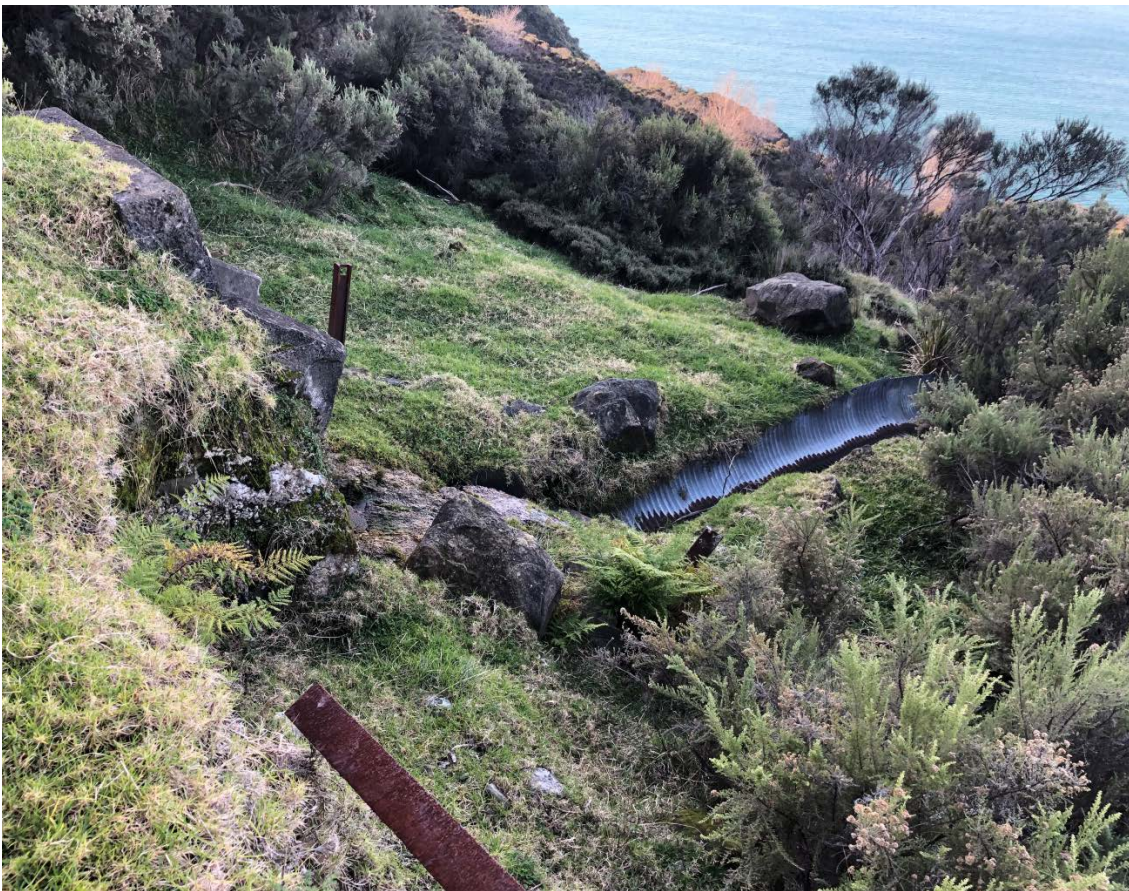
Existing flume details – require upgrading and replacement

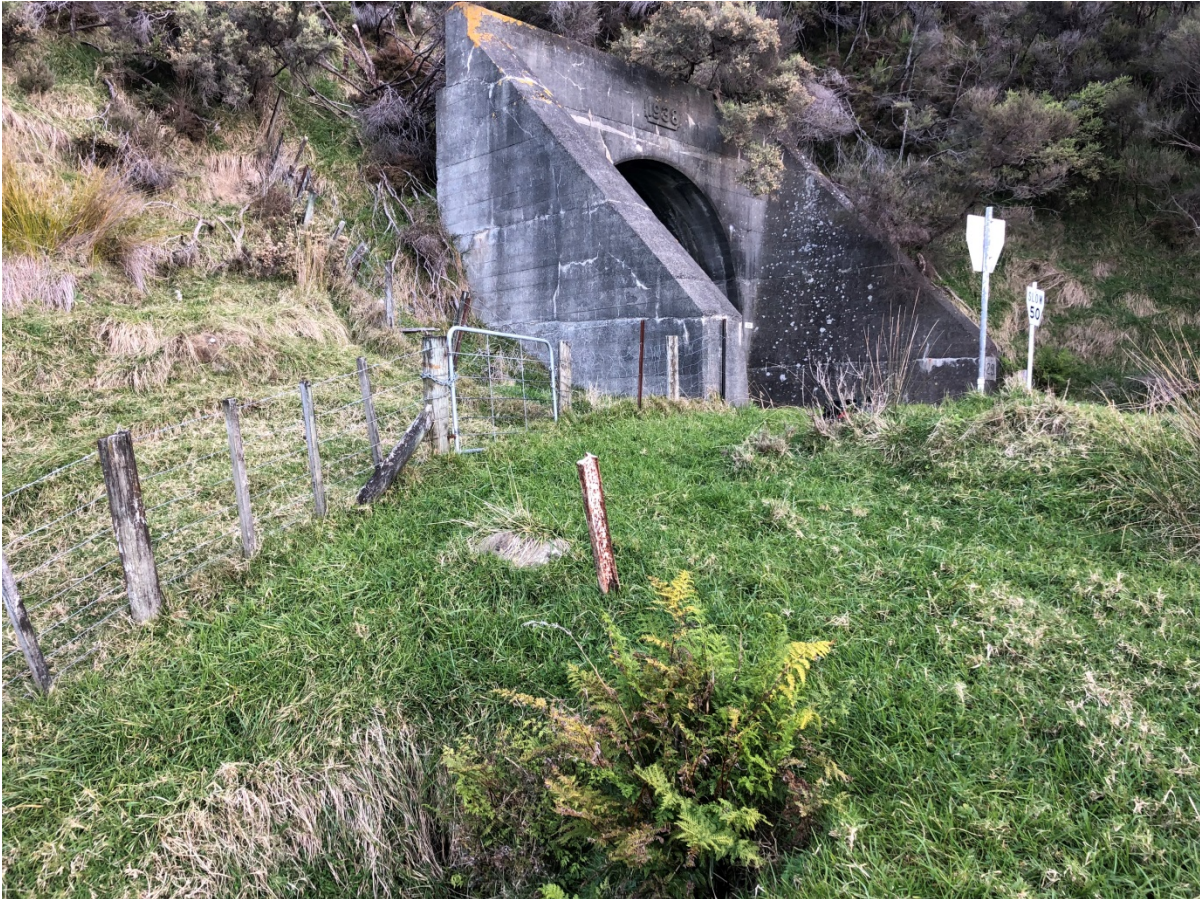
Tunnel 23 drainage outlet in picture foreground – requires cleanout.

<b>Repair Task:</b>	<b>Task 14a – Tunnel 23 Northern Portal</b>
<b>Track Location:</b>	Rail Chainage 355.354km
<b>Description:</b>	Drainage works @ Northern Portal
<b>Required Works</b>	Clean out swale and outfall drainage at northern portal Establish where significant sound of water coming from nominal 355.28km inside tunnel - google & drone images suggest deeply scoured narrow gully on slope above tunnel centreline, is water getting down in behind tunnel lining ?
<b>Scale/ Scope/Volumes:</b>	Scale & volumes TBC Predominantly clean up work, minor works package
<b>Construction Comment:</b>	
<b>Designer Comment:</b>	Tunnel drainage in generally good condition – clean out outfall, track down exterior lining inflow. Note tunnel is acting as drainage under slope to south, inflow unlikely to be an issue provided tunnel lining is not exposed
<b>Rail Operations:</b>	Work trains past site, including deliveries for dropout 4.

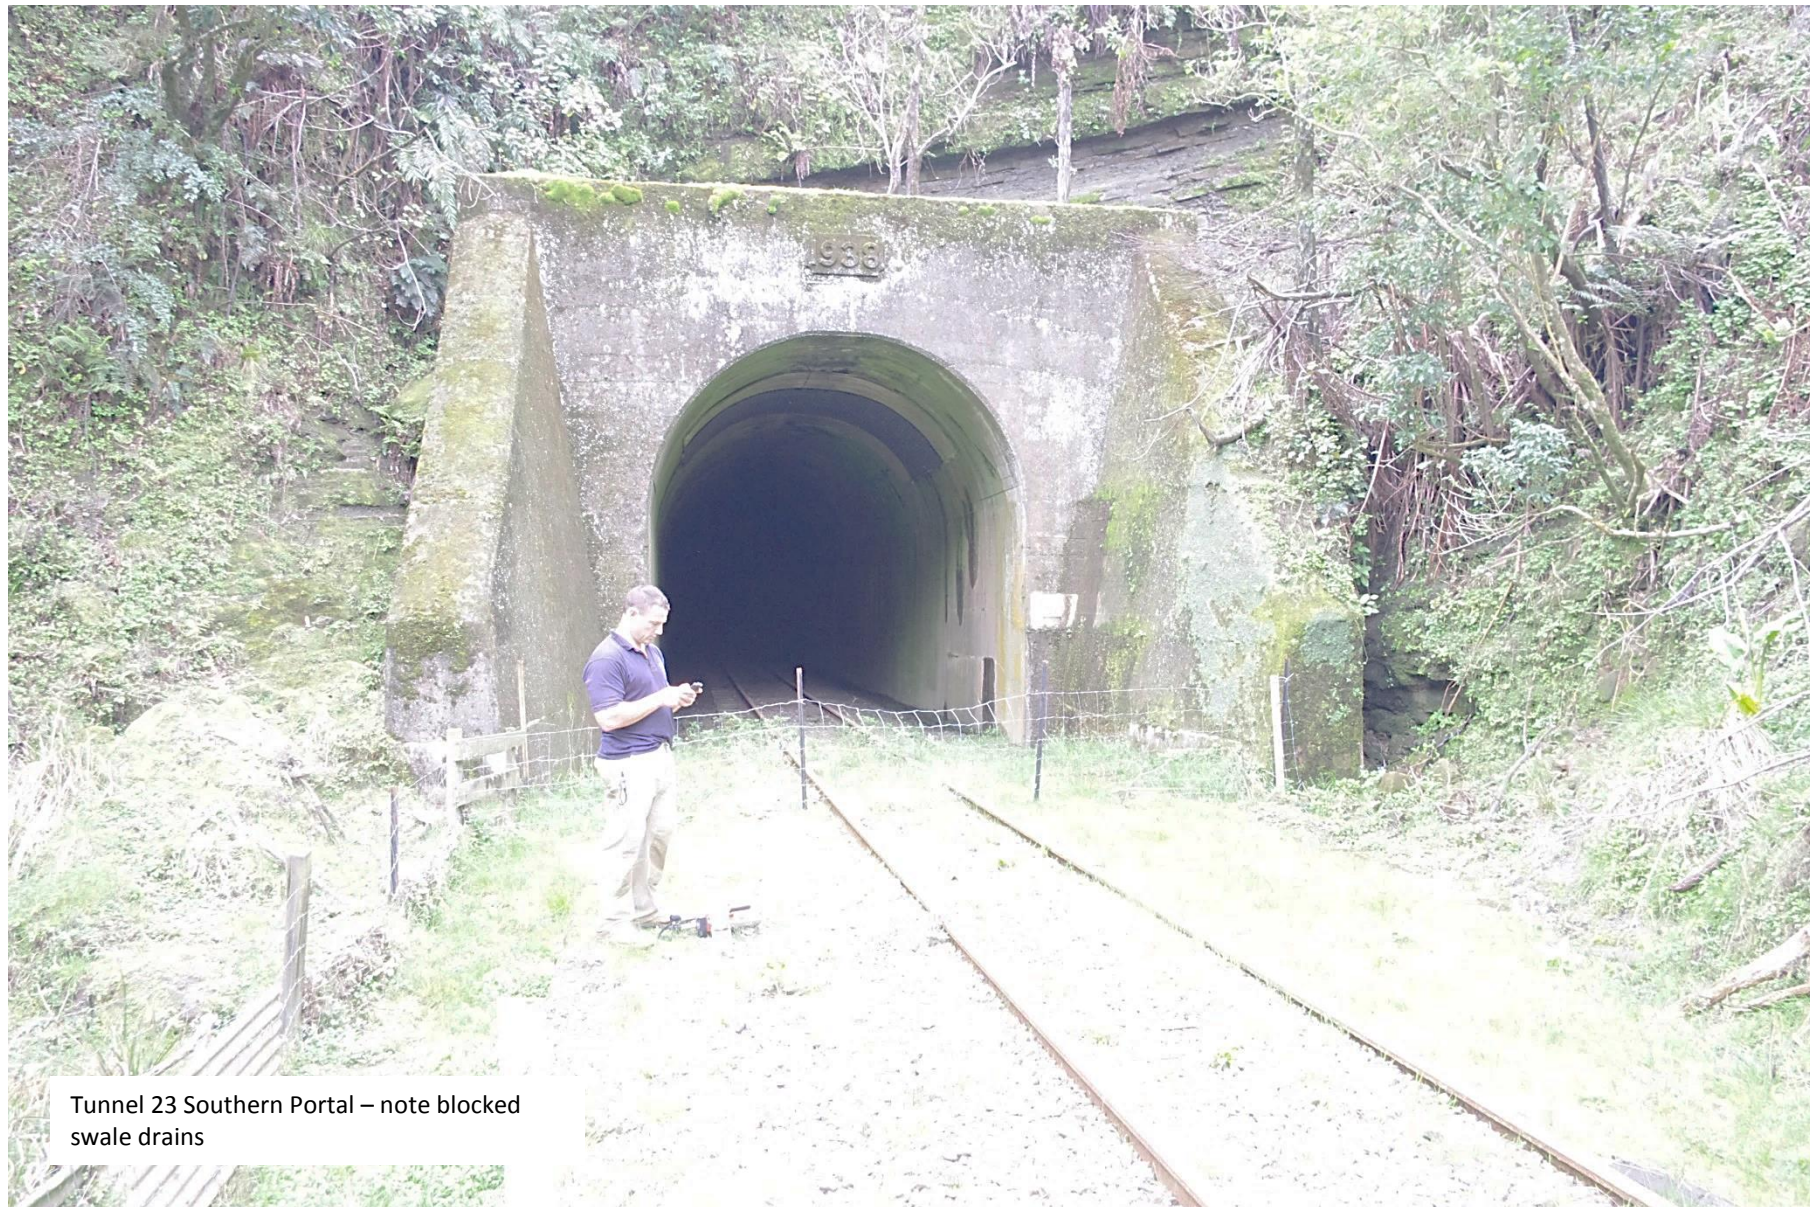
Tunnel 23 Southern Portal – note blocked swale drains

<b>Repair Task:</b>	<b>Task 14b – Tunnel 23 Southern Portal</b>
<b>Track Location:</b>	Rail Chainage 355.41km
<b>Description:</b>	Drainage works @ Southern Portal
<b>Required Works</b>	Clean out swale drainage - extend and deepen towards south. Install new 900mm diameter culvert adjacent to existing culvert @ 355.420km as additional bypass capacity
<b>Scale/ Scope/Volumes:</b>	Scale & volumes TBC
<b>Construction Comment:</b>	Two 455mm diameter culverts recorded on KR culvert log (positions need checked against mobile road data): 355.411km, 455mm diameter, 10m long, 1.5m deep ( note seen on site – blocked) 355.420km, 10m long, 1.5km deep ( next to portal)
<b>Designer Comment:</b>	Evidence of water and silt flowing back into tunnel for 50 to 100m – additional outlet capacity required plus swale cleanouts. Extend swale cleanout southwards to Tikiwhata stream next to Bridge 271 – approx. meterage 355.080km New 900mm culvert.

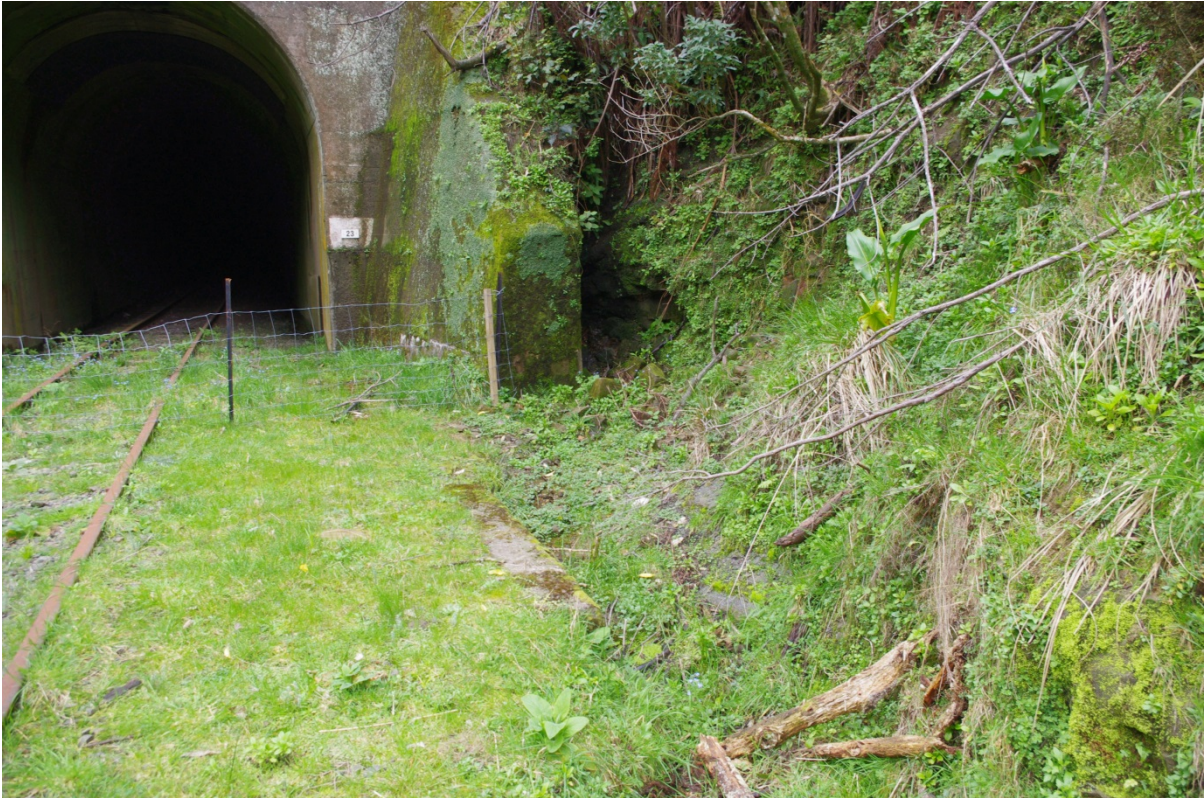
2013 Photographs – blocked swale drainage and culvert inlet (assumed 355.420km location)
