<b>Repair Task:</b>	<b>Task 12 – Rock Scaling 355.42 - 355.79</b>
<b>Track Location:</b>	Rail Chainage 355.42-355.79
<b>Description:</b>	Cliff face areas require scaling to remove significant rock fall hazard.
<b>Required Works</b>	
<b>Scale/ Scope/Volumes:</b>	Allow to scale cliff face Allow to put 20 tonne excavator up on bench and remove collected rocks - push out onto formation bench below. Remove track and sleeper sets prior.
<b>Construction Comment:</b>	Require expert assistance to define scale and scope of problem - prelim budget 12 days of actual abseil work on site.
<b>Designer Comment:</b>	Require expert assistance to define scale and scope of problem - prelim budget 12 days of actual abseil work on site.
<b>Rail Operations:</b>	Work trains past site, including deliveries for Dropout 3 & 4.

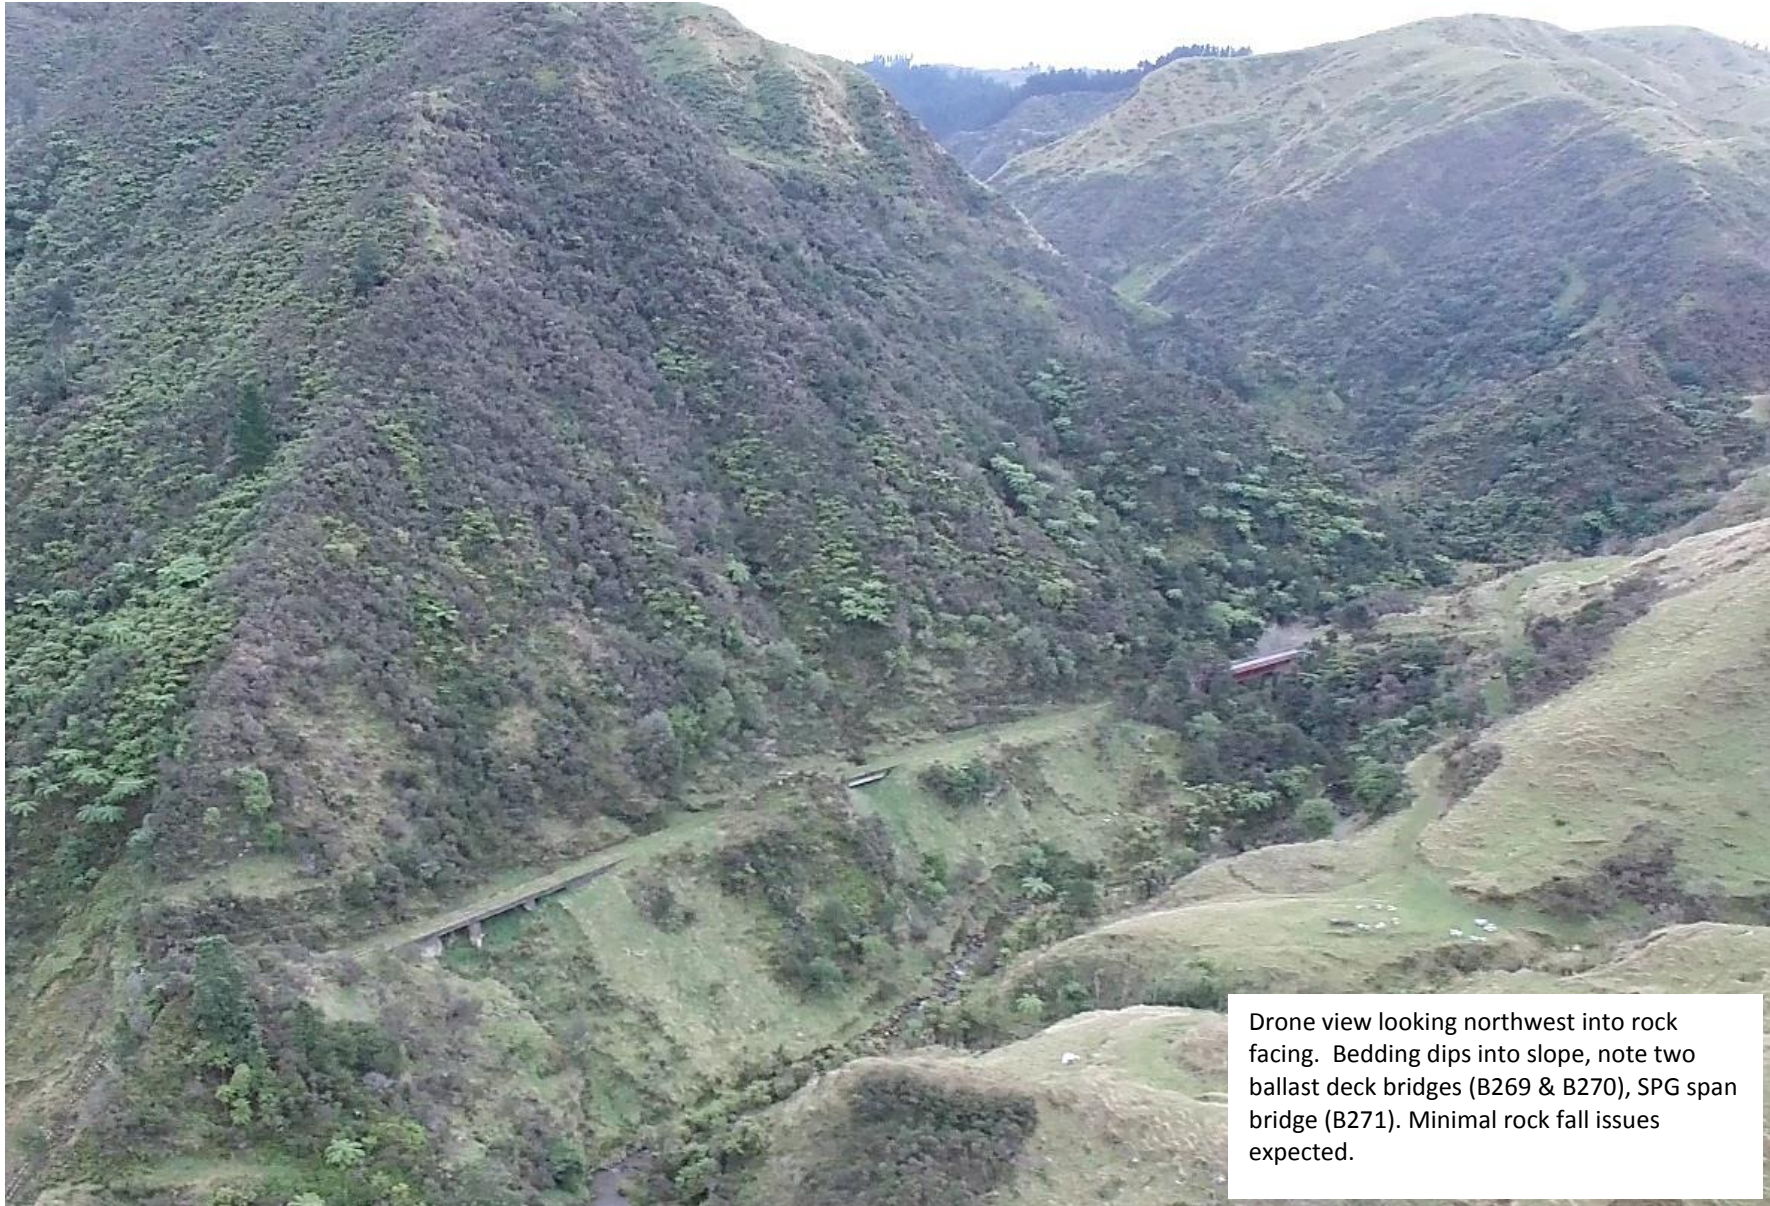
Drone view looking northwest into rock facing. Bedding dips into slope, note two ballast deck bridges (B269 & B270), SPG span bridge (B271). Minimal rock fall issues expected.

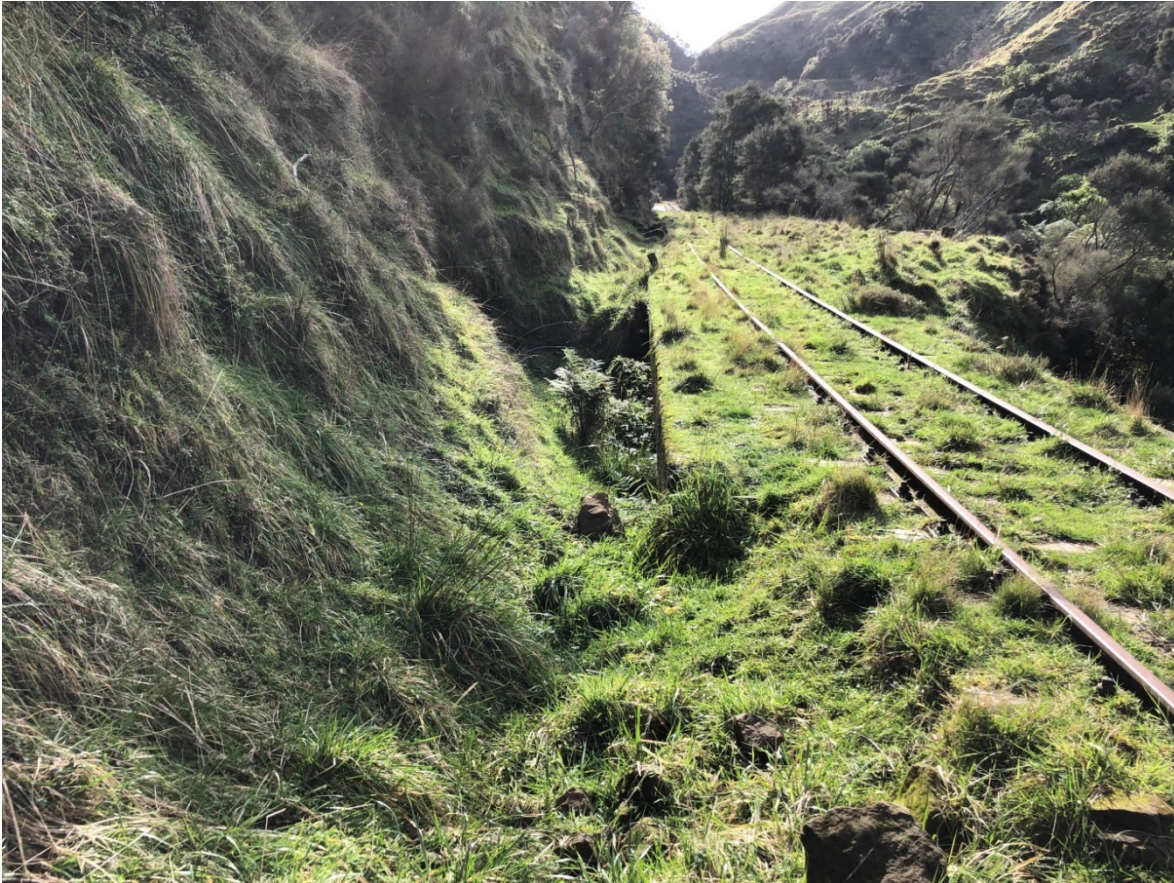
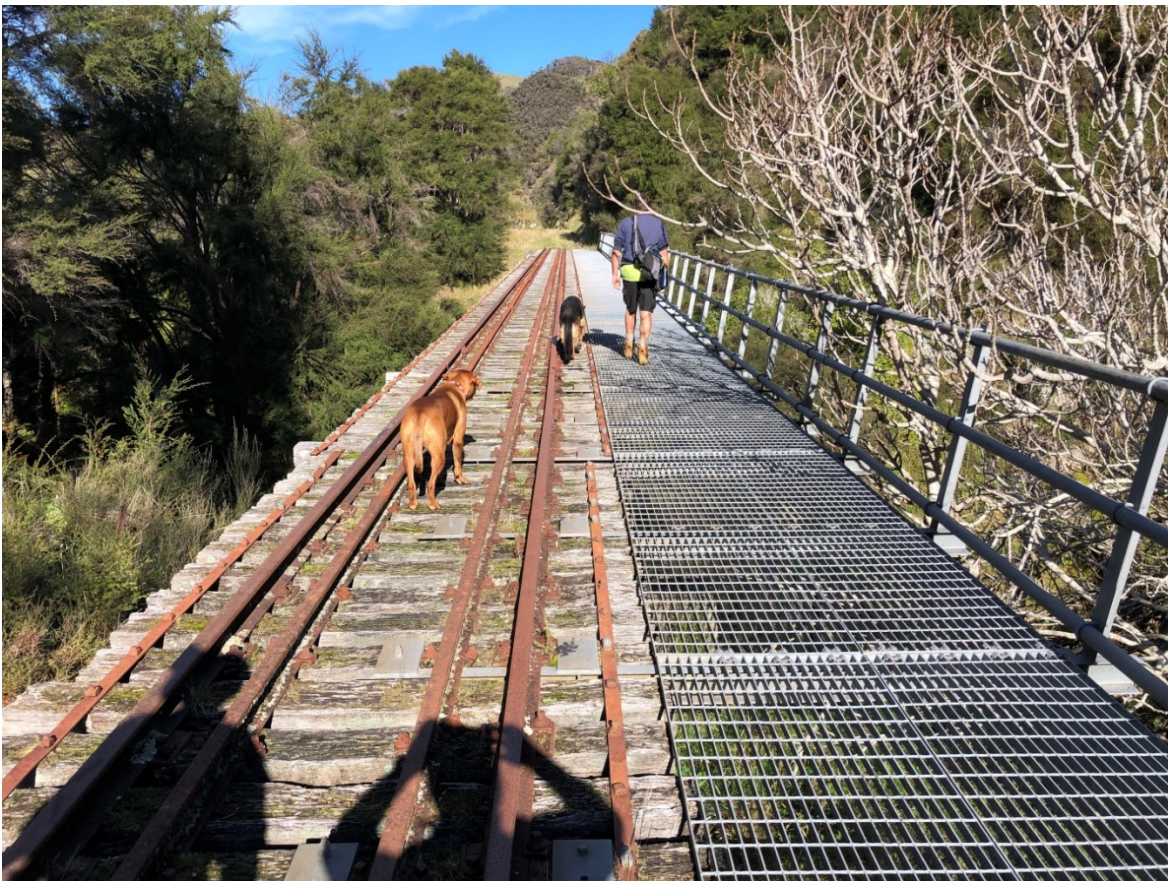
2019 Photos – looking across Bridge 270 to north (above), Bridge 271 to south (below)

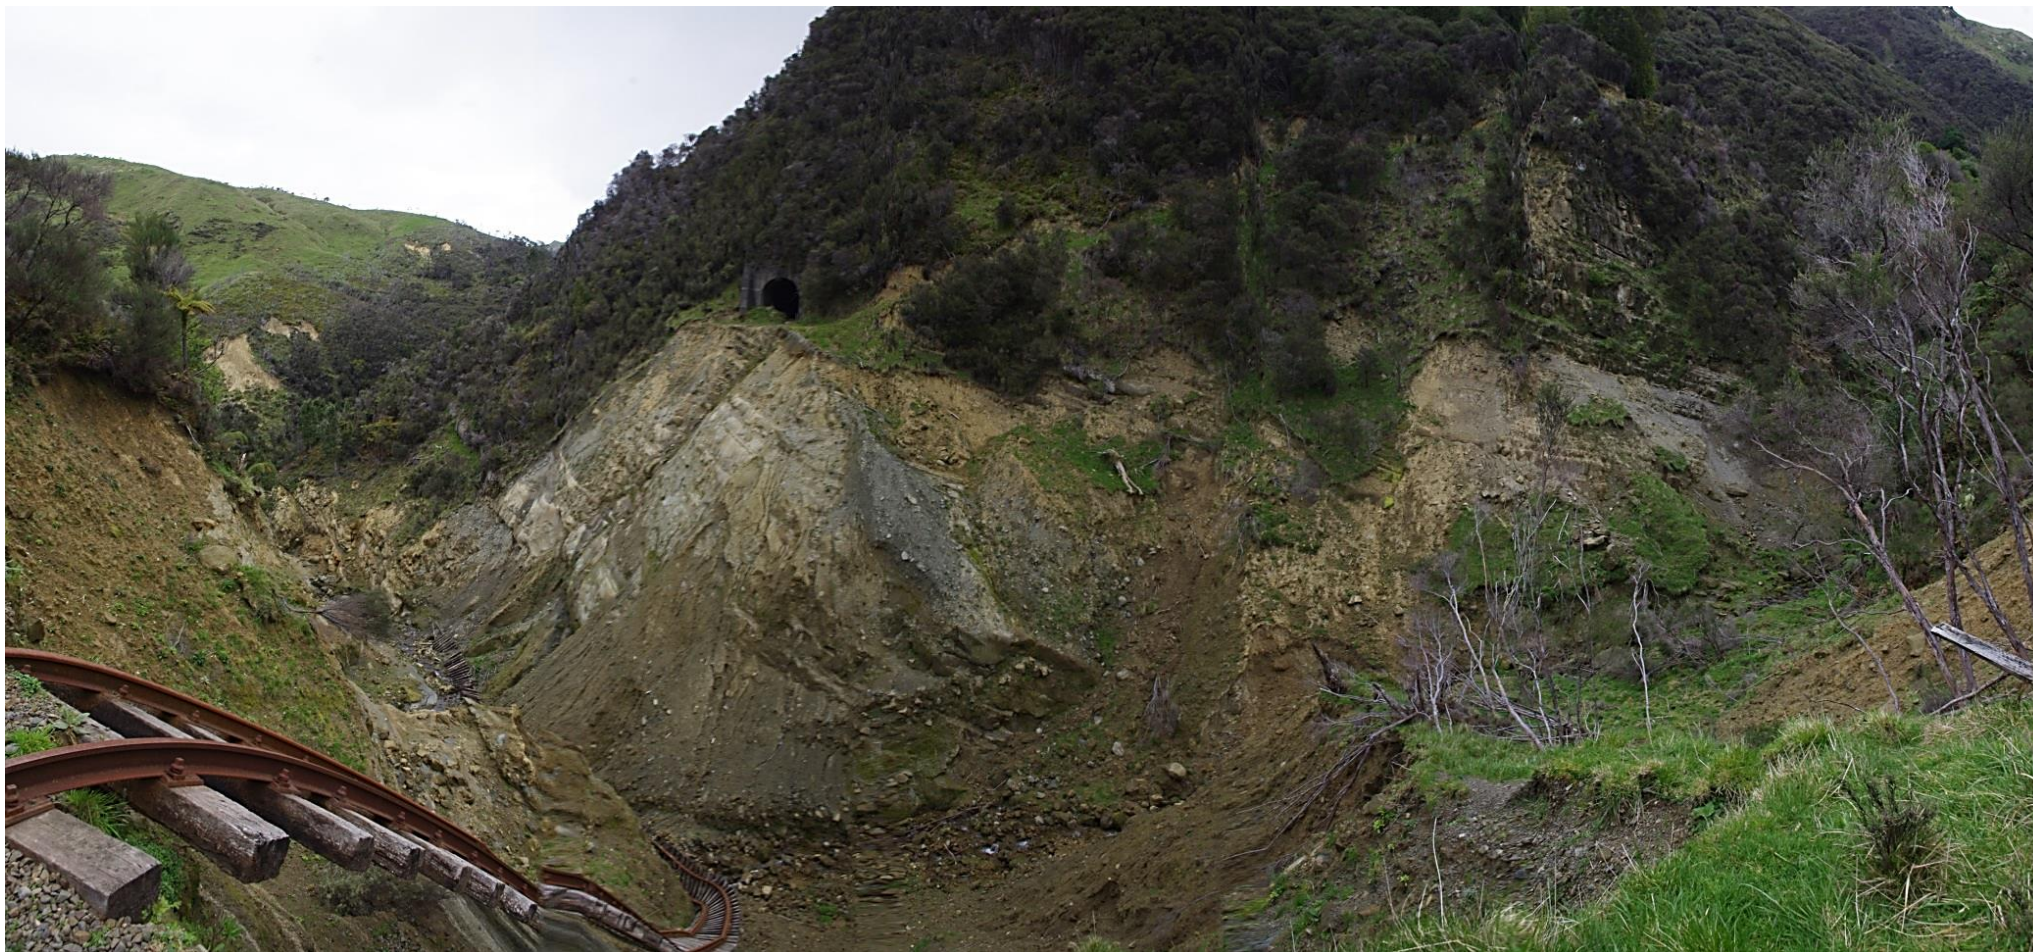
2013 view looking south. Note remnant tunnel spoil in base of gully along base of southern facing – this is mostly eroded away in 2019 photos

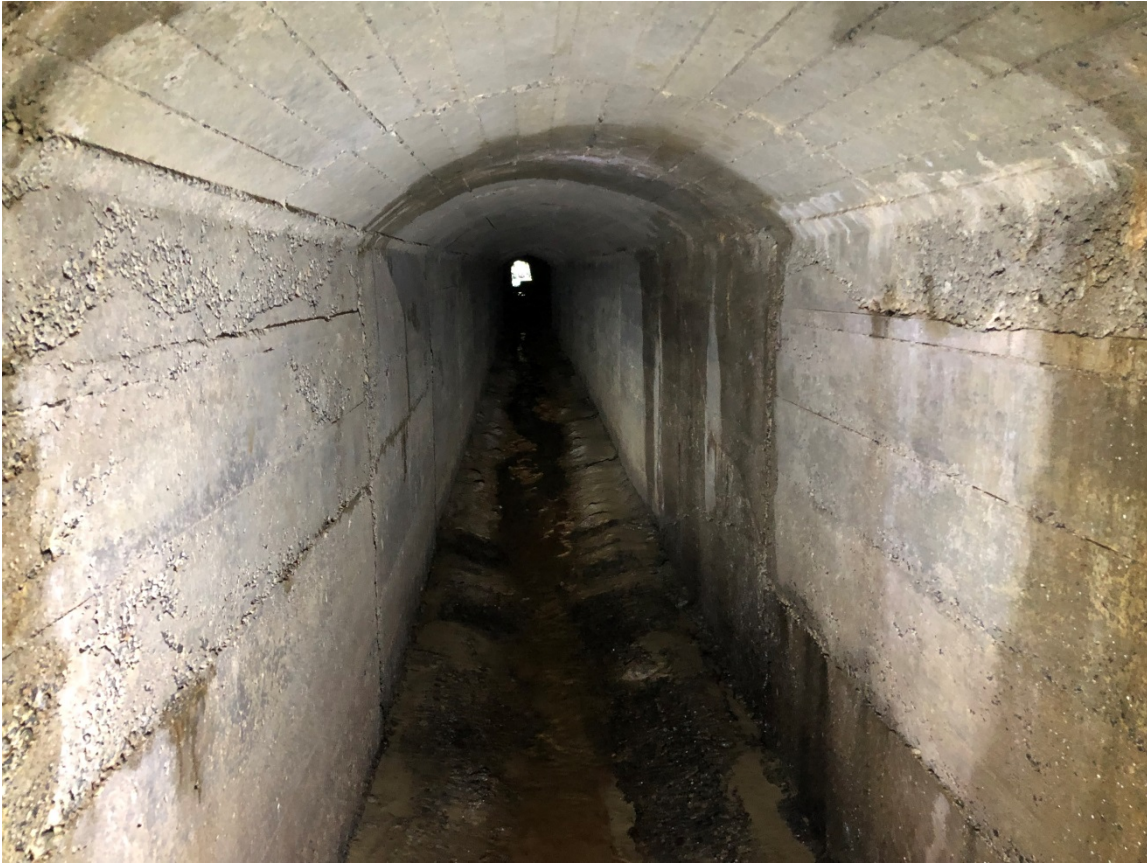
Drainage drive photos – above is nominal 2.5\*2.5 tunnel section for 60m downstream of arch culvert

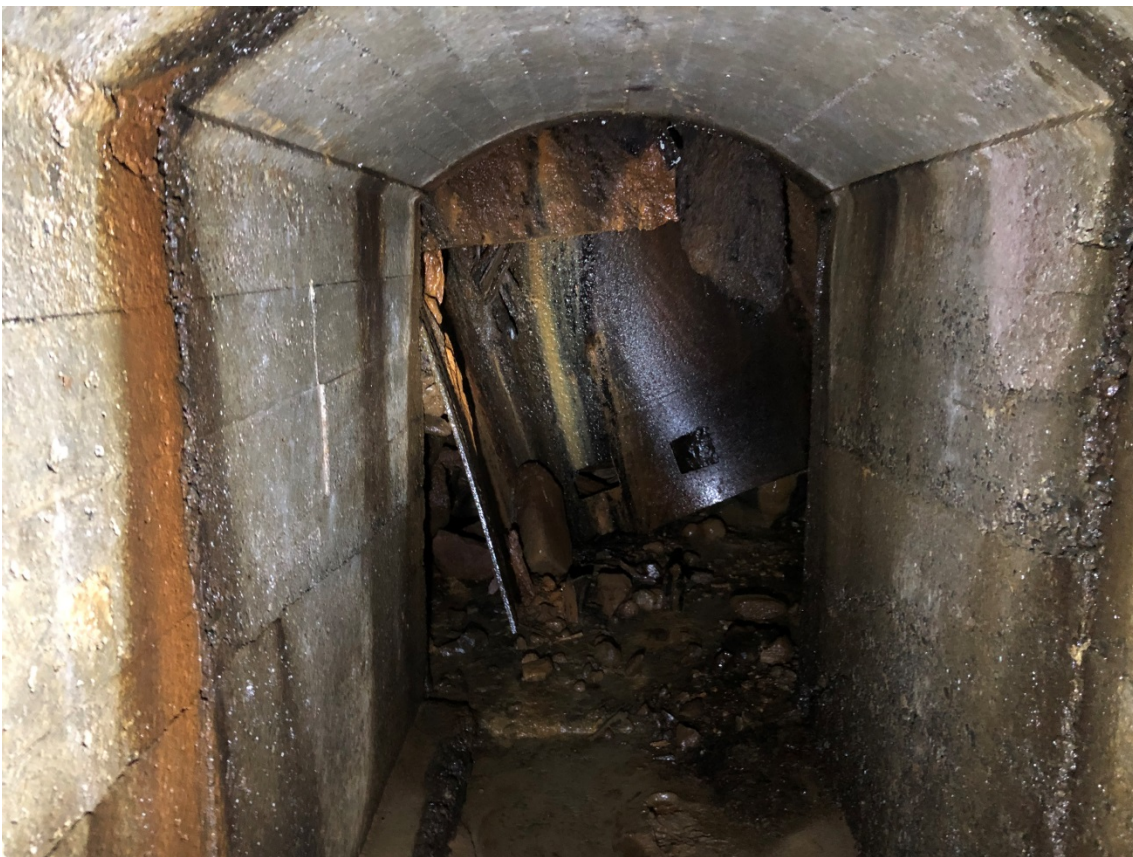
1.22 wide by 1.8m high arch culvert, 30m long @ upstream end. Note blocked inlet

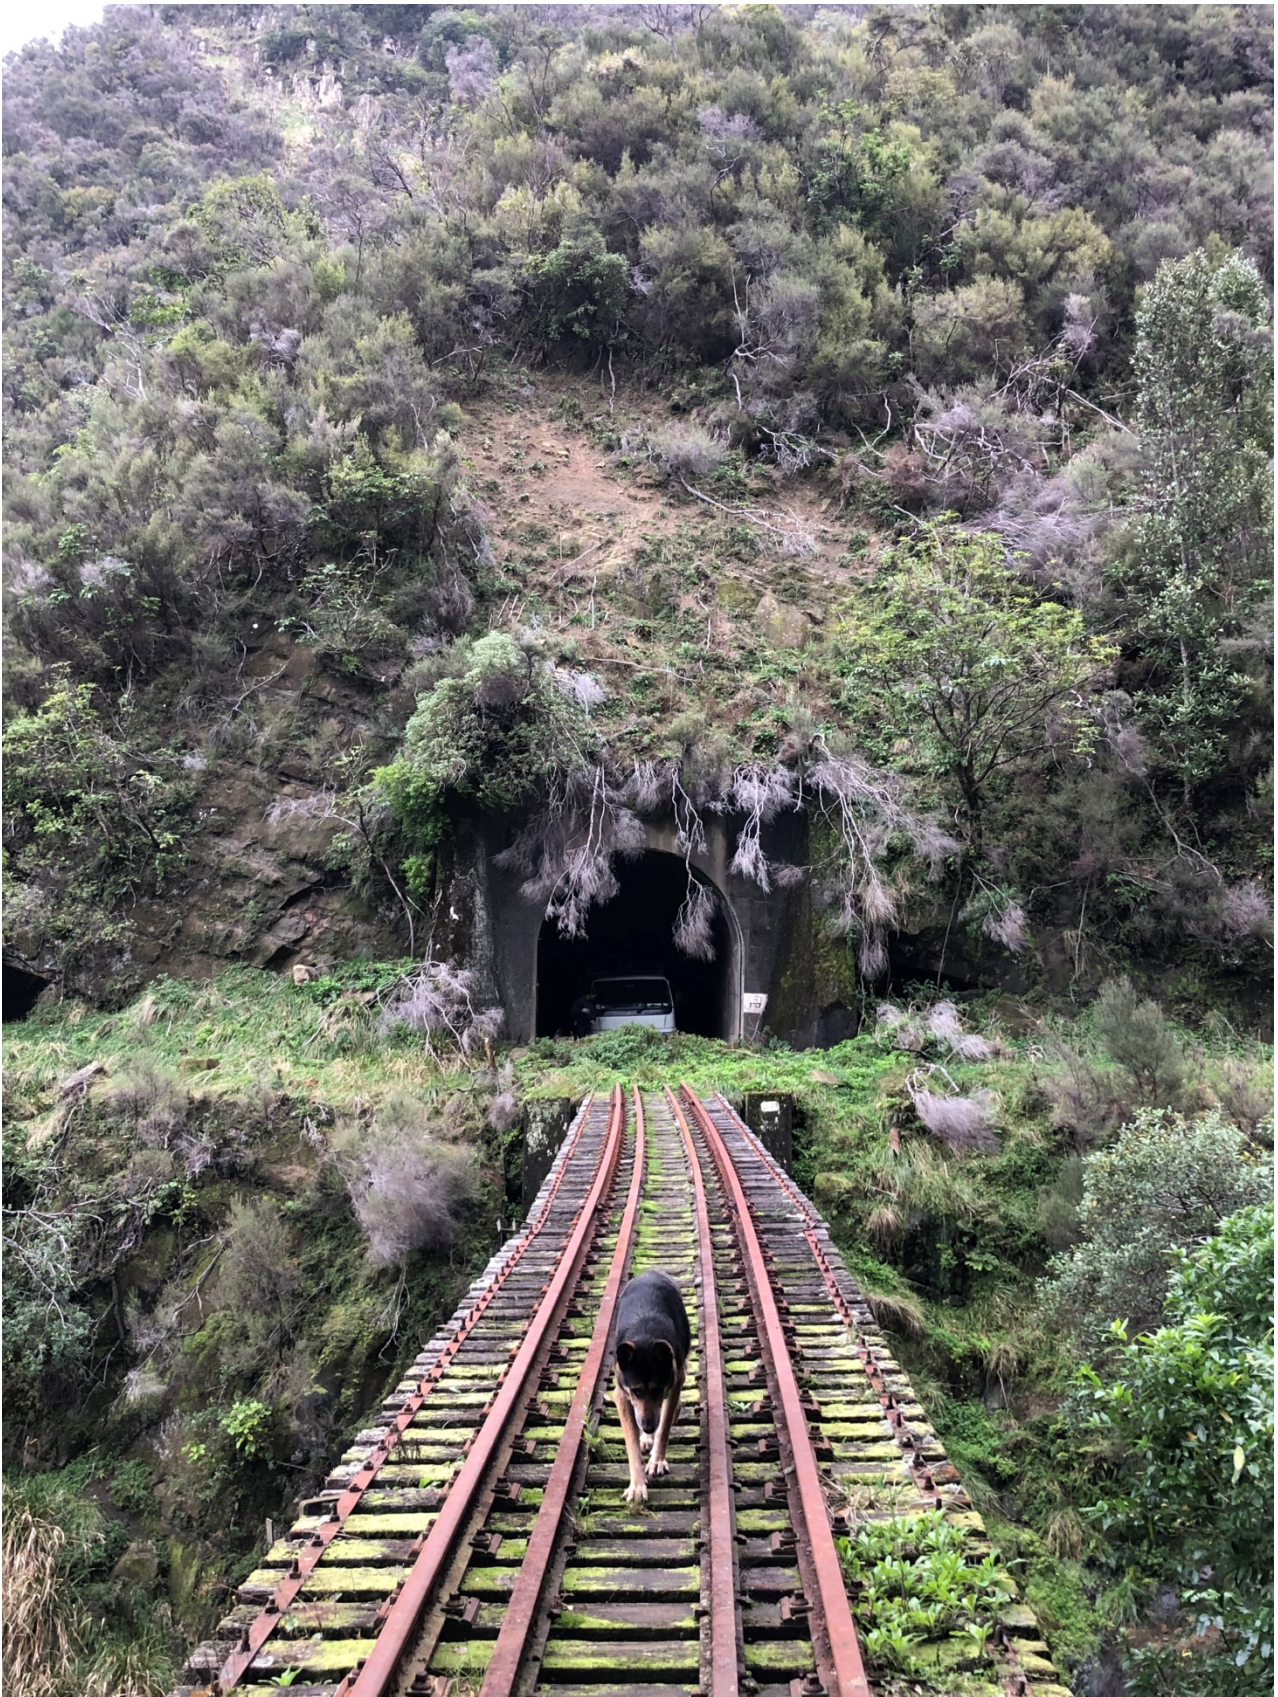
View looking into Tunnel 19 northern portal – note minor slip above portal entrance with debris on track. Bridge 268A in foreground.

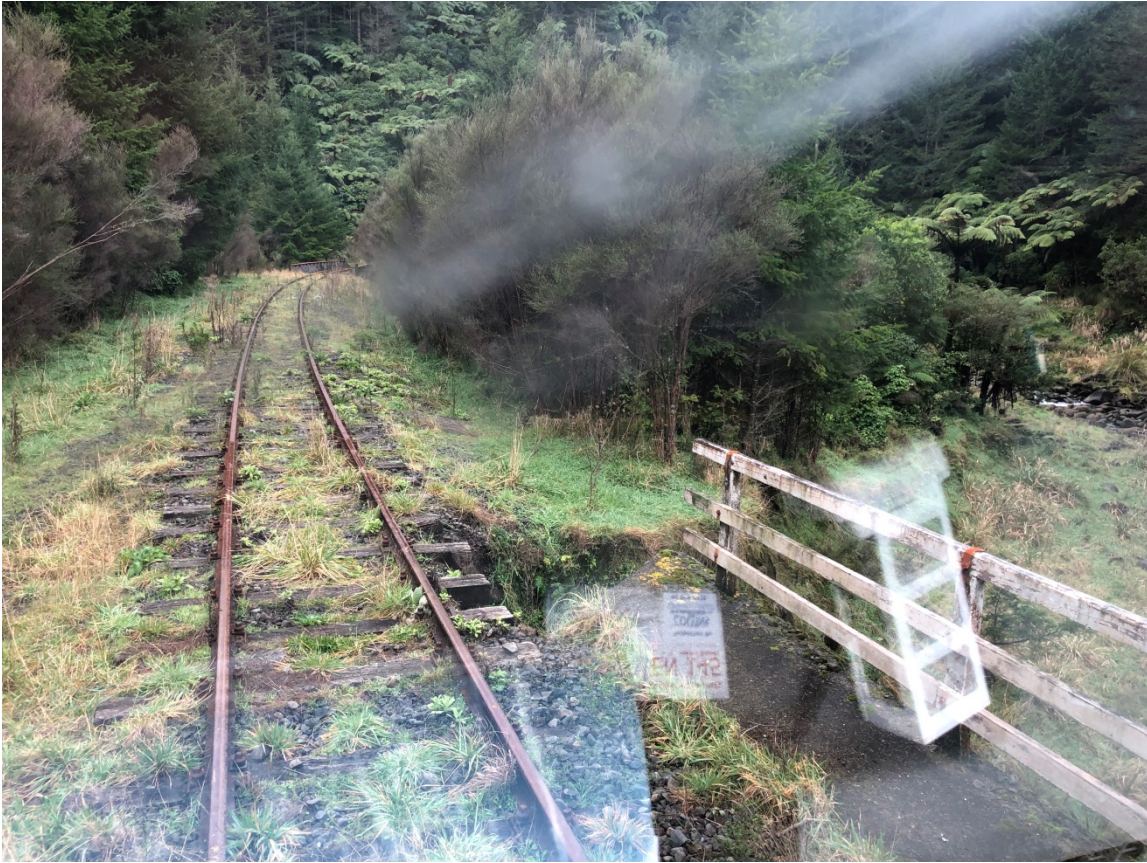
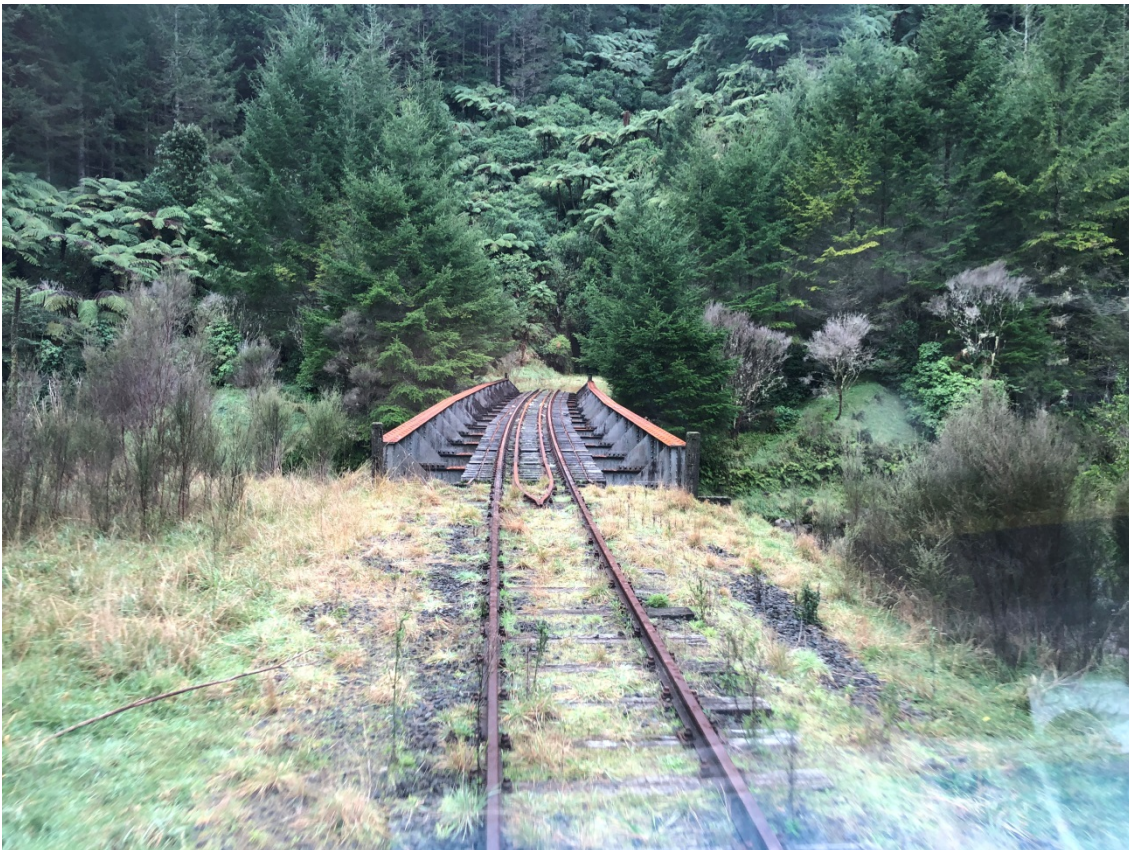
Bridge 266 above showing minor erosion repair works, Bridge 267 below.

<b>Repair Task:</b>	<b>Task 20 Tikiwhata Tunnel Southern Bridges</b>
<b>Track Location:</b>	Rail Chainage 350.25km
<b>Description:</b>	Erosion Protection Bridge 266 & 267
<b>Required Works</b>	
<b>Scale/ Scope/Volumes:</b>	Allow to use large rock to provide additional erosion protection on northern bridge abutment 266 Check erosion protection on bridge 267
<b>Construction Comment:</b>	
<b>Designer Comment:</b>	
<b>Rail Operations:</b>	Unlikely to have rail operations during works

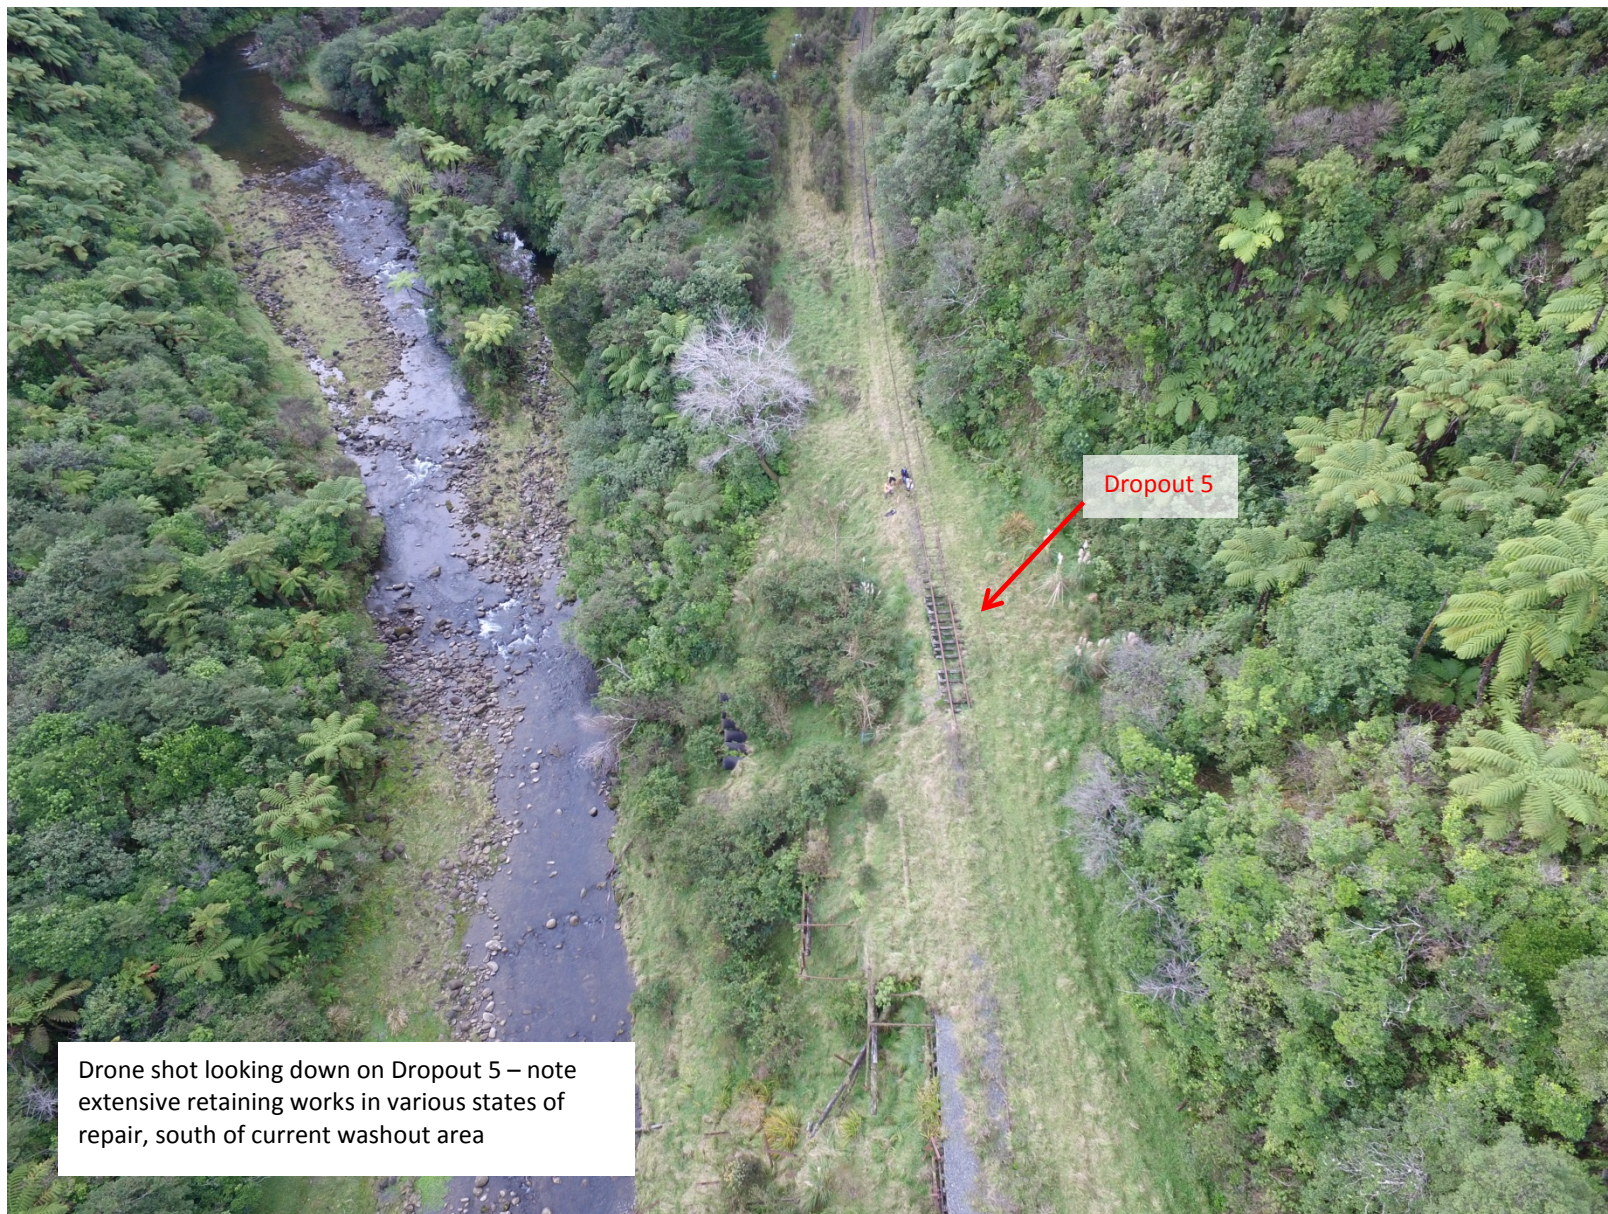
Drone shot looking down on Dropout 5 – note extensive retaining works in various states of repair, south of current washout area

<b>Repair Task:</b>	<b>Task 22 – Dropout 5</b>
<b>Track Location:</b>	Rail Chainage 349km
<b>Description:</b>	Formation repair, track drainage upgrade, possible minor track slew
<b>Required Works</b>	
<b>Scale/ Scope/Volumes:</b>	<p>Repair scour under track and reinstate formation with low height concrete block walls.</p> <p>Assess swale drainage and upgrade water movement - likely blocked culverts, may require additional culverts or upgrading.</p> <p>Track slew dependant on rebuild proximity to bank - significant erosion has occurred immediately downstream. Consider large rock scour protection or short river structure to push water out from bank toe.</p>
<b>Construction Comment:</b>	Relatively minor works to repair; additional erosion protection should be considered while plant and machinery are in area.
<b>Designer Comment:</b>	<p>Dropout 5 constructed on extensive 1940s embankment filling – see photos.</p> <p>Repair scour under track and reinstate formation with concrete block walls. Consider additional erosion protection at toe of embankment.</p> <p>Assess swale drainage and upgrade water movement - likely blocked culverts, may require additional culverts or upgrading.</p> <p>Track slew dependant on rebuild proximity to bank - significant erosion has occurred immediately downstream. Consider large rock scour protection or short river structure to push water out from bank toe.</p>

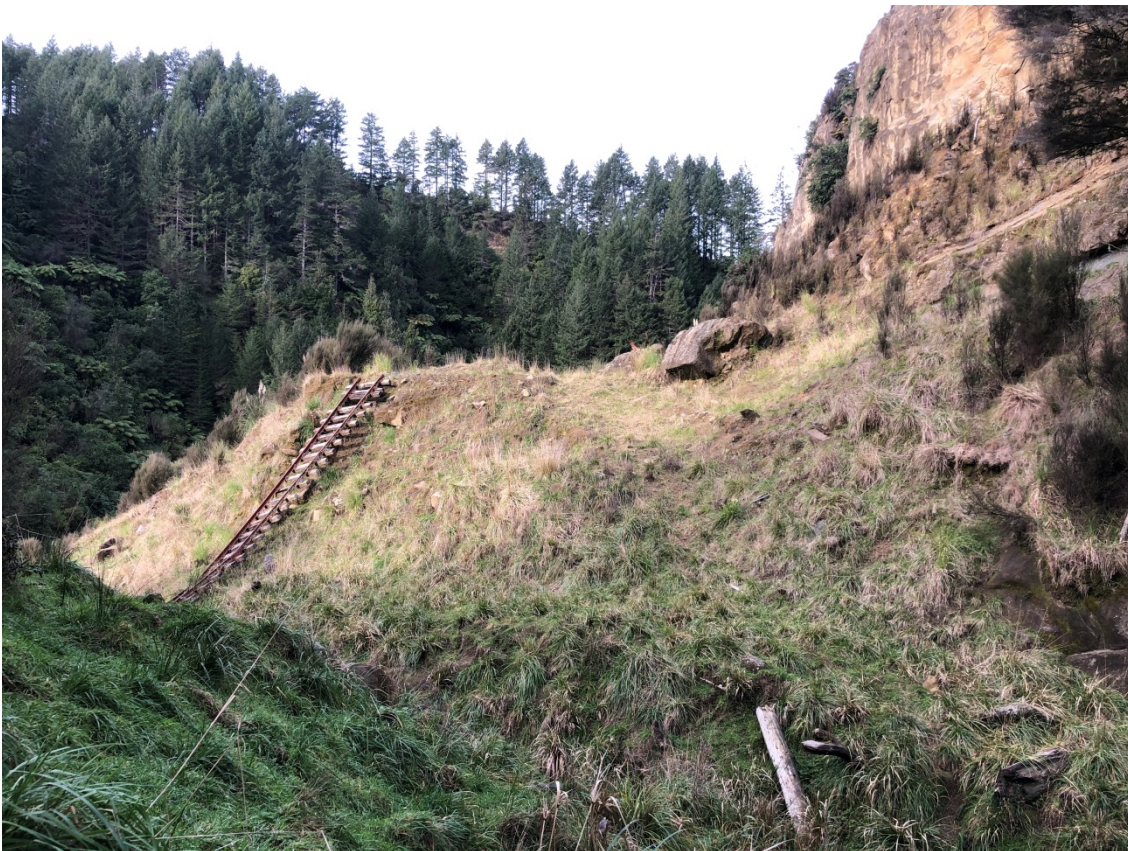
Existing culvert under washout – note details not on KR culvert log (Dimensions TBC)

<b>Repair Task:</b>	<b>Task 23 – Dropout 6</b>
<b>Track Location:</b>	Rail Chainage 347.73m
<b>Description:</b>	Drop out six nominal upstream catchment area of some 0.3km <sup>2</sup> , washout dimensions nominal 30m wide by 40m long by 10 – 12 metres deep.
<b>Required Works</b>	Requires formation repair, track drainage upgrade, possible minor track slew around bluff to south
<b>Scale/ Scope/Volumes:</b>	<p>Note this work is additional track damage post March 2012 event – failed sometime in 2014 / 2016 ( date unknown)</p> <p>Repair overtopping washout under track and reinstate formation with steep reinforced MSE slope on downstream edge, local cohesive fill on upslope side. Use either imported Nuhaka Quarry fill or GAP 80/ 100 from Maraetaha Station stockpile for MSE block.</p> <p>Cleanout existing culvert to act as low level bypass and install new higher level culvert as emergency bypass. ( note existing culvert is not on KR culvert list)</p> <p>Assess swale drainage and upgrade water movement on either side of washout - likely blocked culverts, may require additional culverts or upgrading.</p>

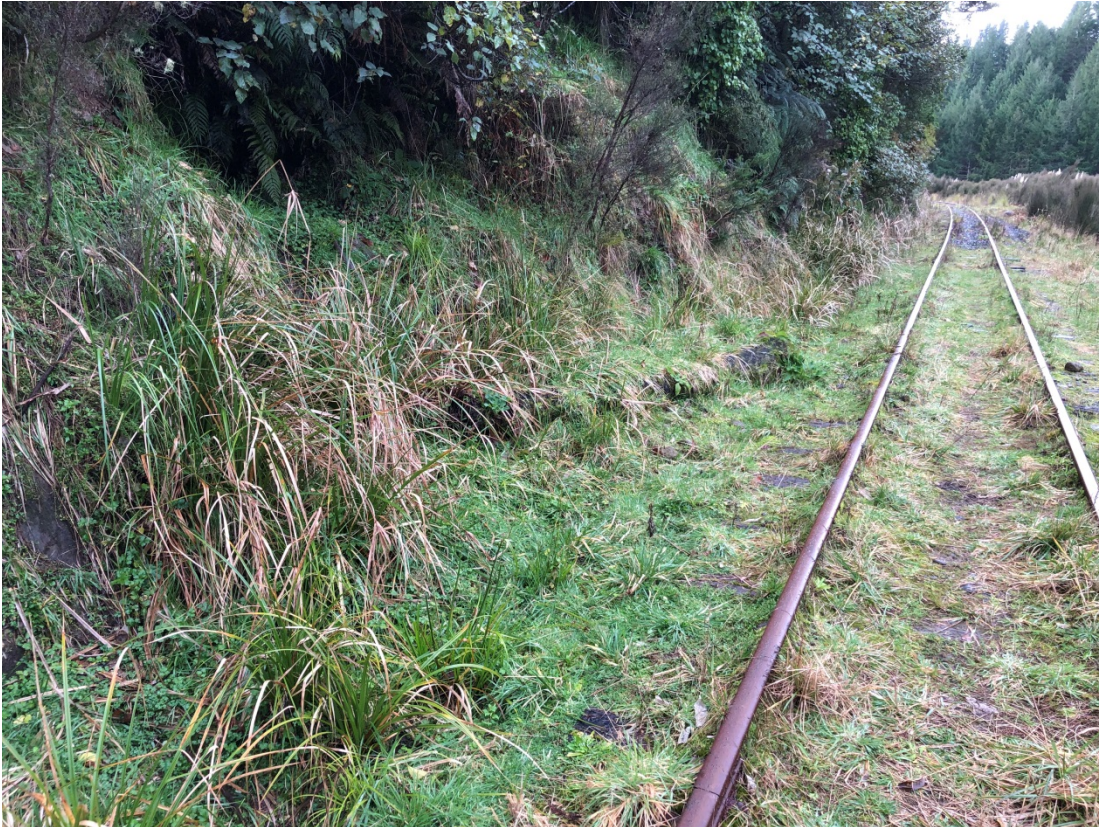
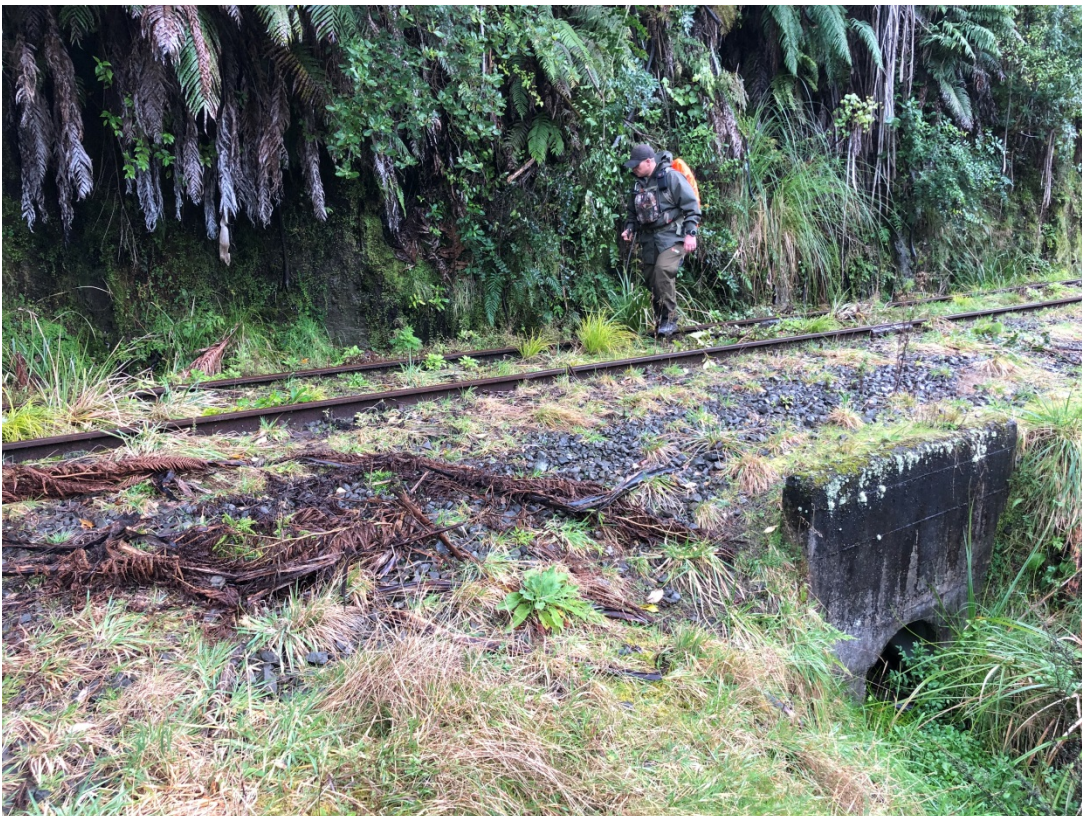
Typical culvert and swale photos in area of interest – note heavily blocked swales, blocked culvert inlets and outlets, over grown vegetation.

<b>Repair Task:</b>	<b>Task 24 – Culverts around Tunnel 13 – 19</b>
<b>Track Location:</b>	Rail Chainage 345km-350.25km
<b>Description:</b>	Culvert and swale cleanouts and repairs
<b>Required Works</b>	Multiple culvert & swale issues extending from Kopuawhara viaduct through to Tikiwhata Tunnel 19 – culvert cleanout, outlet protection, scour protection, excavation / cleanout and reshaping of swale drains
<b>Scale/ Scope/Volumes:</b>	
<b>Construction Comment:</b>	Several specific culverts have tasks against them – this is a generic culvert assessment and swale cleanout task to cover other culverts not specifically inspected and addressed. At least 40 culverts between Kopuawhara Viaduct and Tikiwhata Tunnel southern portal – at least 9 with dimensions greater than 800mm or larger. All require assessment for cleanout and swale deepening and cleaning.
<b>Designer Comment:</b>	
<b>Rail Operations:</b>	Potential for work trains past site, including deliveries for dropout 4, 5 & 6 from southern and northern ends, dependant on program timing

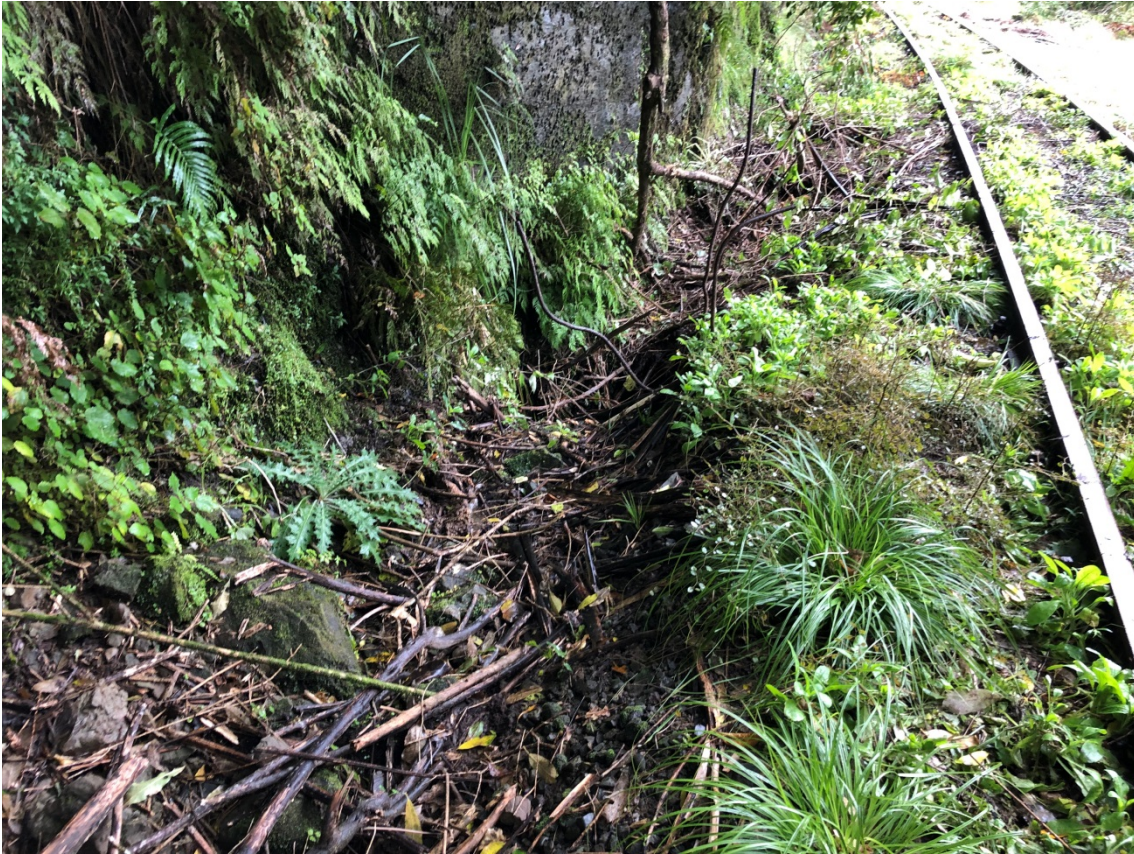
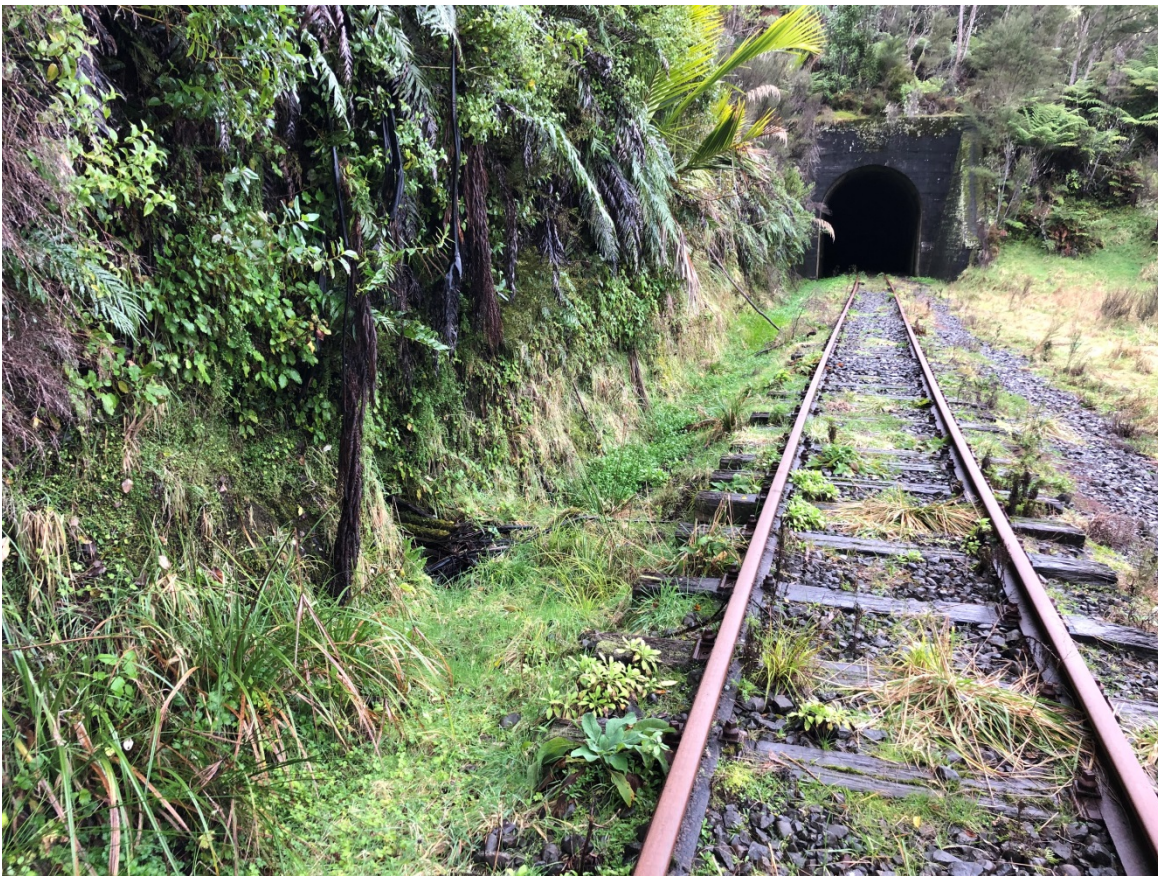
Swale and drain areas looking north into tunnel 15
