<b>Repair Task:</b>	<b>Task 27 – Bridge 262 Opoutama Abutment</b>
<b>Track Location:</b>	Rail Chainage 335.43km
<b>Description:</b>	Repair abutment erosion and reinstate abutment support on northern end of Bridge 262
<b>Required Works</b>	Repair abutment erosion and reinstate abutment support on northern end of Bridge 262
<b>Scale/ Scope/Volumes:</b>	Abutment retaining design, require coastal design input. Check structure issues with Novare.
<b>Construction Comment:</b>	
<b>Designer Comment:</b>	Combination concrete block walling and hard rock spoils to control coastal erosion at head of the beach.
<b>Rail Operations:</b>	Work trains past site, including potential deliveries for Dropouts 4 – 6 from southern end, dependant on program timing.

<b>Repair Task:</b>	<b>Task 28 – Seawall Reinstatement &amp; Erosion Protection @ 335.26km</b>
<b>Track Location:</b>	Rail Chainage 335.26km
<b>Description:</b>	Seawall reinstatement over nominal 60m of track formation
<b>Required Works</b>	
<b>Scale/ Scope/Volumes:</b>	<p>Existing seawall requires repair / extension – has been ongoing design issue since late 1960s. Original 1938 seawalls were butted up against rock outcrop that has eroded away

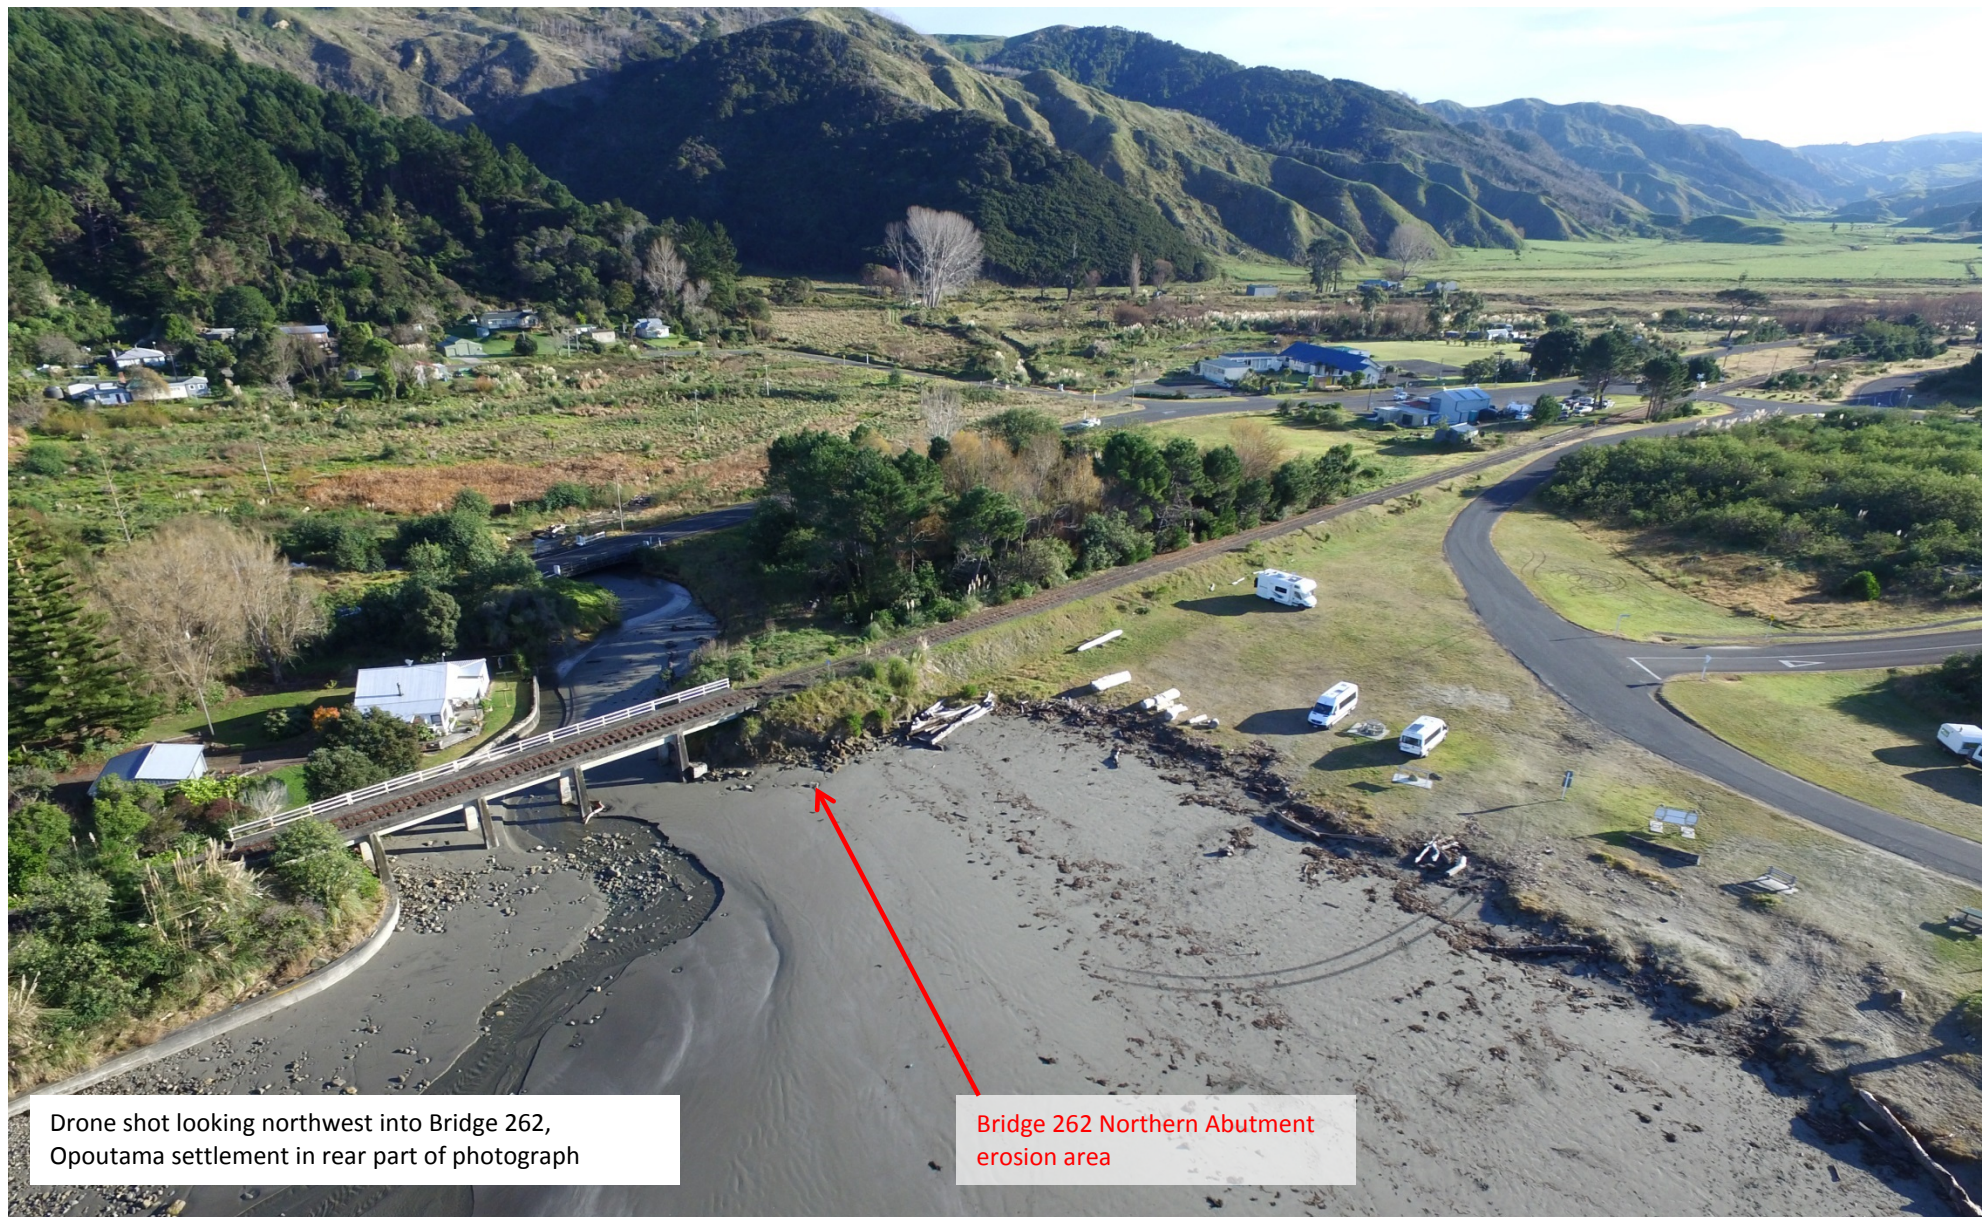
Drone shot looking northwest into Bridge 262,  
Opoutama settlement in rear part of photograph

Bridge 262 Northern Abutment  
erosion area

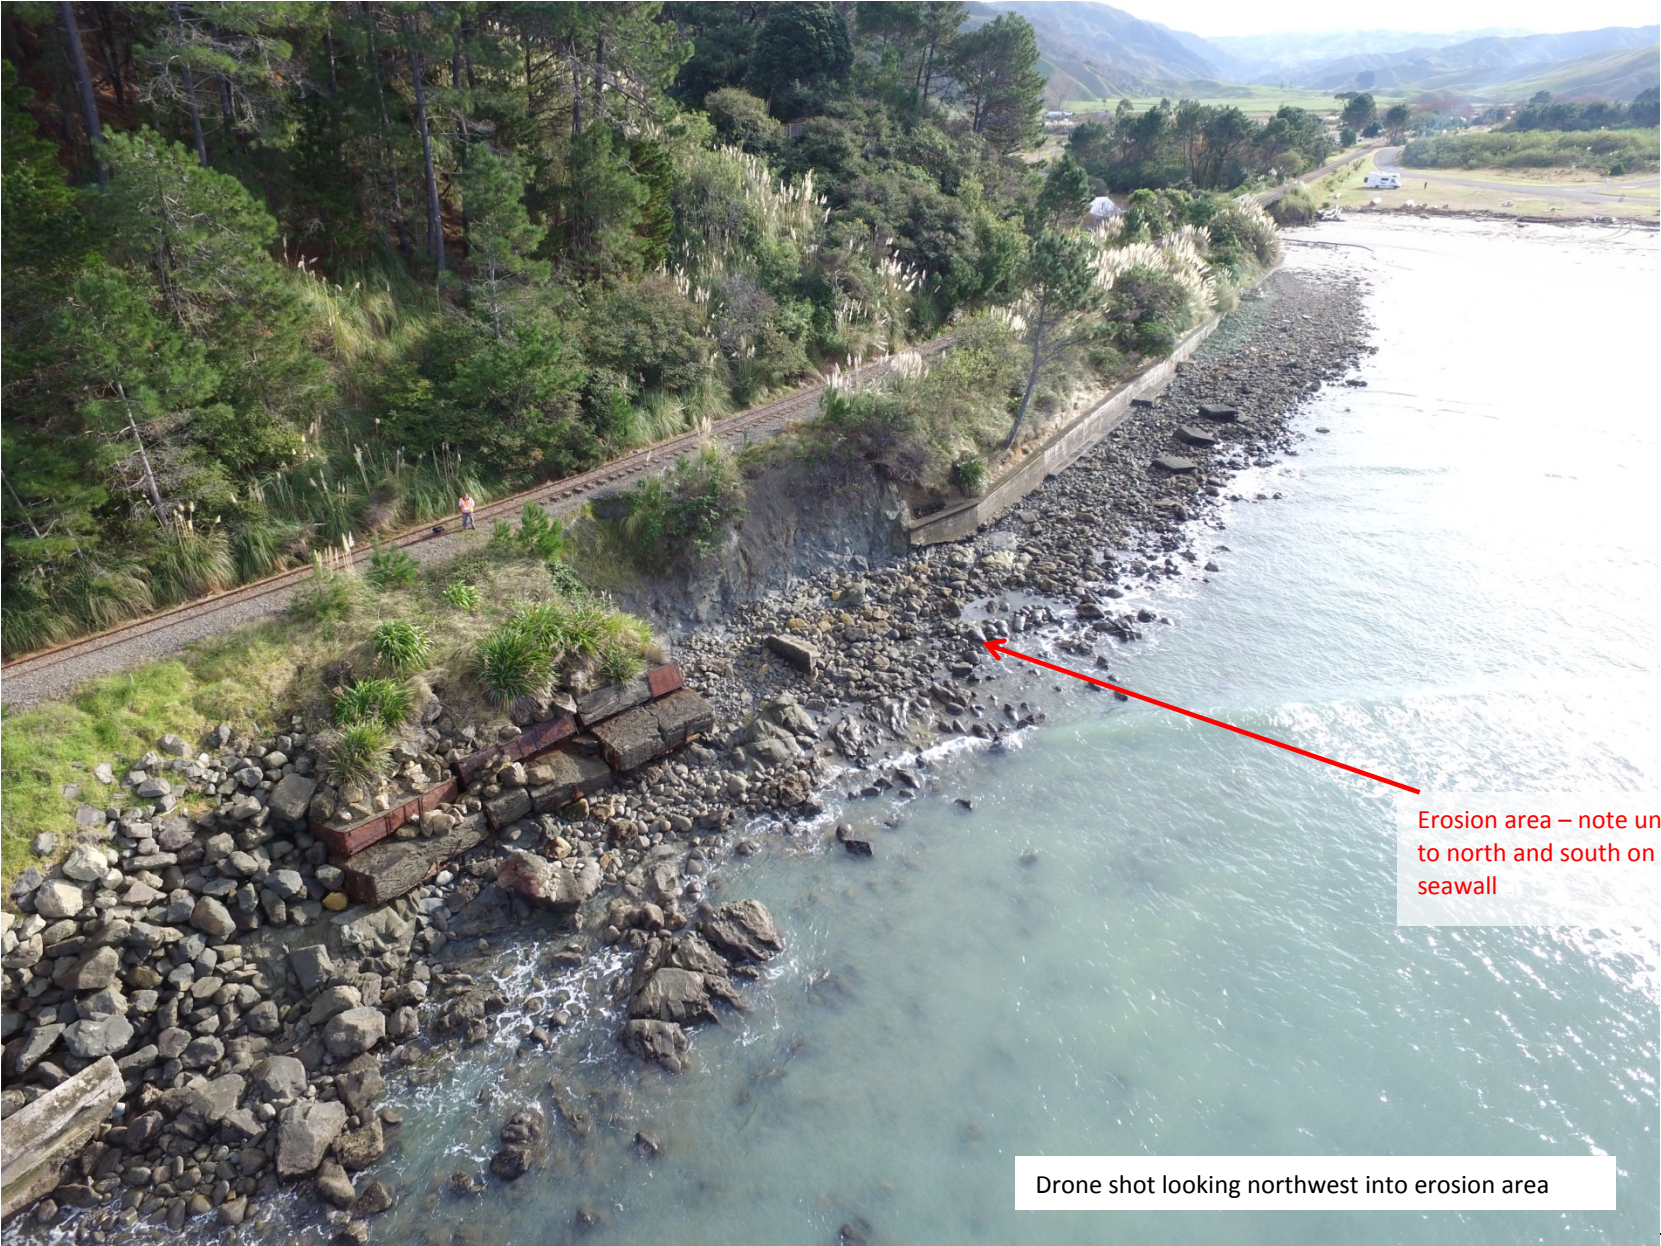
Erosion area – note undermining  
to north and south on existing  
seawall

Drone shot looking northwest into erosion area

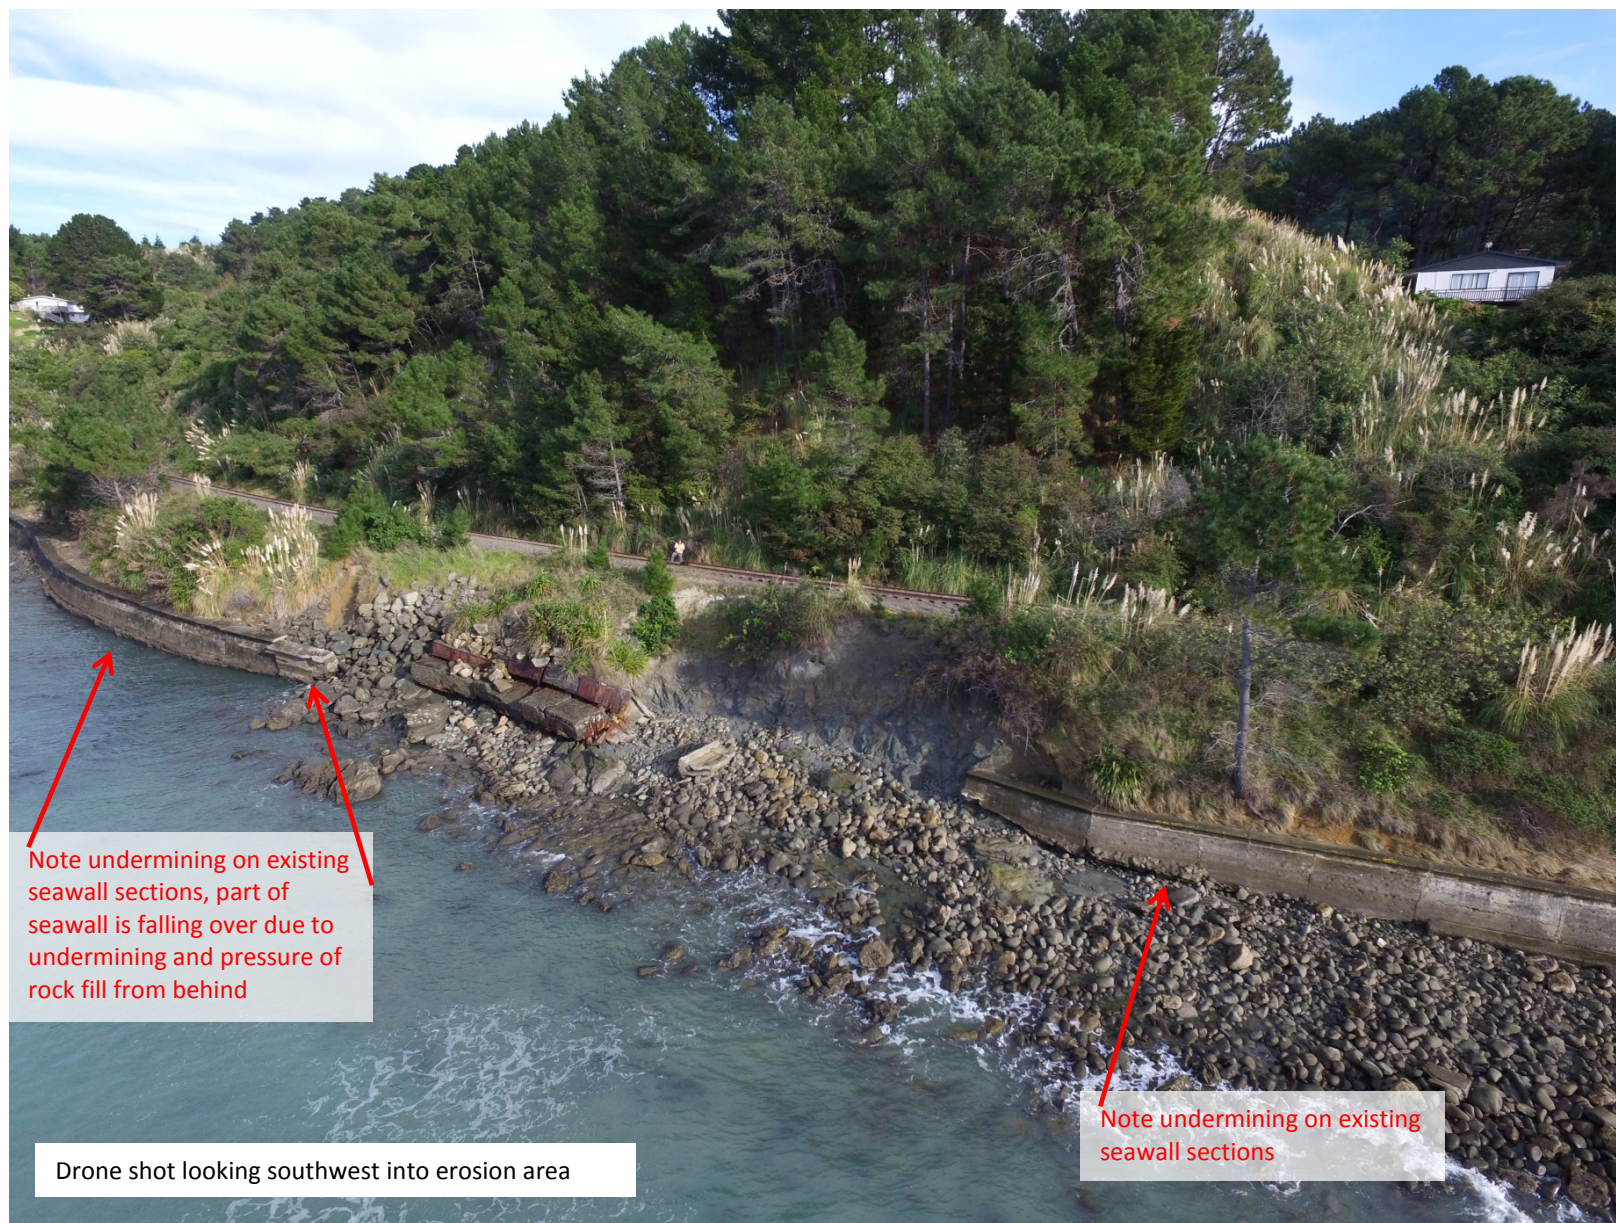
Note undermining on existing seawall sections, part of seawall is falling over due to undermining and pressure of rock fill from behind

Drone shot looking southwest into erosion area

Note undermining on existing seawall sections

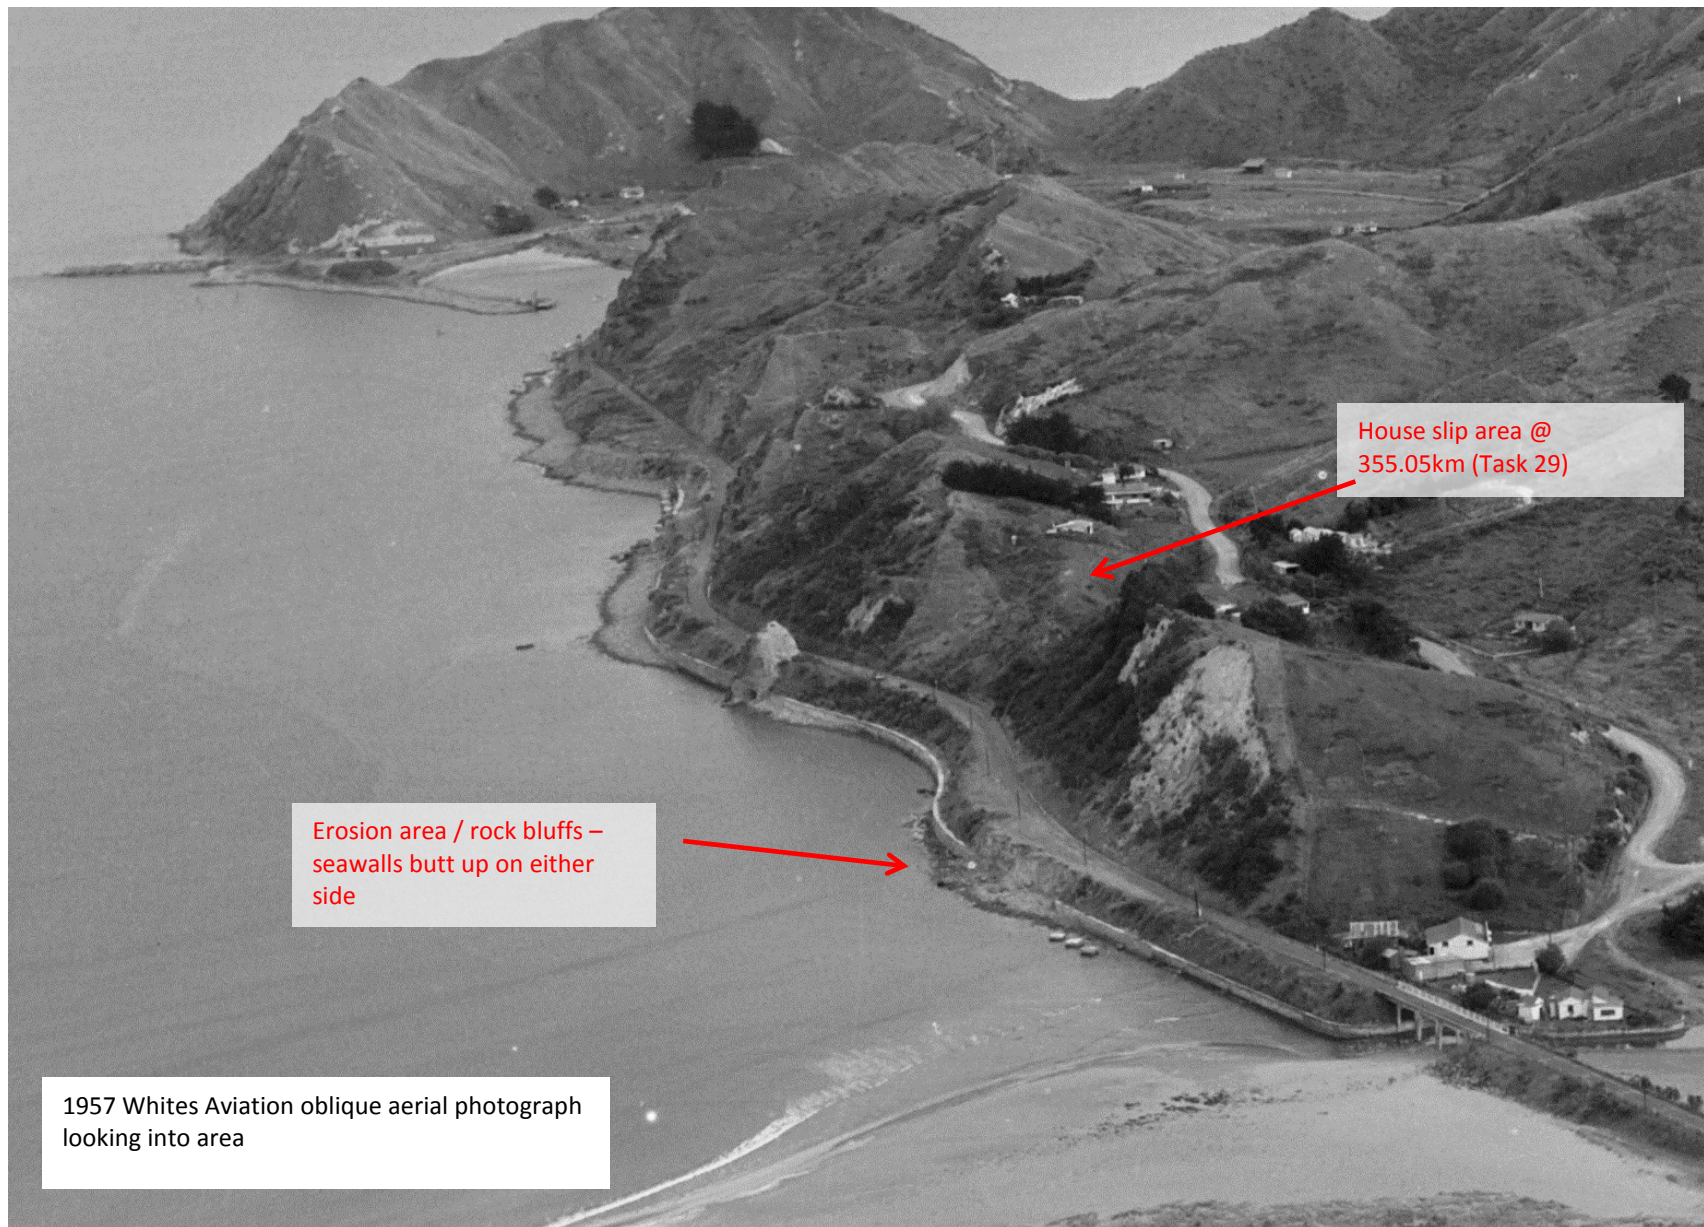
Erosion area / rock bluffs –  
seawalls butt up on either  
side

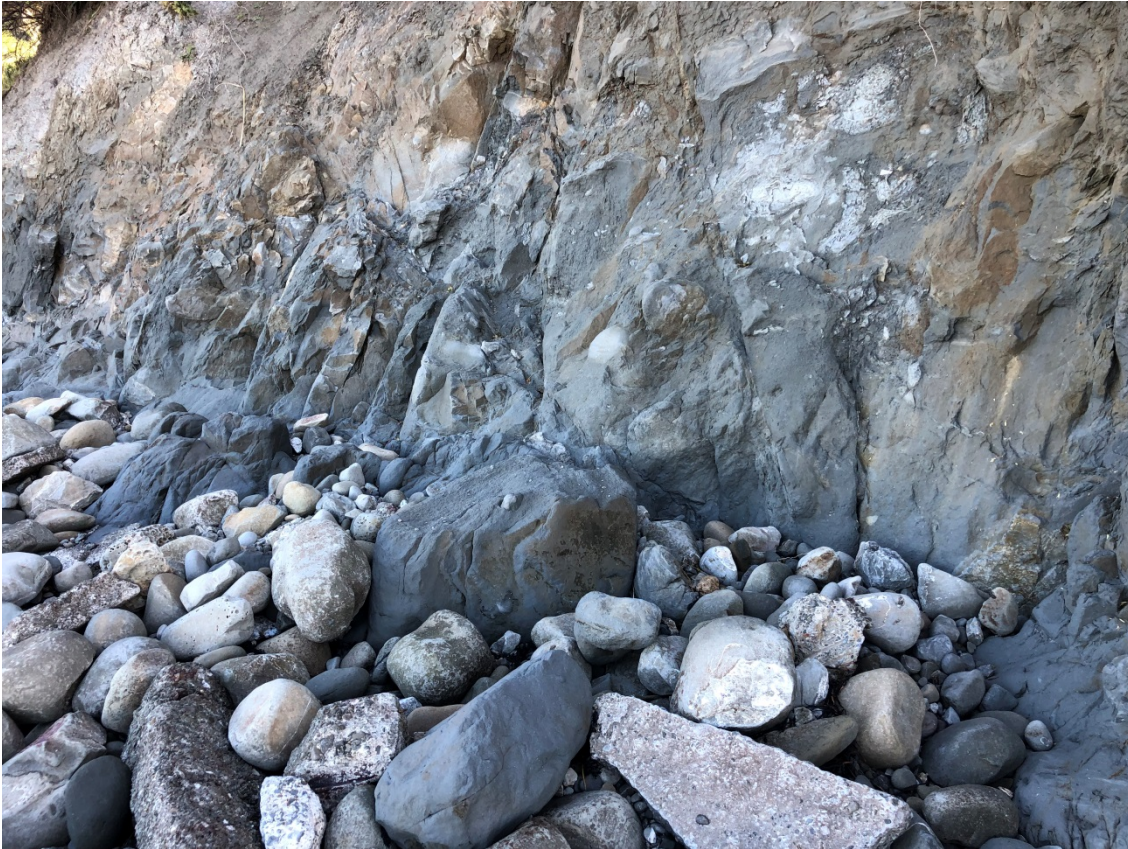
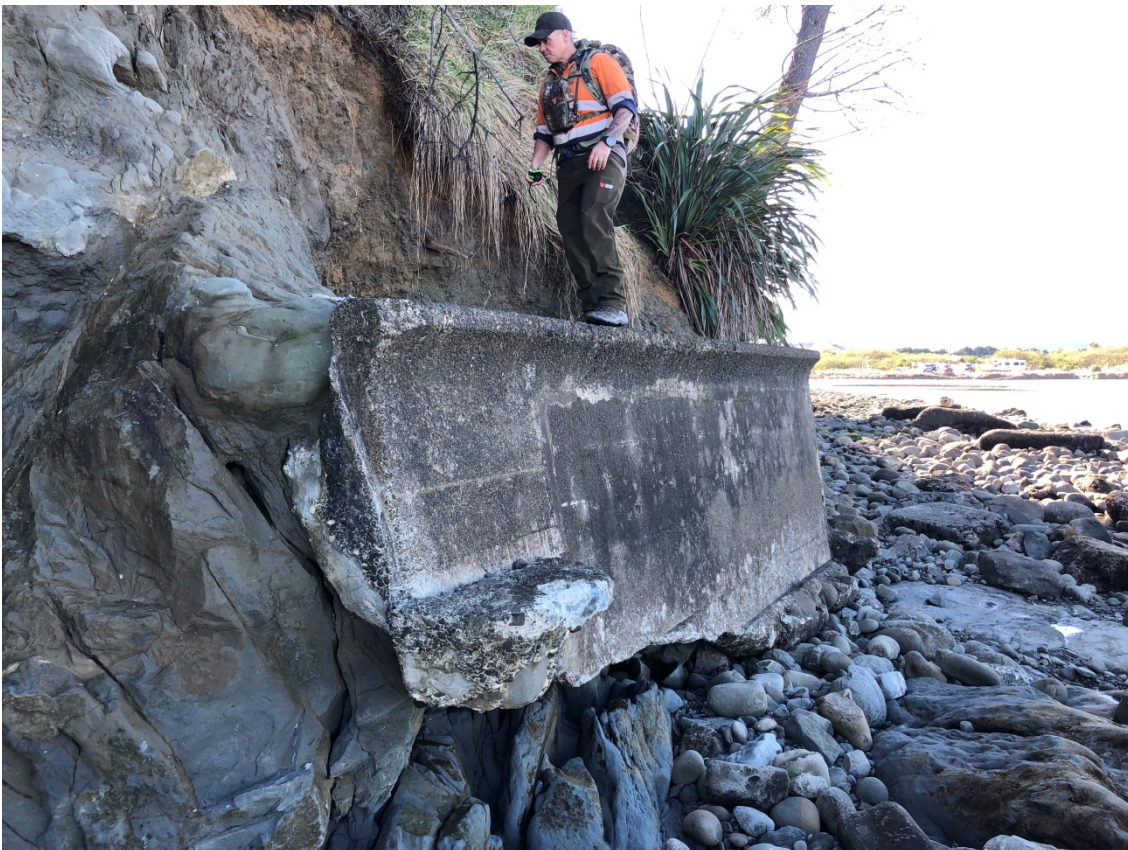
Photos showing general erosion areas and underlying fractured rockmass

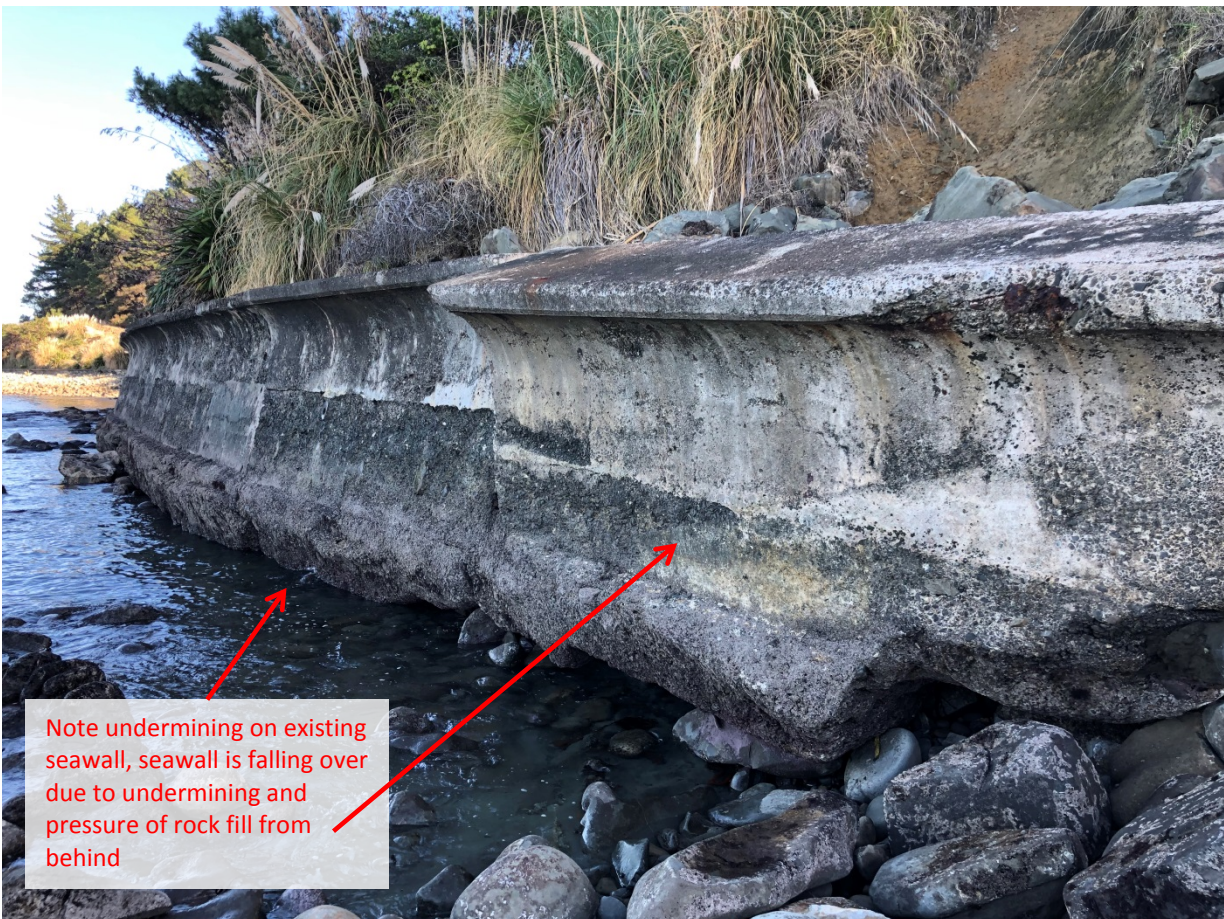
Note undermining on existing seawall, seawall is falling over due to undermining and pressure of rock fill from behind

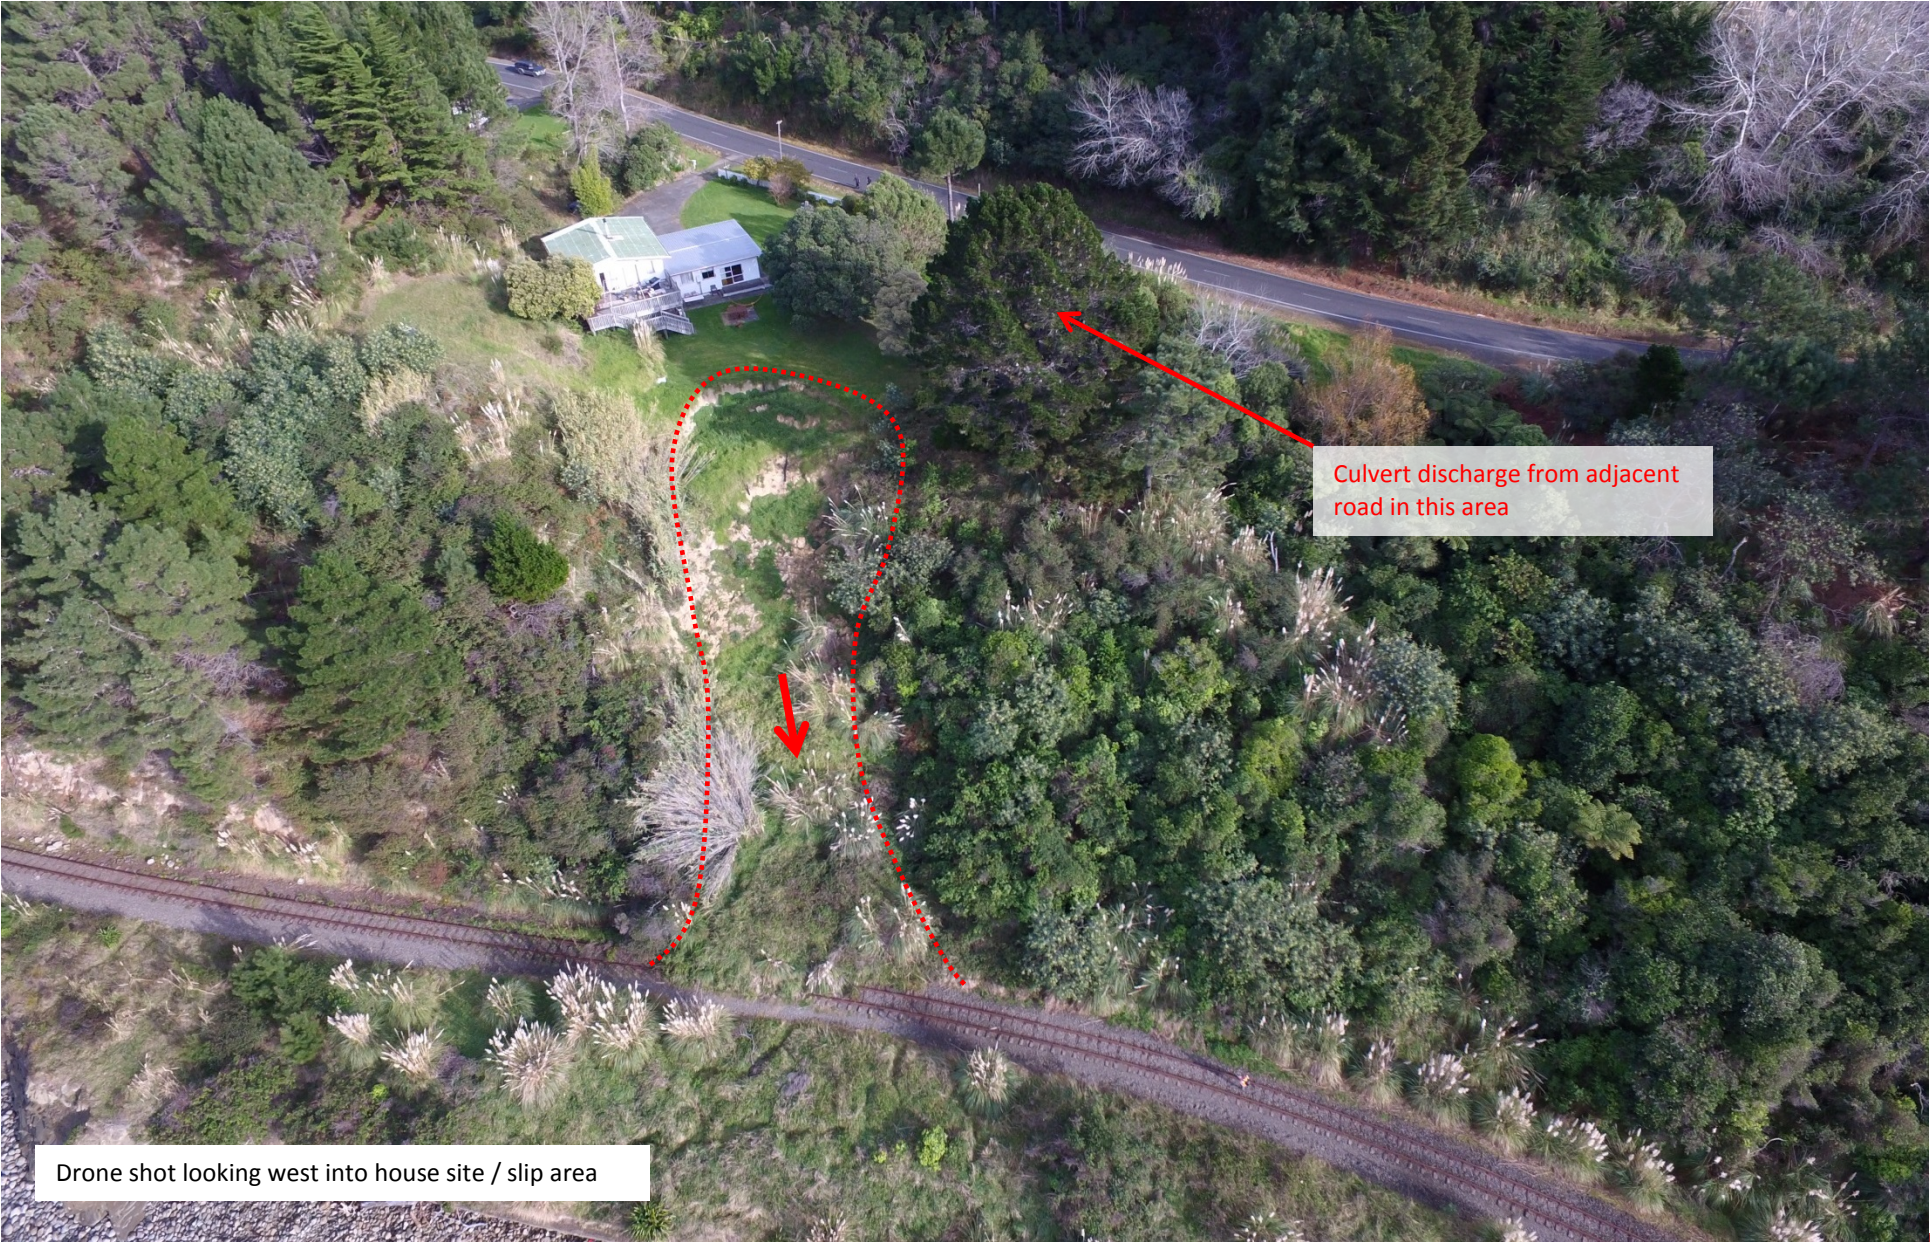
Culvert discharge from adjacent road in this area

Drone shot looking west into house site / slip area

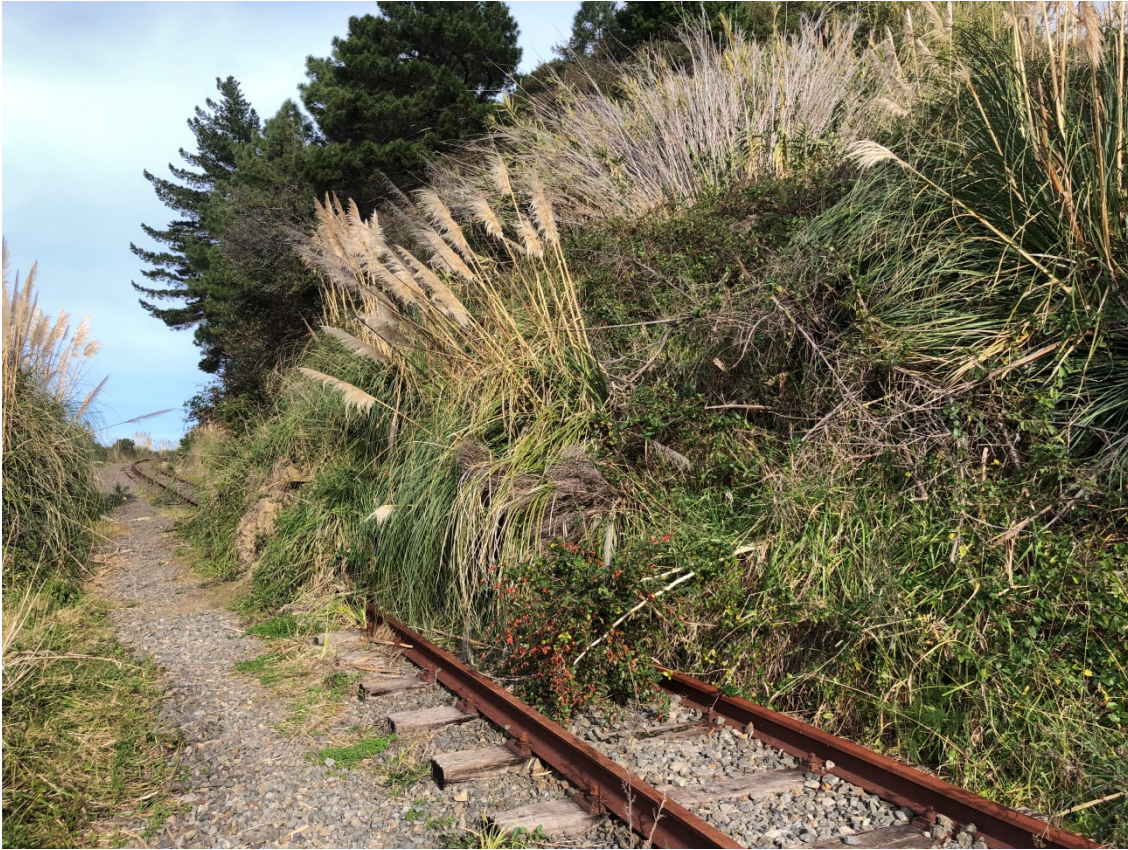
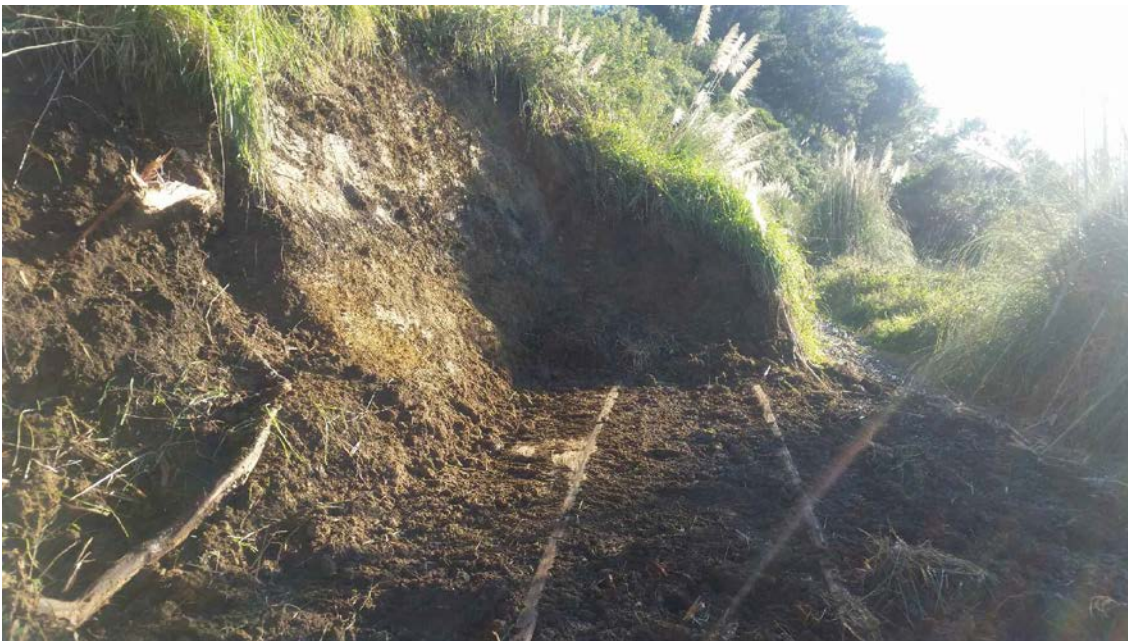
Site clearance works early July 2019 for track access - note minimum material removed to provide access (leaving as much buttress in place as practicable), pending further geotechnical assessment.

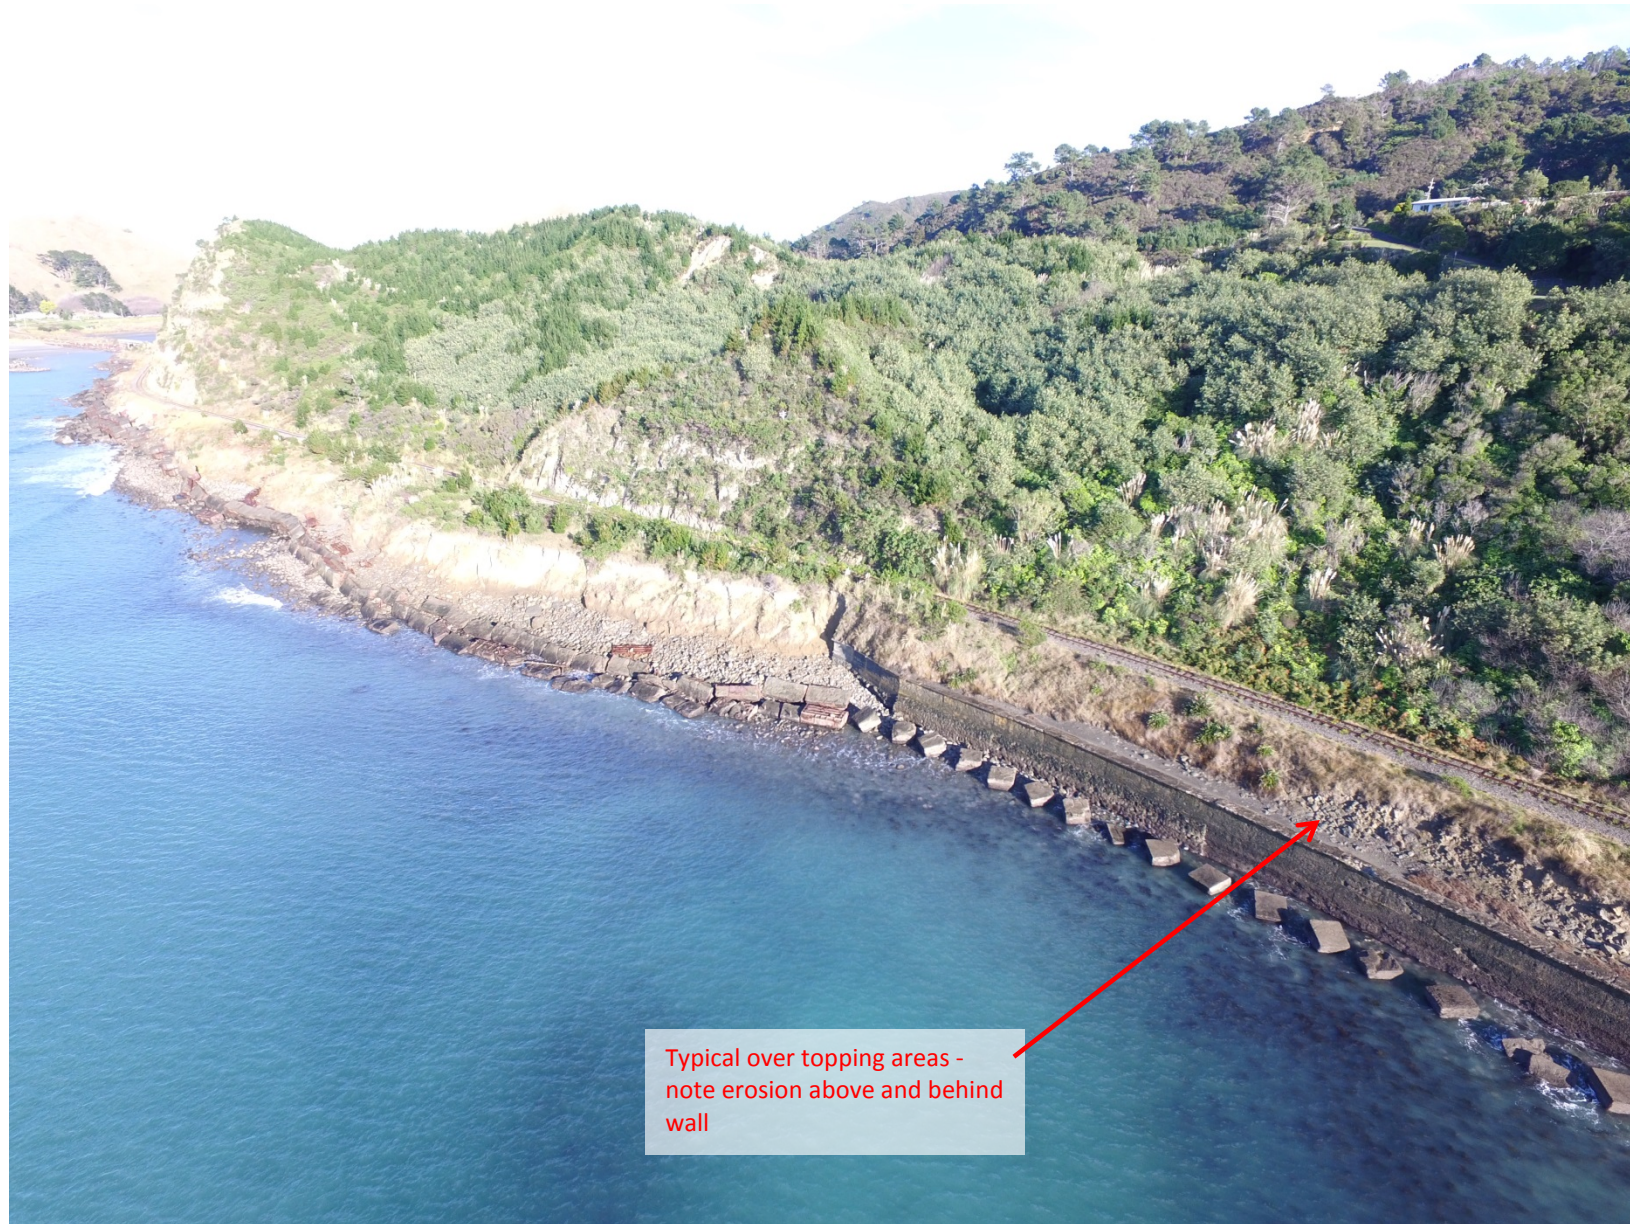
Typical over topping areas -  
note erosion above and behind  
wall

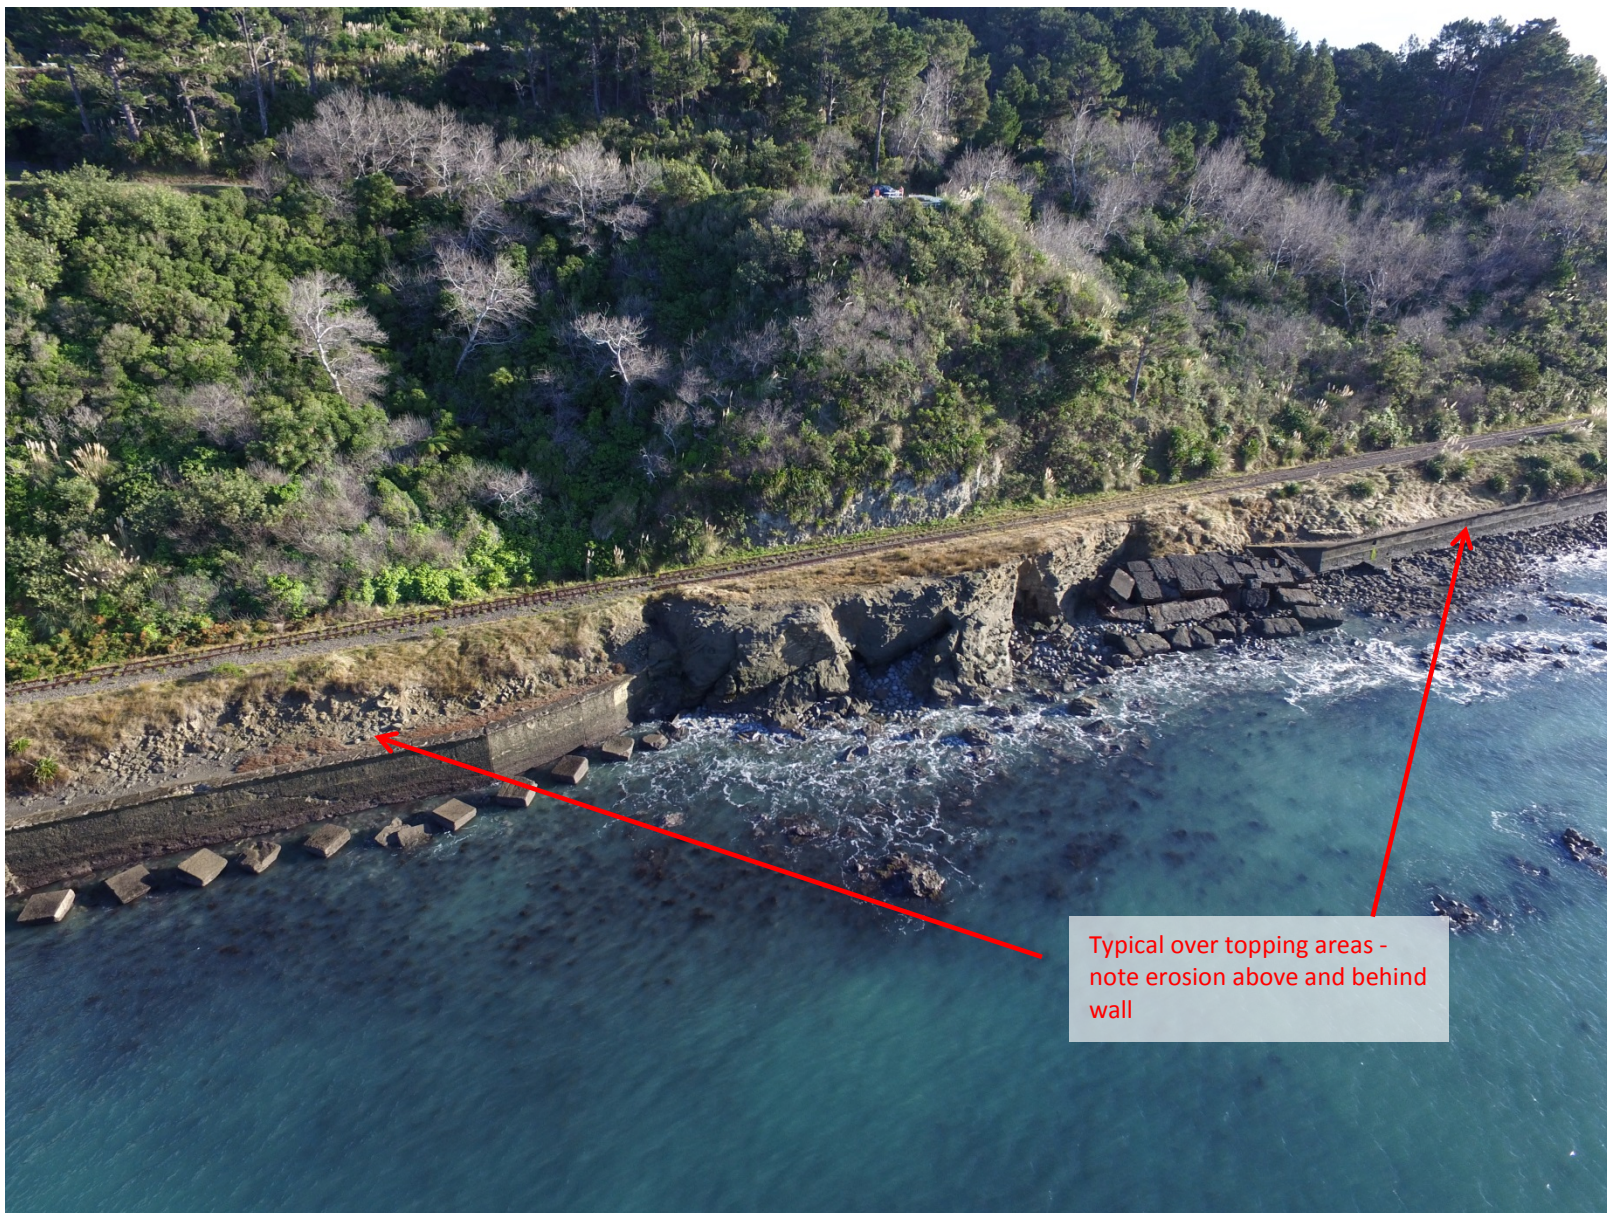
Typical over topping areas -  
note erosion above and behind  
wall

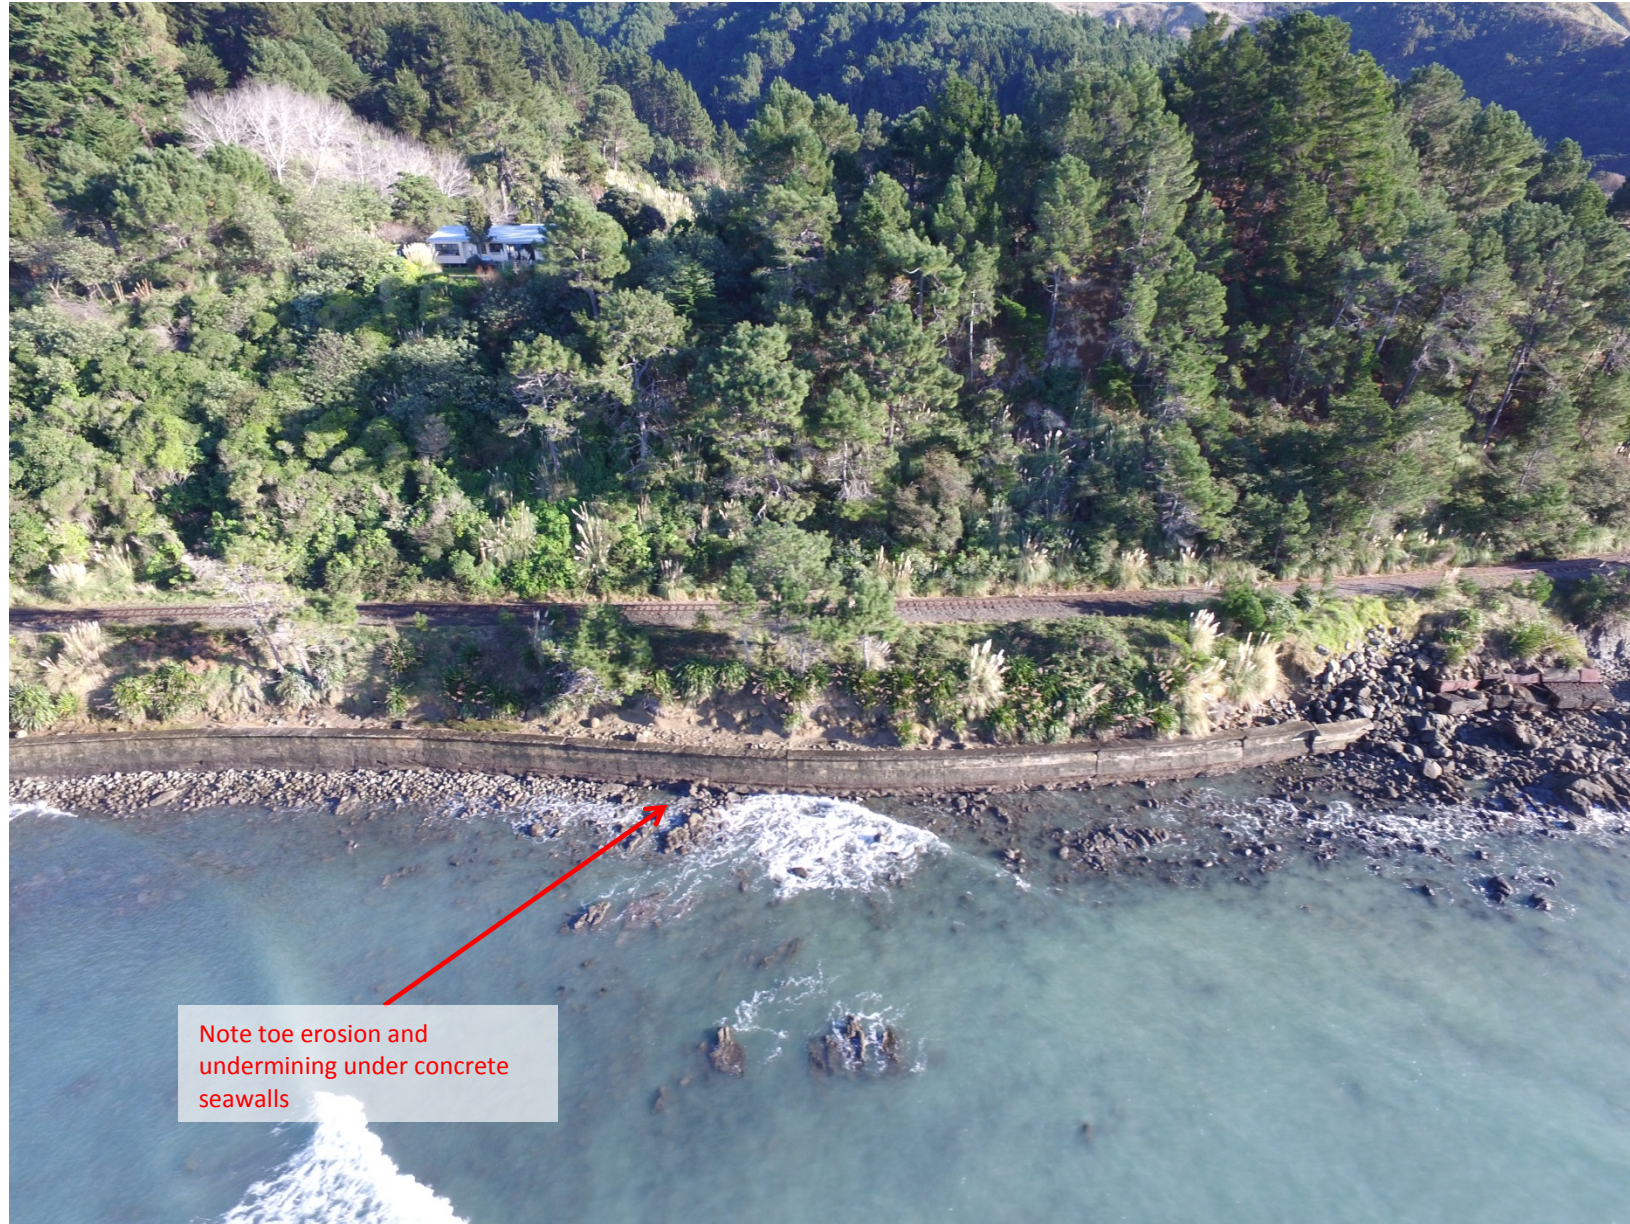
Note toe erosion and  
undermining under concrete  
seawalls
