<b>Repair Task:</b>	<b>Task 27 – Bridge 262 Opoutama Abutment</b>
<b>Track Location:</b>	Rail Chainage 335.43km
<b>Description:</b>	Repair abutment erosion and reinstate abutment support on northern end of Bridge 262
<b>Required Works</b>	Repair abutment erosion and reinstate abutment support on northern end of Bridge 262
<b>Scale/ Scope/Volumes:</b>	Abutment retaining design, require coastal design input. Check structure issues with Novare.
<b>Construction Comment:</b>	
<b>Designer Comment:</b>	Combination concrete block walling and hard rock spoils to control coastal erosion at head of the beach.
<b>Rail Operations:</b>	Work trains past site, including potential deliveries for Dropouts 4 – 6 from southern end, dependant on program timing.

<b>Repair Task:</b>	<b>Task 28 – Seawall Reinstatement &amp; Erosion Protection @ 335.26km</b>
<b>Track Location:</b>	Rail Chainage 335.26km
<b>Description:</b>	Seawall reinstatement over nominal 60m of track formation
<b>Required Works</b>	
<b>Scale/ Scope/Volumes:</b>	<p>Existing seawall requires repair / extension – has been ongoing design issue since late 1960s. Original 1938 seawalls were butted up against rock outcrop that has eroded away

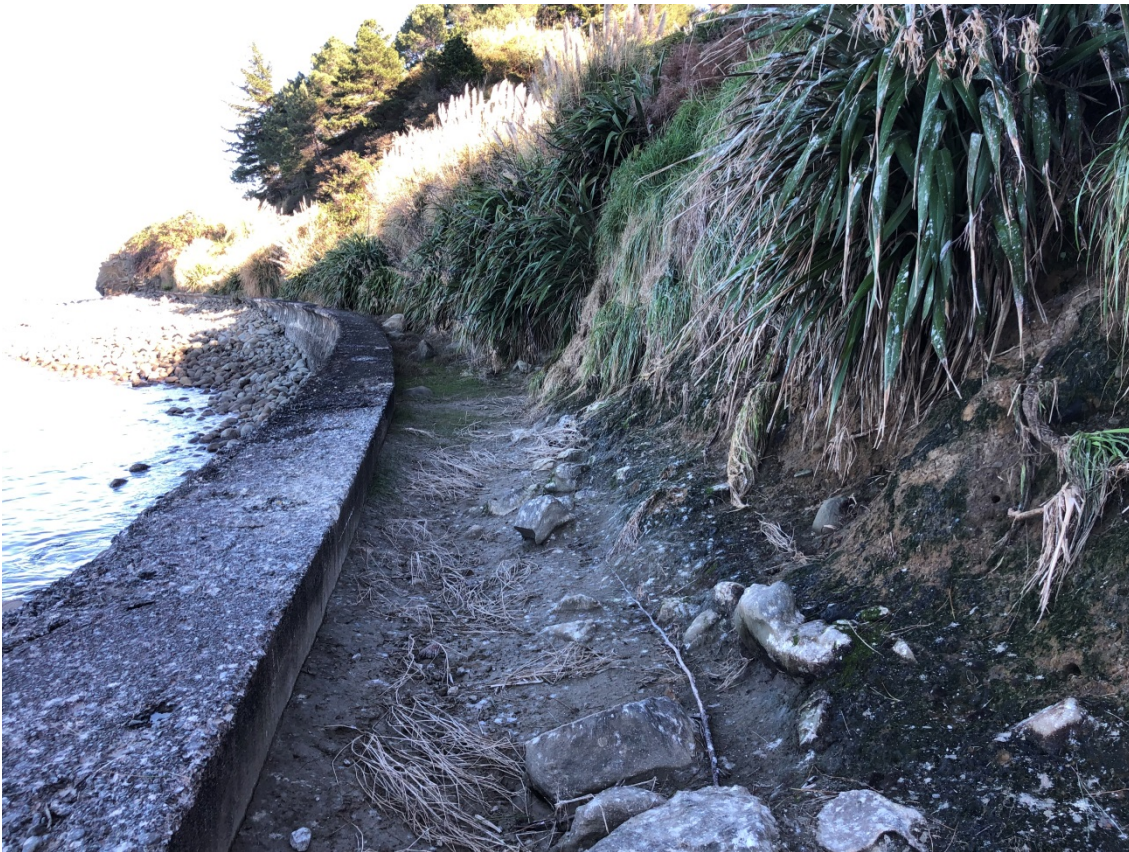
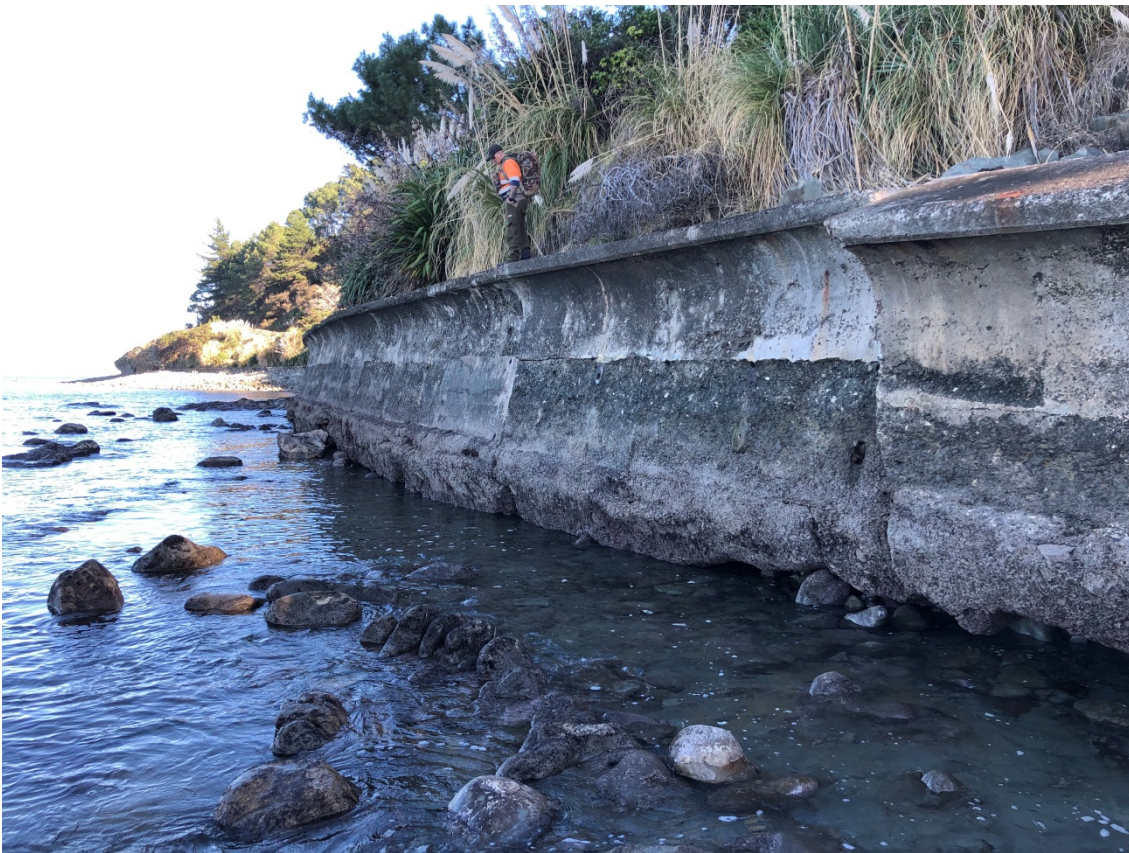
Typical photos of toe erosion and wall over topping erosion

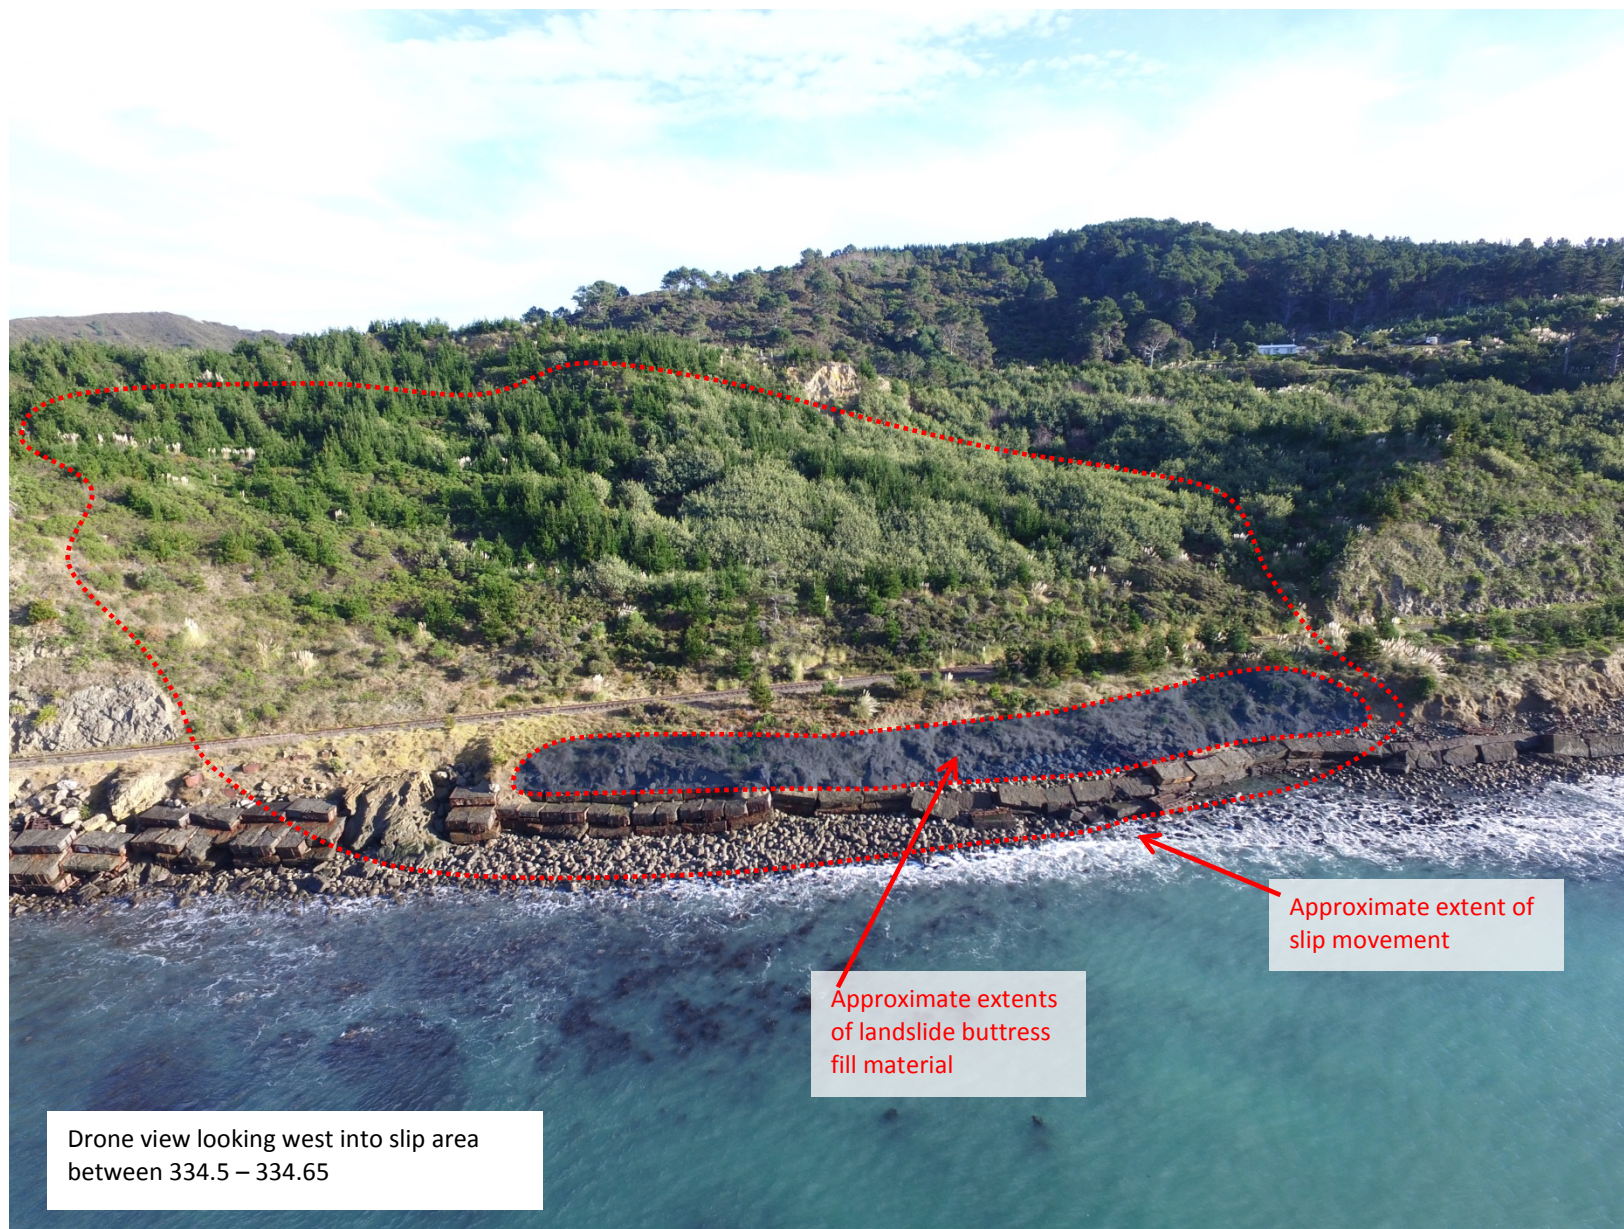
Drone view looking west into slip area  
between 334.5 – 334.65

Approximate extents  
of landslide buttress  
fill material

Approximate extent of  
slip movement

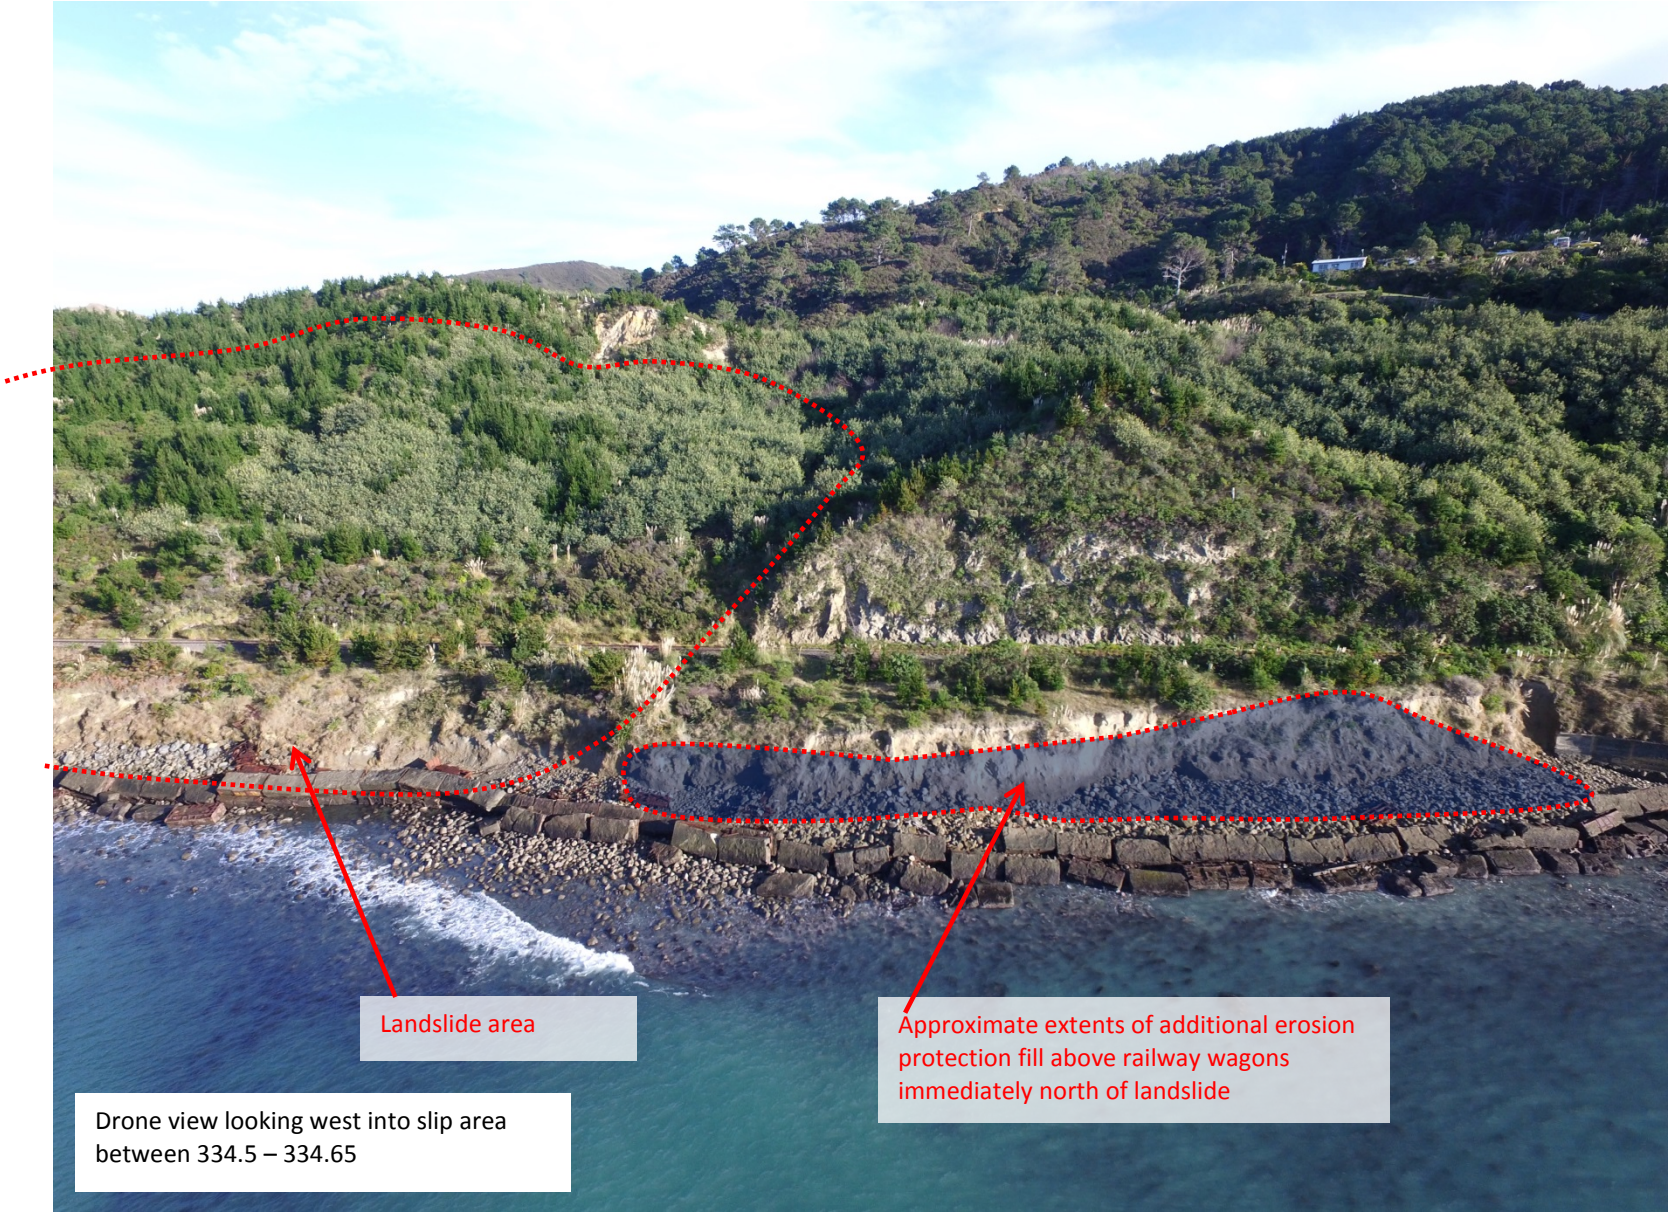
Drone view looking west into slip area  
between 334.5 – 334.65

Landslide area

Approximate extents of additional erosion  
protection fill above railway wagons  
immediately north of landslide

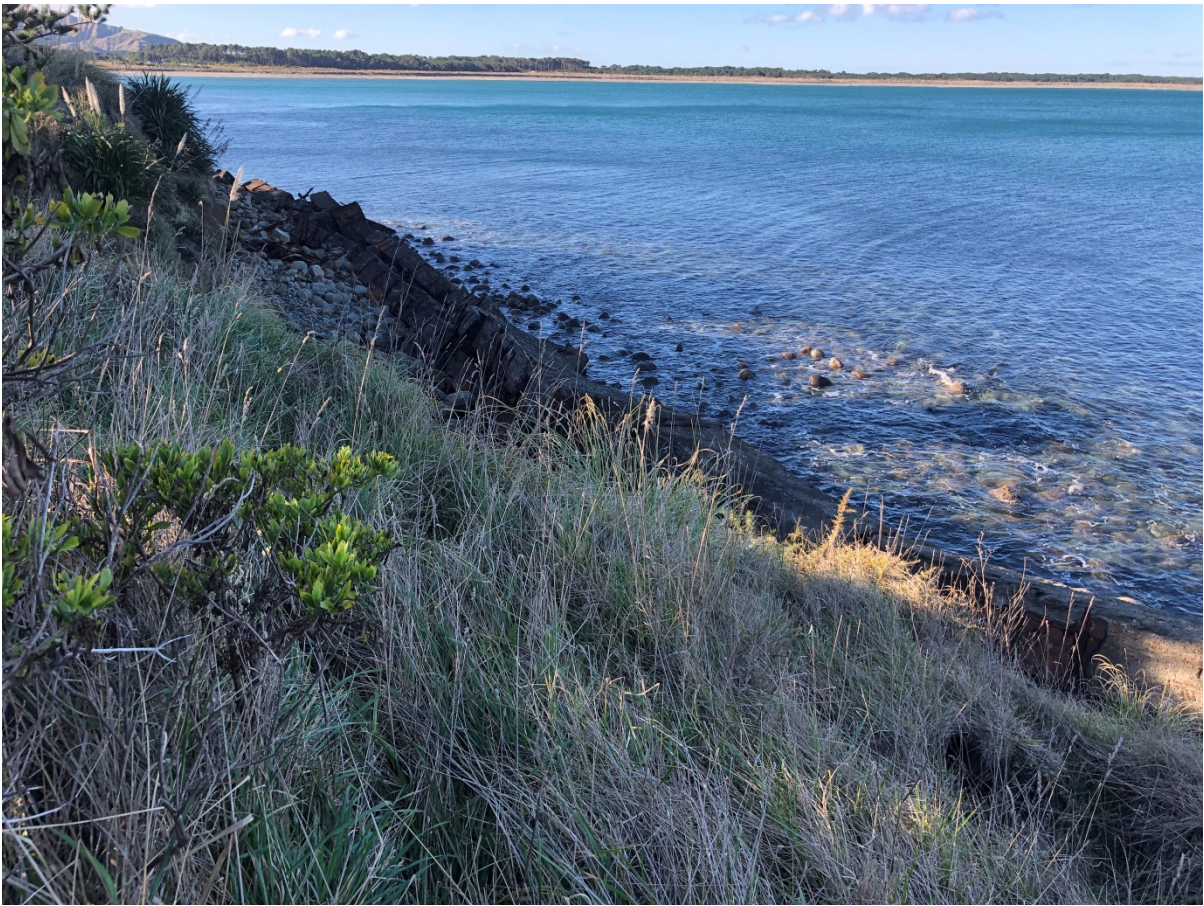
Photos showing landslip / wagons at ground level

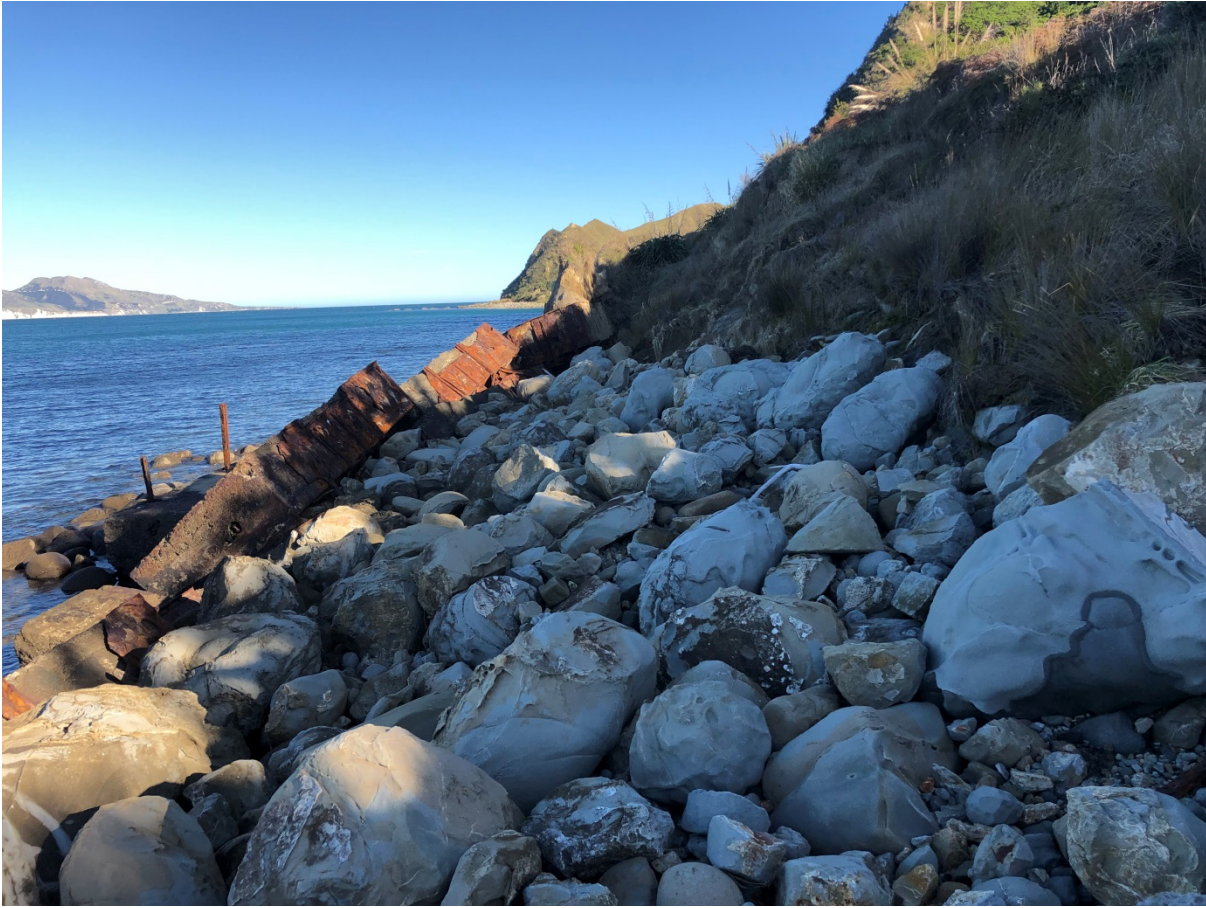
Photos showing landslip / wagons at ground level

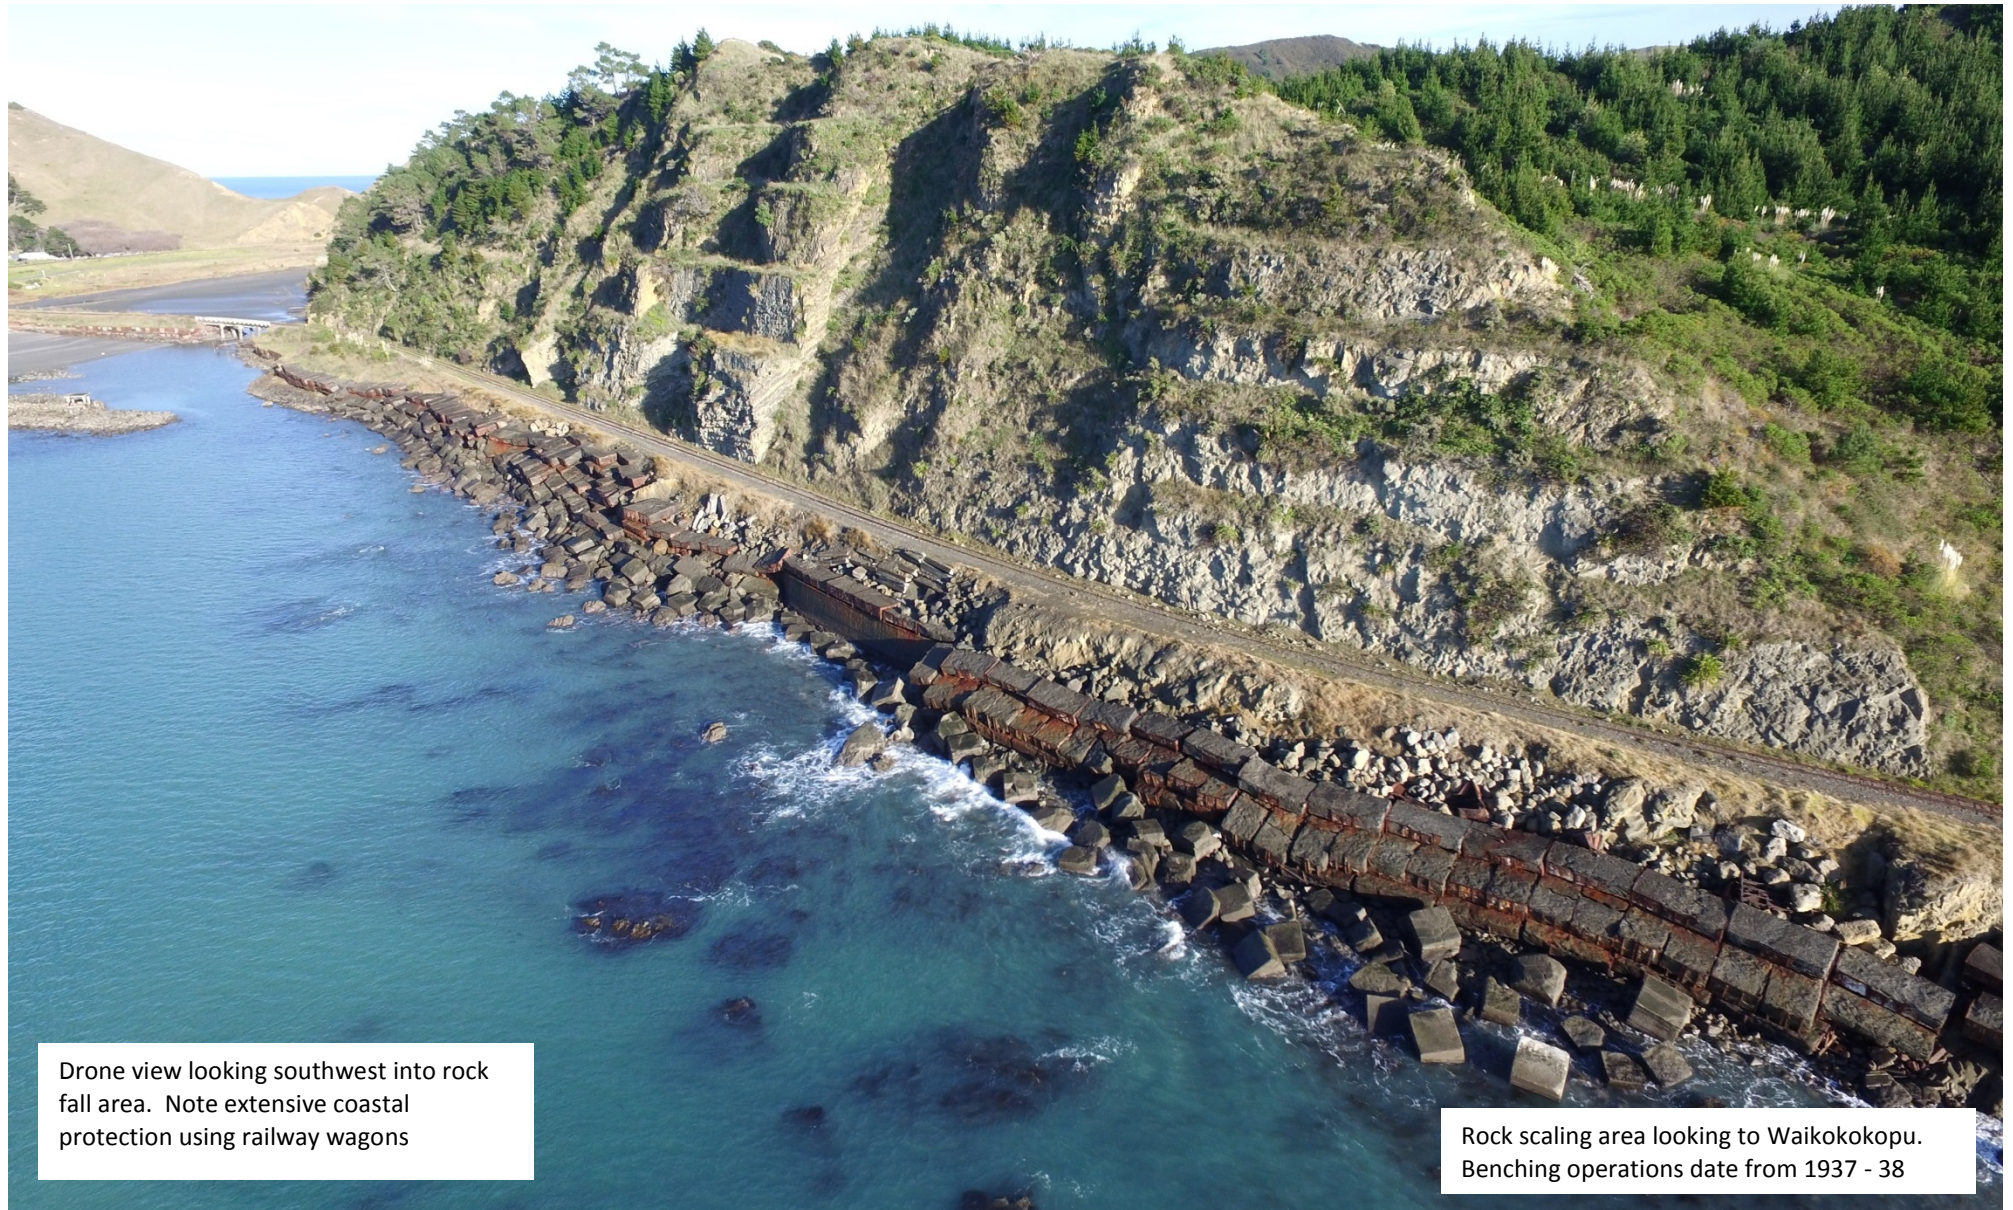
Drone view looking southwest into rock fall area. Note extensive coastal protection using railway wagons

Rock scaling area looking to Waikokokopu. Benching operations date from 1937 - 38

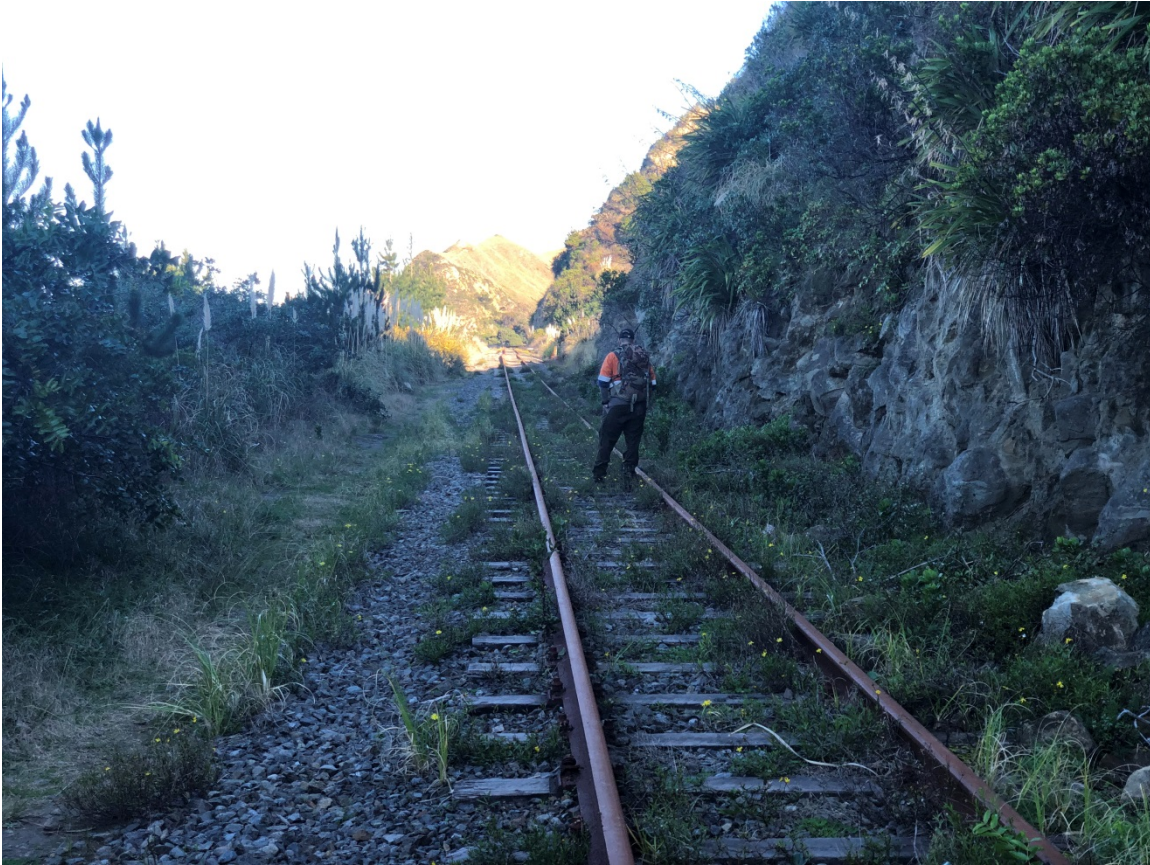
View of track looking south to bridge 261 – note relatively limited drop rock in side swales.

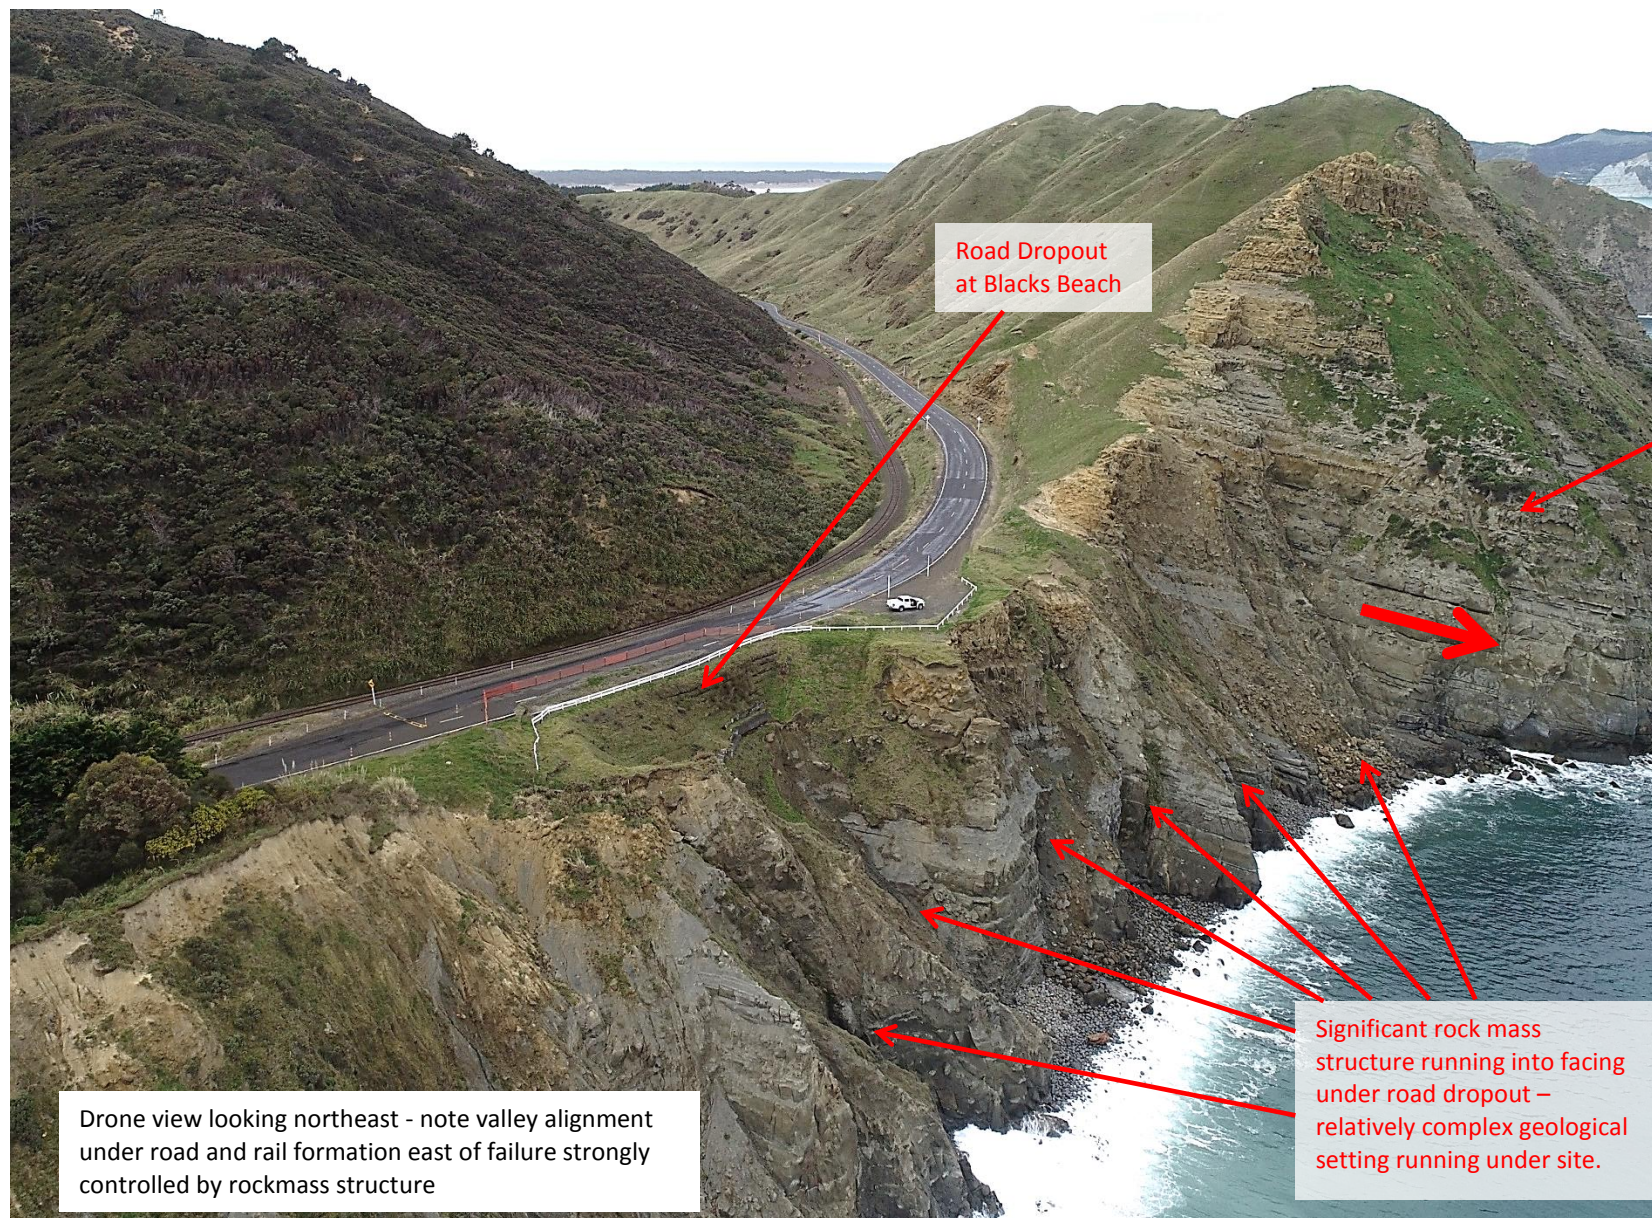
Road Dropout  
at Blacks Beach

Note bedding dip approx.  
10-15 degrees seaward;  
varies around site, flatter  
under slip area

Significant rock mass  
structure running into facing  
under road dropout –  
relatively complex geological  
setting running under site.

Drone view looking northeast - note valley alignment  
under road and rail formation east of failure strongly  
controlled by rockmass structure

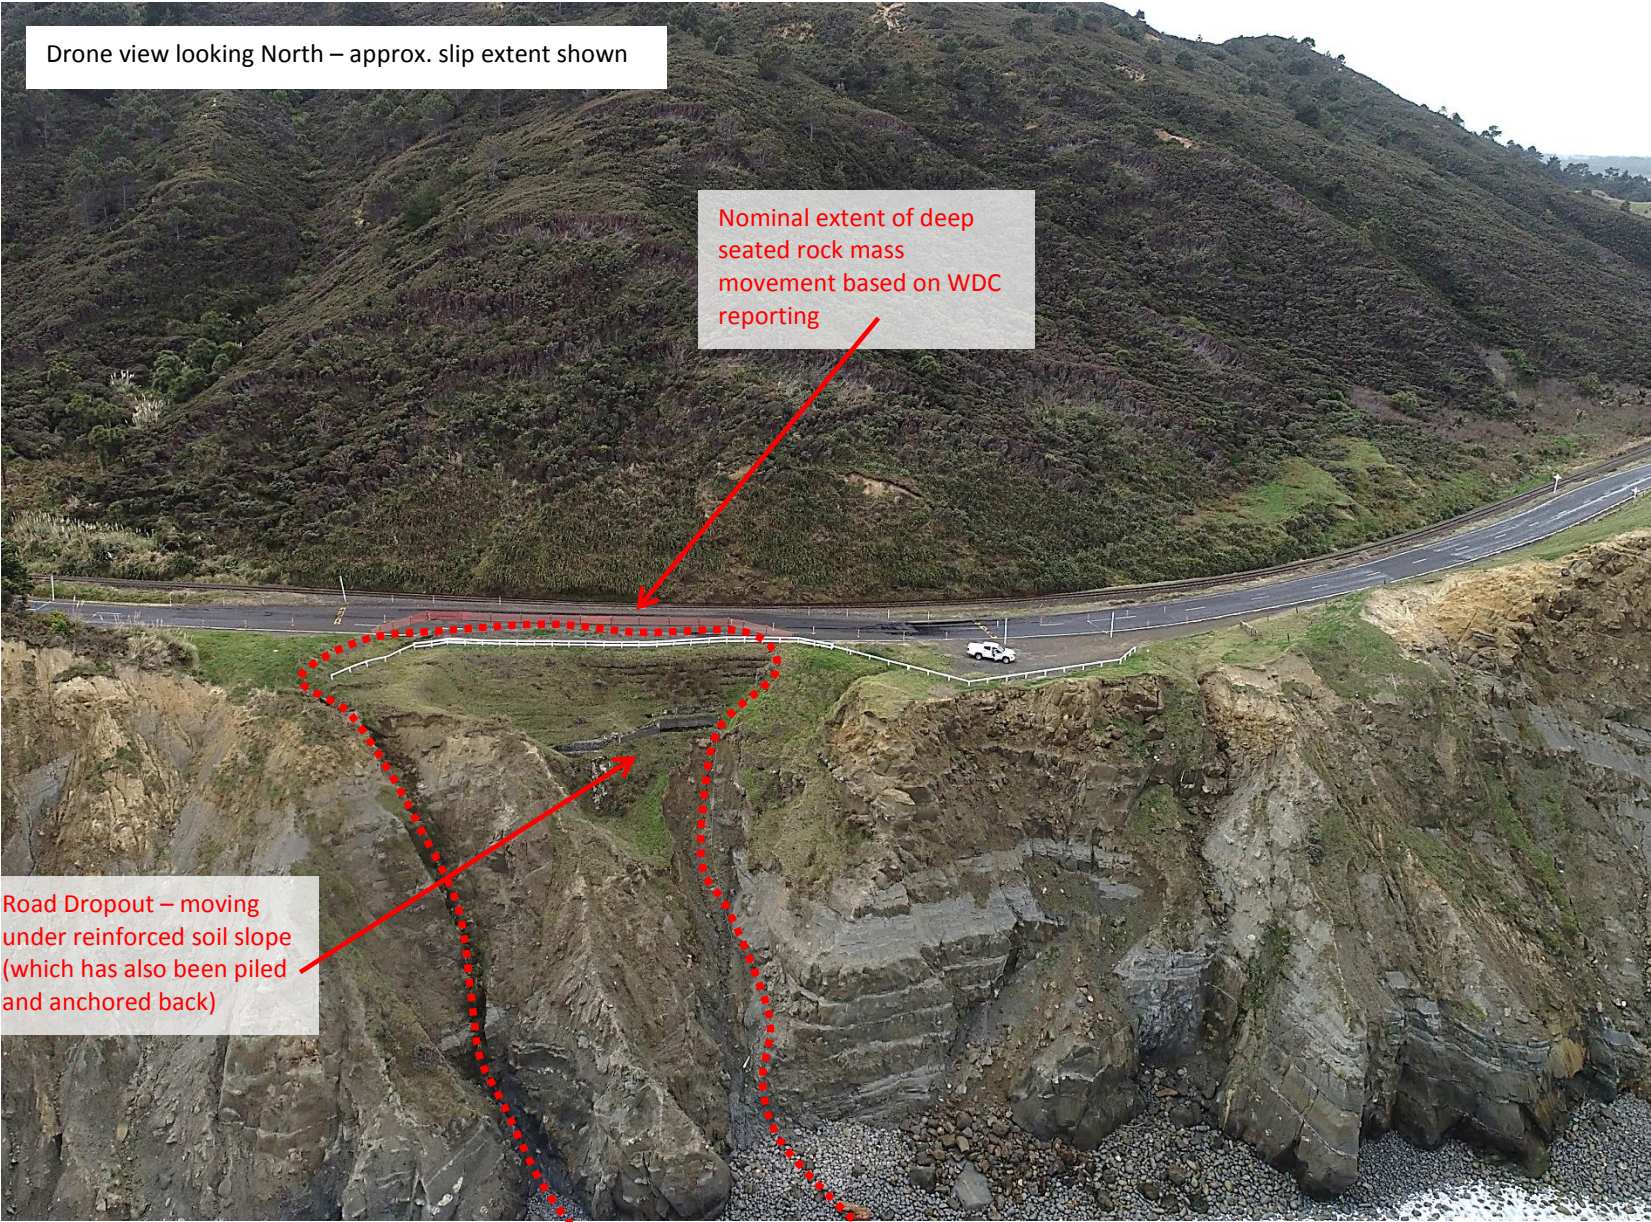
Drone view looking North – approx. slip extent shown

Nominal extent of deep seated rock mass movement based on WDC reporting

Road Dropout – moving under reinforced soil slope (which has also been piled and anchored back)

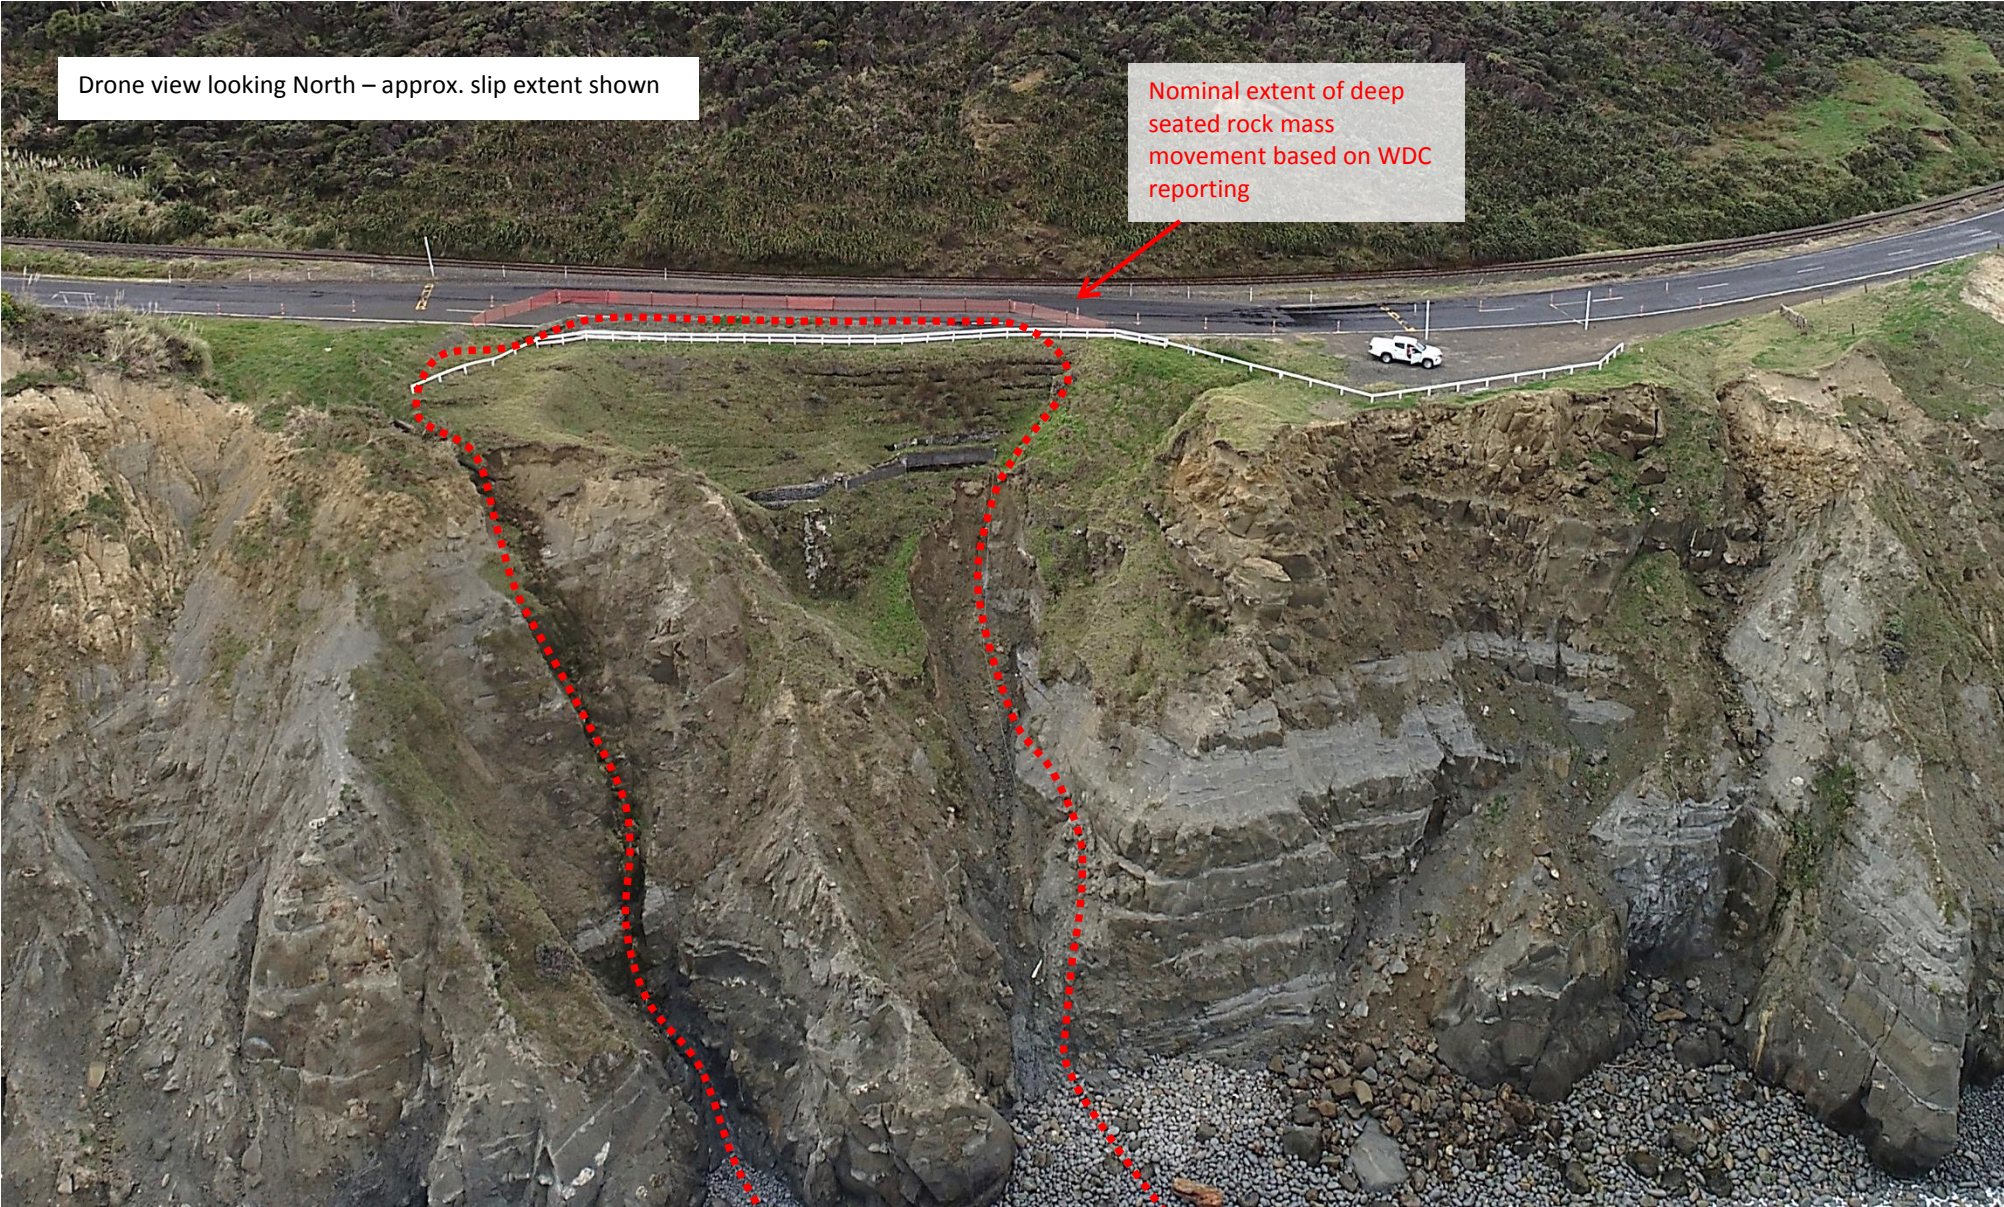
Road Dropout  
at Blacks Beach

Drone view looking North – approx. slip extent shown

Nominal extent of deep seated rock mass movement based on WDC reporting

1957 planar failure  
movement

Drone view looking West - Blacks Beach in distance; 1957  
planar failure highlighted – approx. slip extent shown

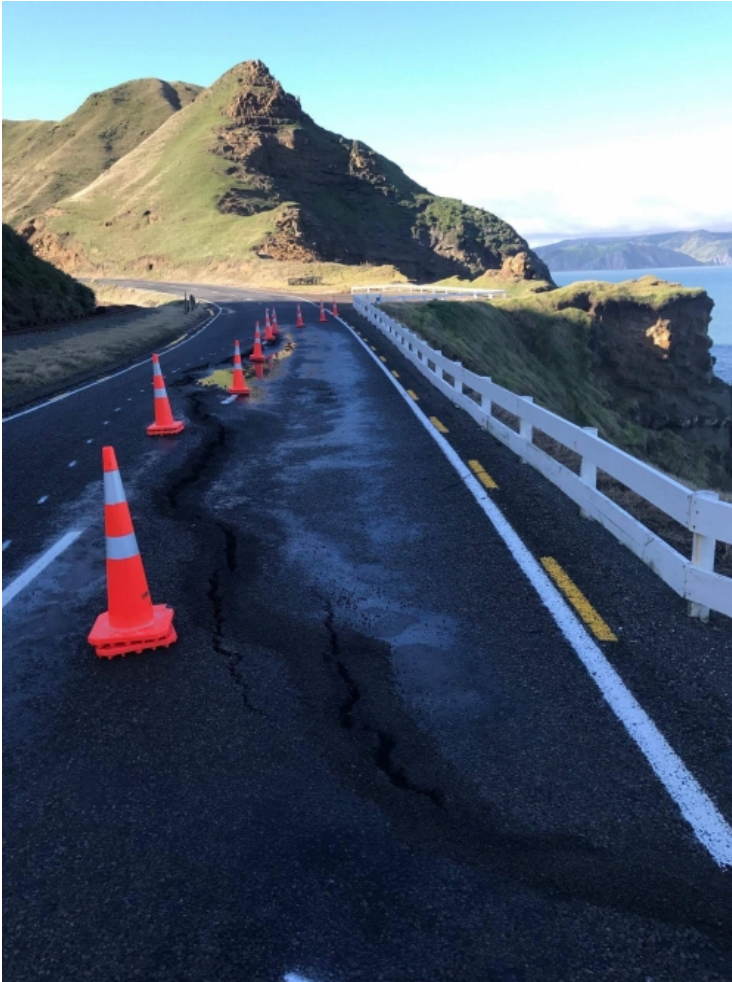
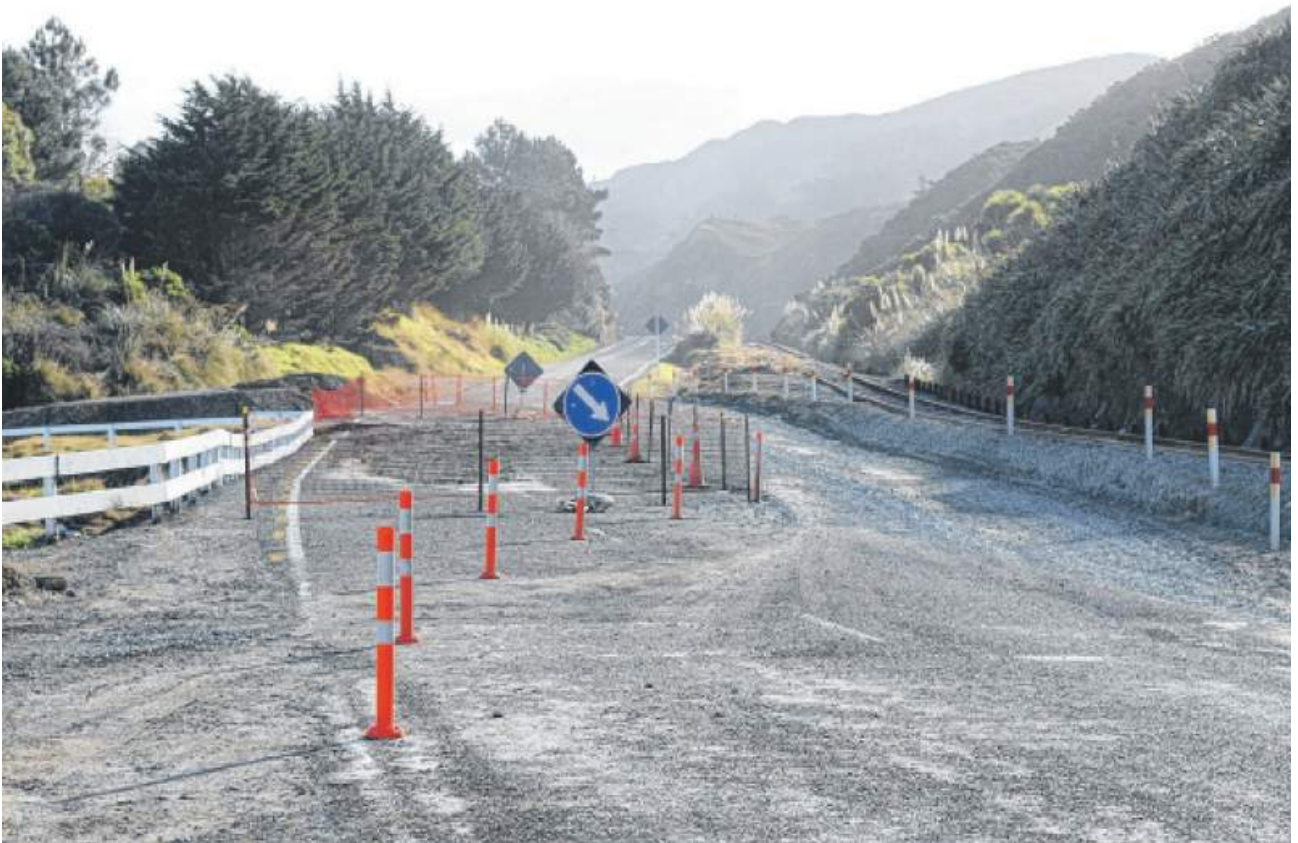
Blacks Beach Dropout – view from road level
