PNGL Wairoa – Gisborne 296.3 - 390.5km Track Formation Repair Works Civil Construction Work Packages 30%Design & Pricing – October 2019

Date: 10th October 2019

Project: FGL 1331

Prepared by: Maurice Fraser - Fraser Geologies Ltd

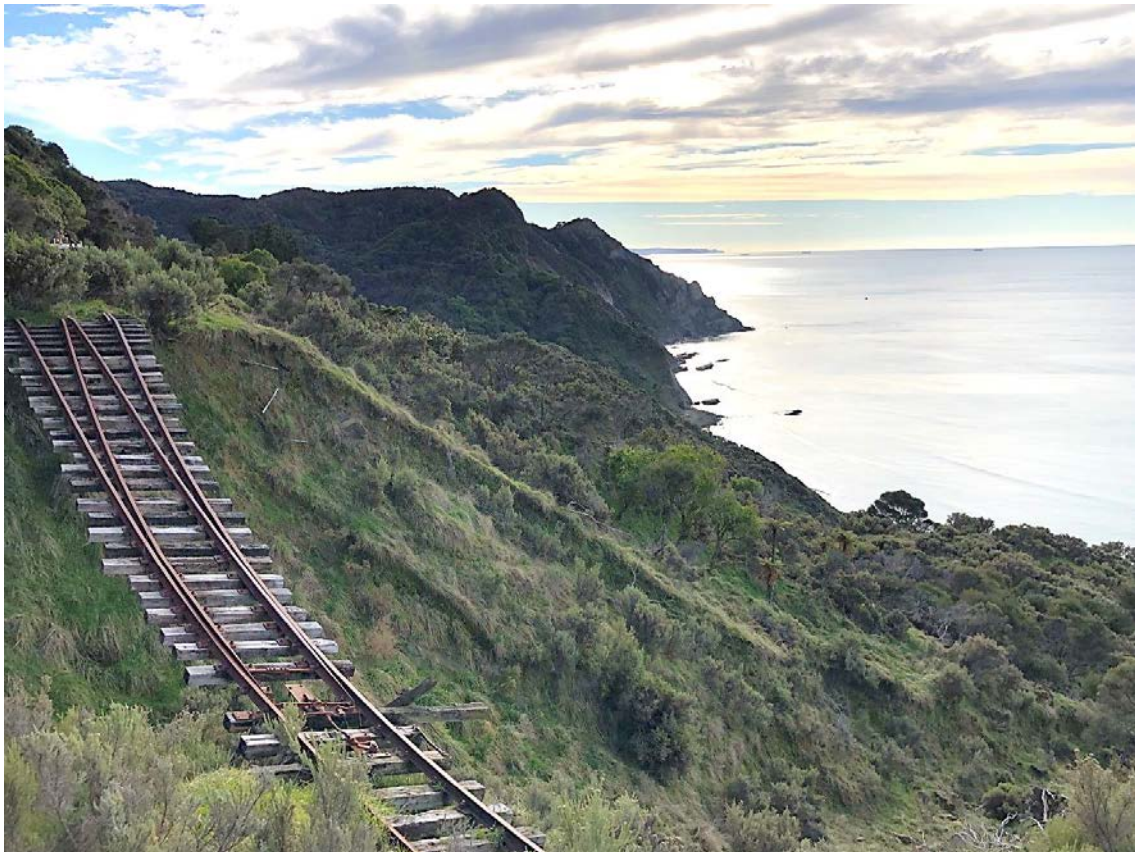
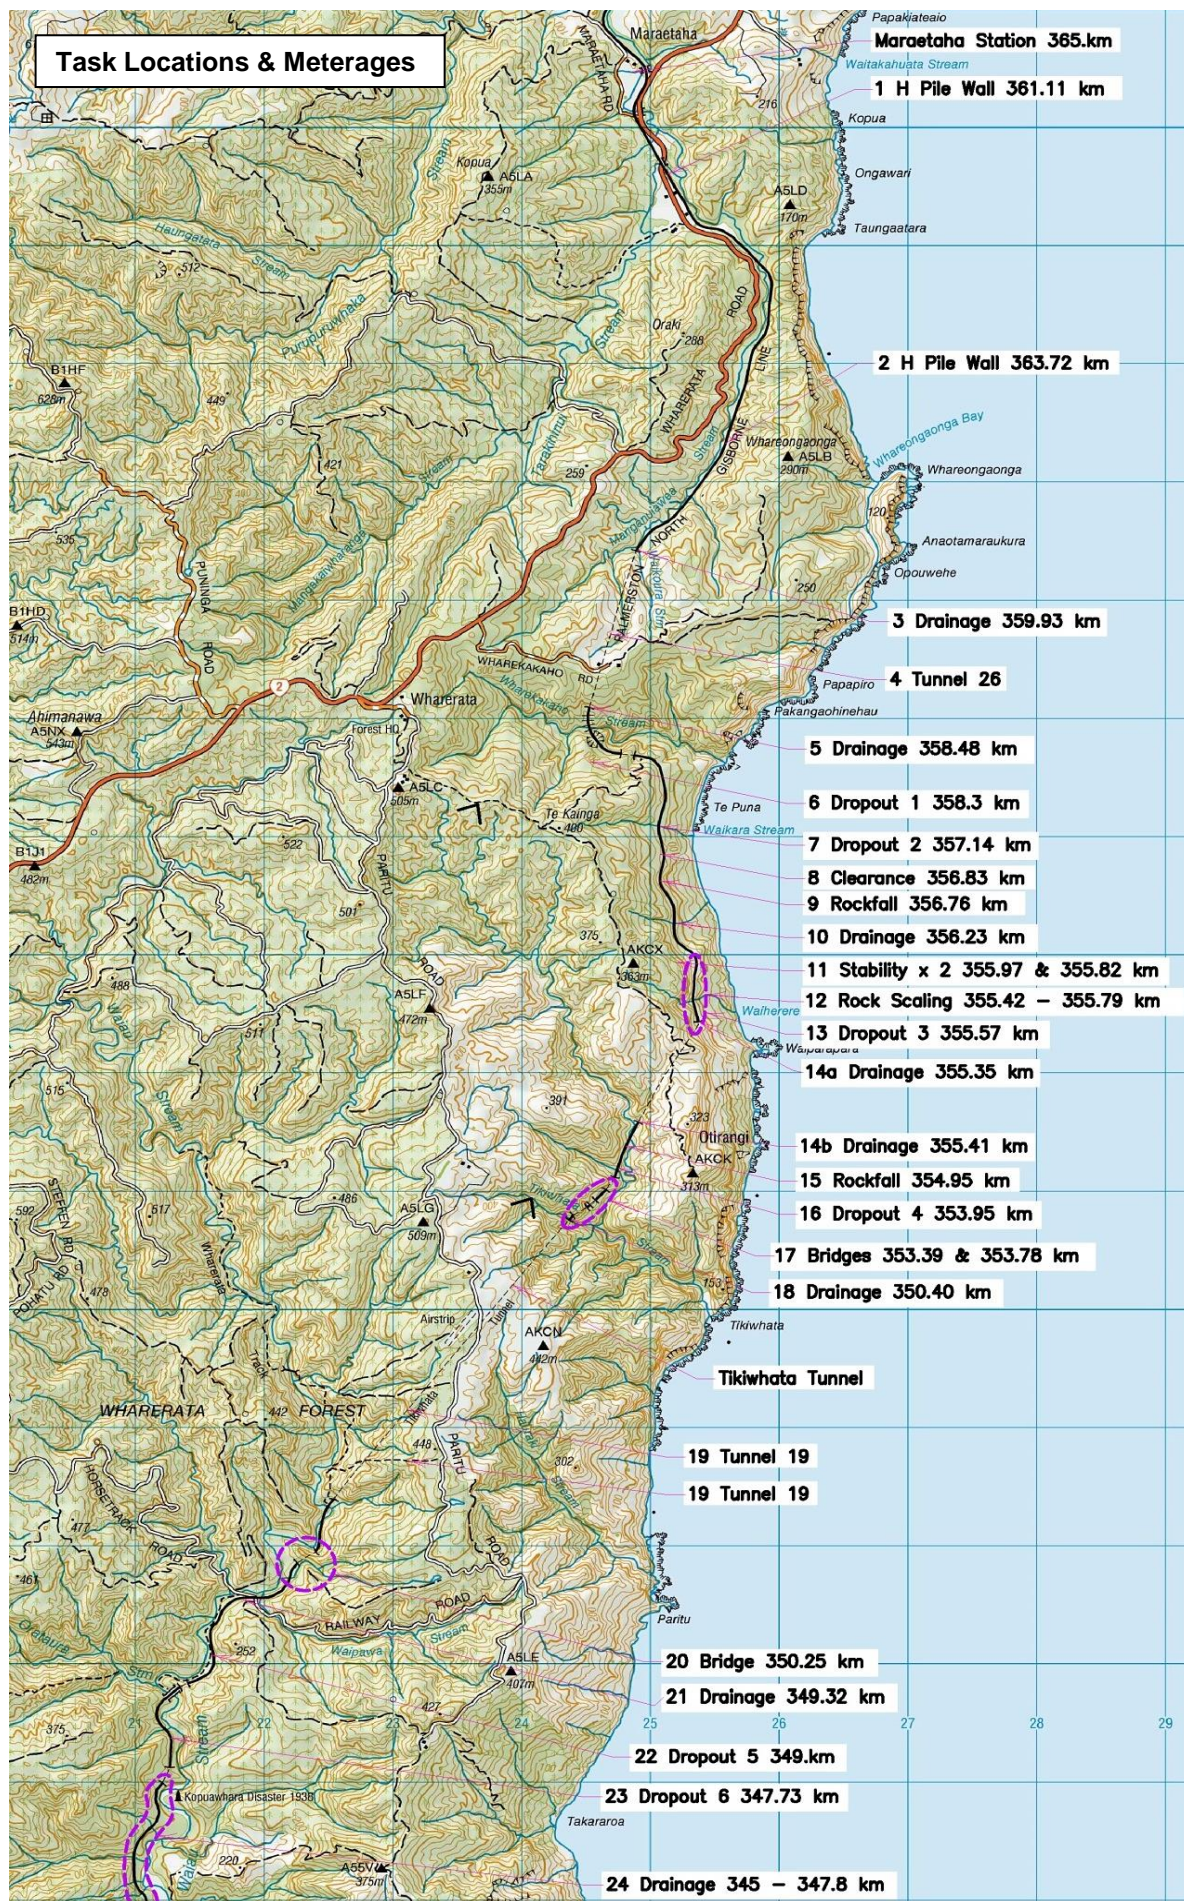
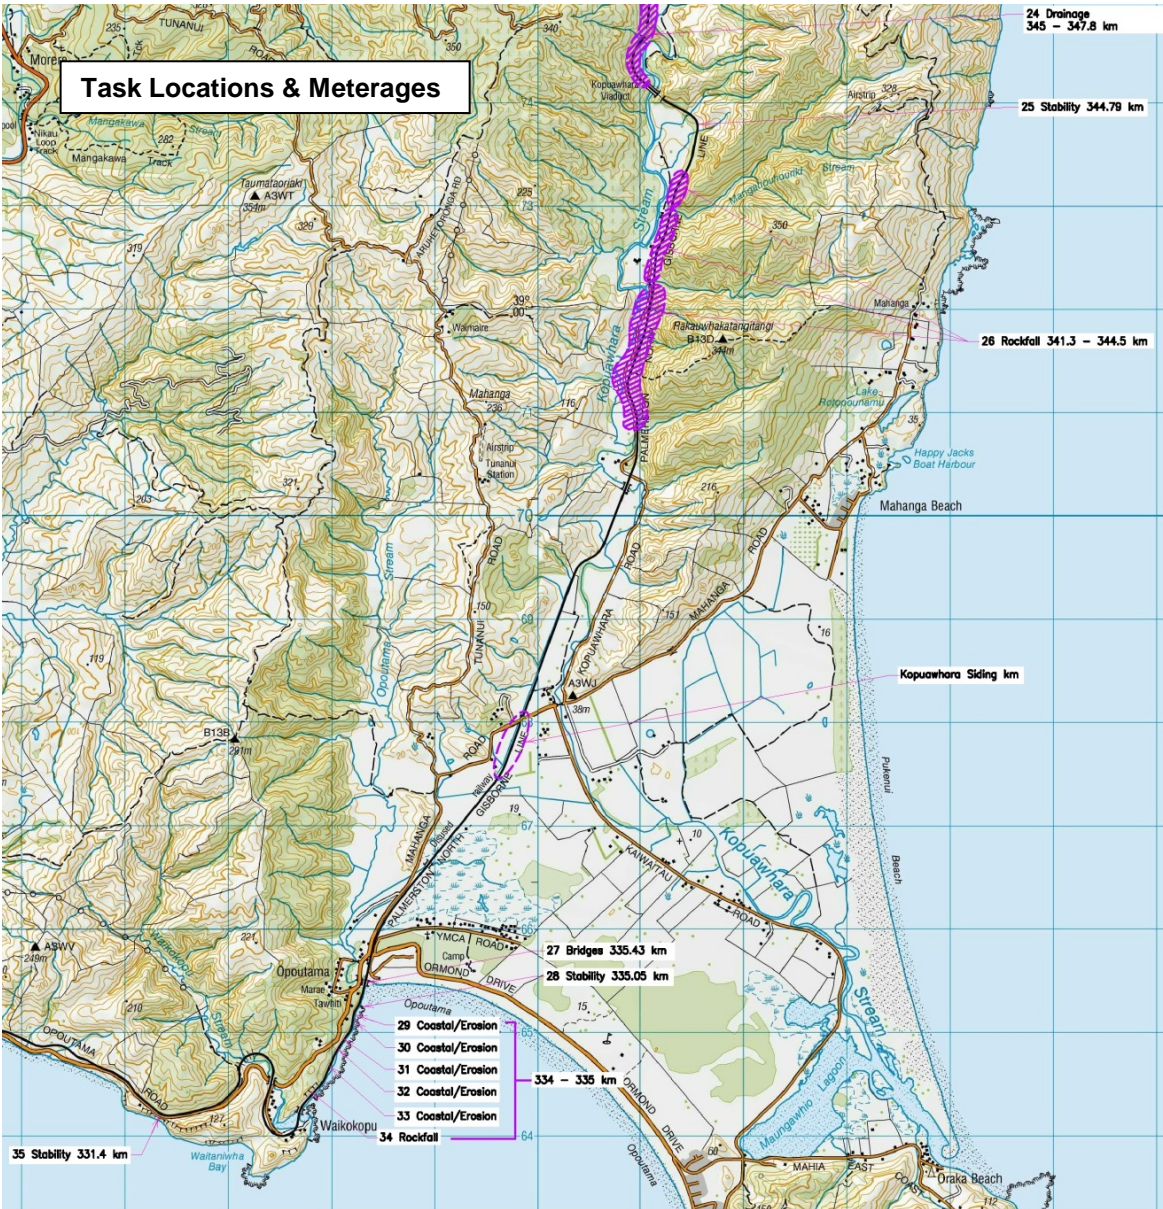
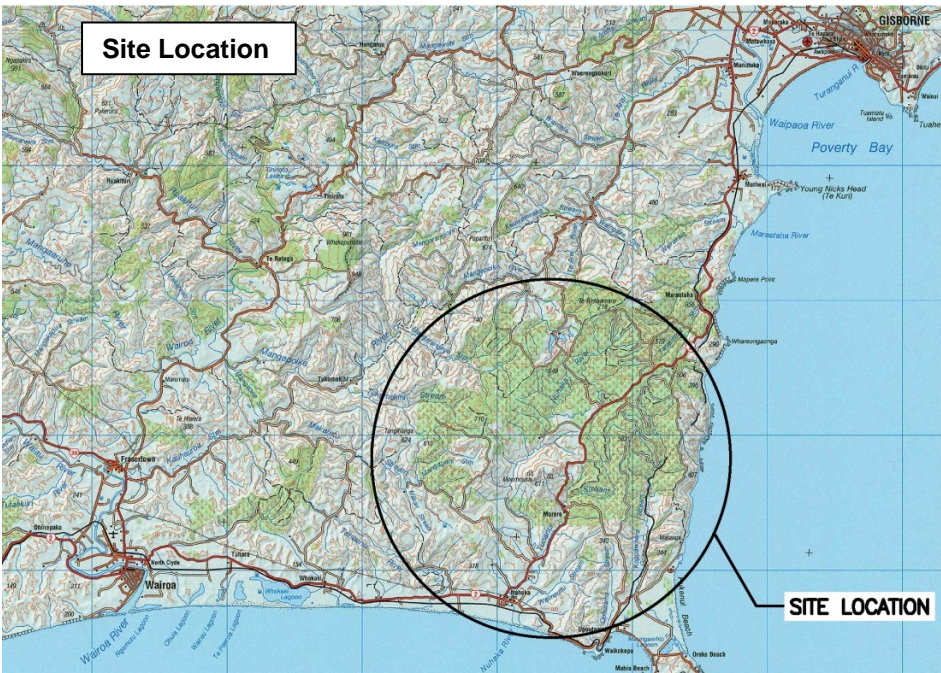
Repair Task:	Task 1 – Embankment Slip 1
Track Location:	Rail Chainage 363.72
Description:	Short washout on embankment edge approx. 150m south of Bridge 274 (over SH2)
Required Works	Driven H pile repair wall with timber lagging nominal 10m long.
Scale/ Scope/Volumes:	Driven H pile repair wall with timber lagging nominal 10m long. Allow driven 250UC73 @ 800 centres, 9m deep with 200*50 H5 timber lagging installed behind rear flange. Nominal trackside retained height 1.5m with sloping embankment toe.
Construction Comment:	Design TBC - steel section sizing to be confirmed. Driven pile design adopted on basis of driving into embankment filling and avoiding drilling works and concrete supply into corridor.
Designer Comment:	Alternative drill & concrete (600mm with temporary casing) as well as walers & tiebacks if required. Timber lagging as required – retention is primarily from arching between steel uprights at close driven centres Steel sections not galvanised

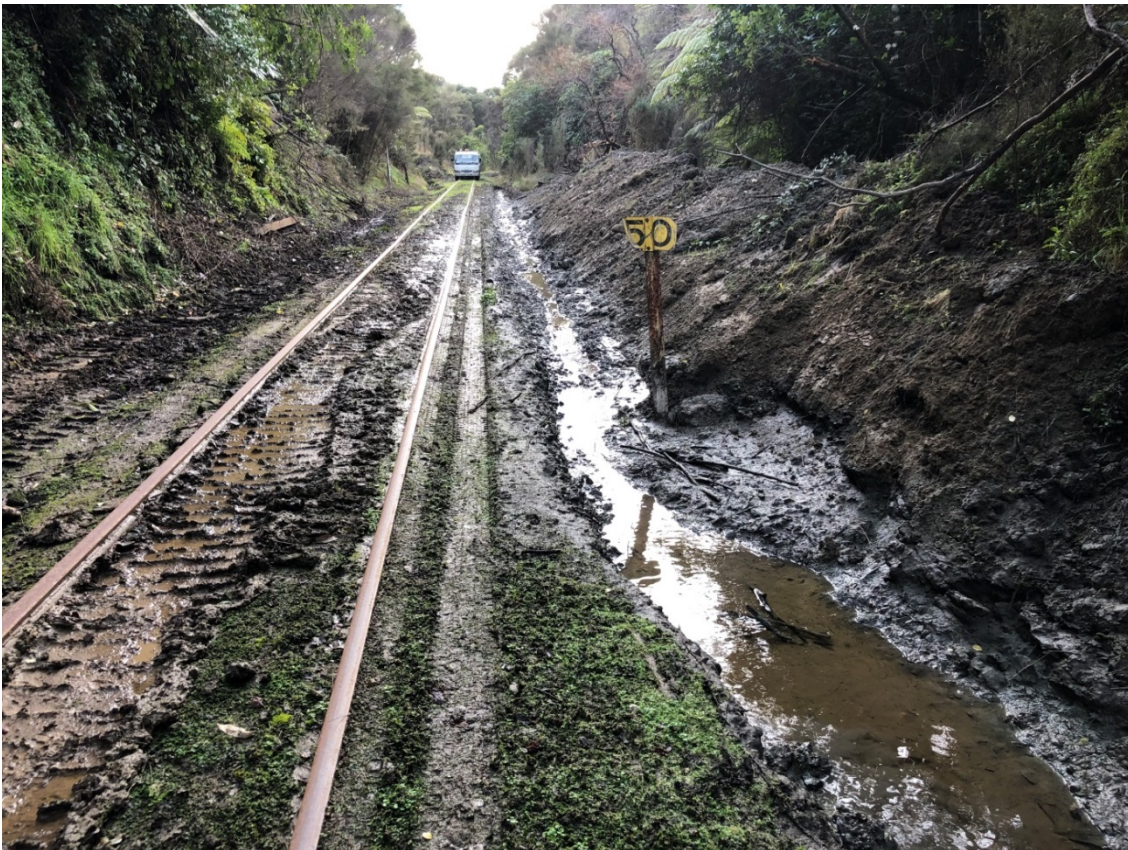
Temporary drainage works undertaken in week of 15 July 2019 – open up tunnel drainage, stockpile spoil against stream to confine sediment to channel and stop water flooding over track. Note significant groundwater drainage flowing out of exposed ballast.

Uncovered tunnel drainage on western side of formation, plus flow through culvert under track.

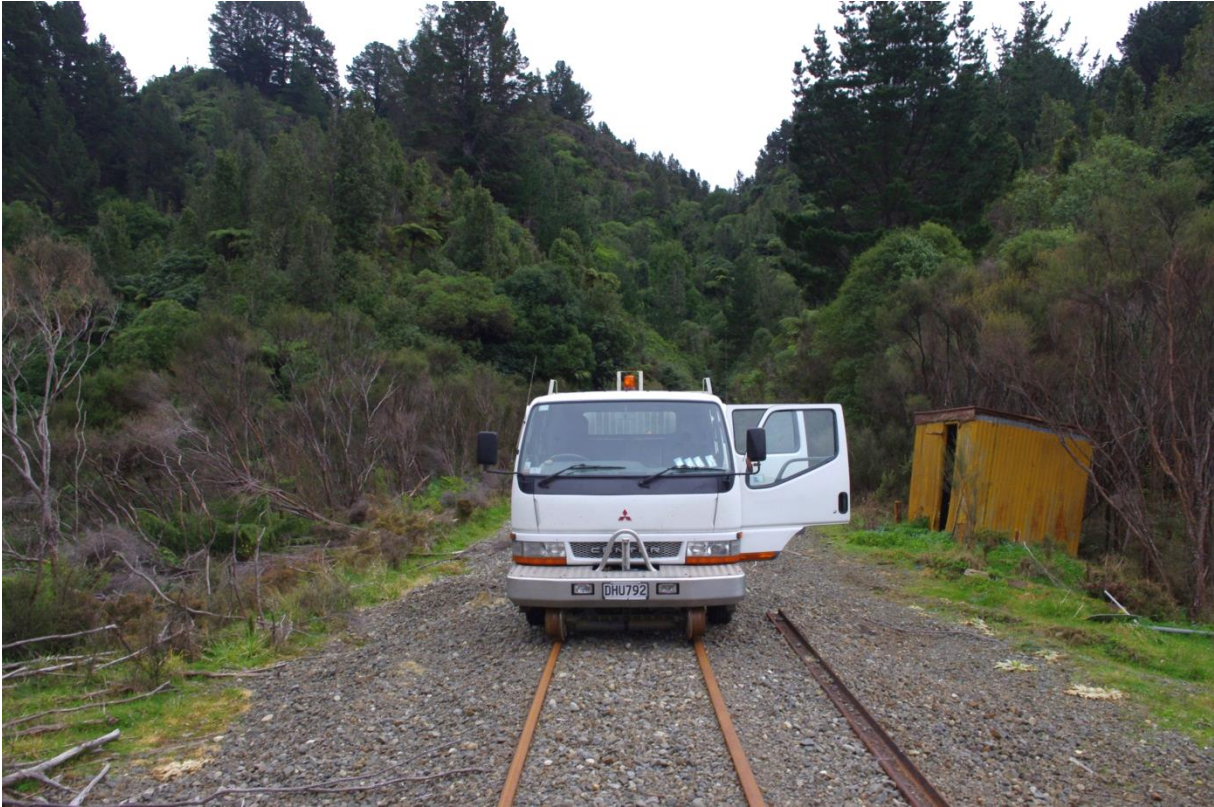
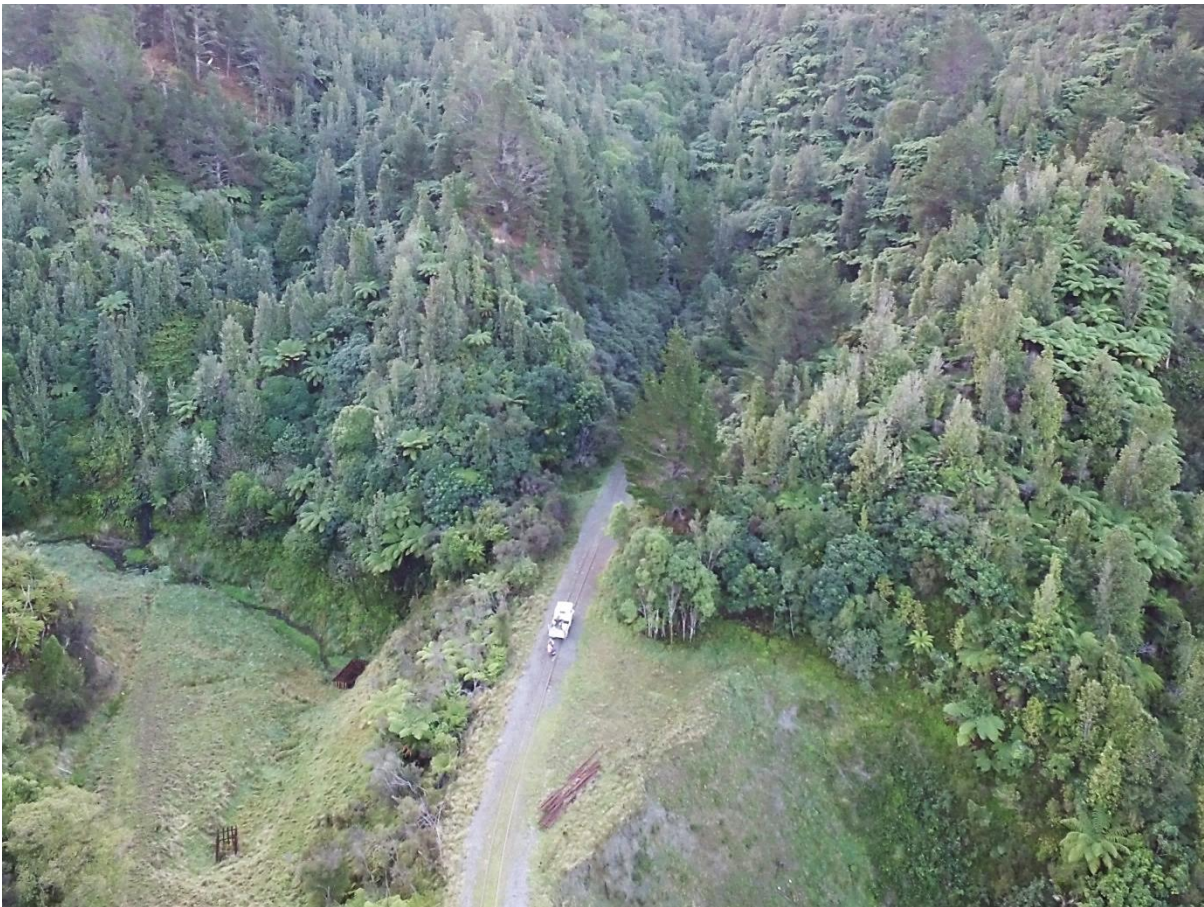
Repair Task:	Task 5 – Wharekakaho Tunnel 26 South Portal
Track Location:	Rail Chainage 358.48km
Description:	Southern Tunnel Portal Drainage Works
Required Works	Upgrade tunnel cutting drainage works and swales leading out from tunnel portal
Scale/ Scope/Volumes:	Excavate out and reinstate swales coming out from tunnel portal. Nominal 60m of swale deepening & widening on both sides of formation towards Dropout 1.
Construction Comment:	
Designer Comment:	
Rail Operations:	Work trains past site, including deliveries for Beach Loop dropouts.

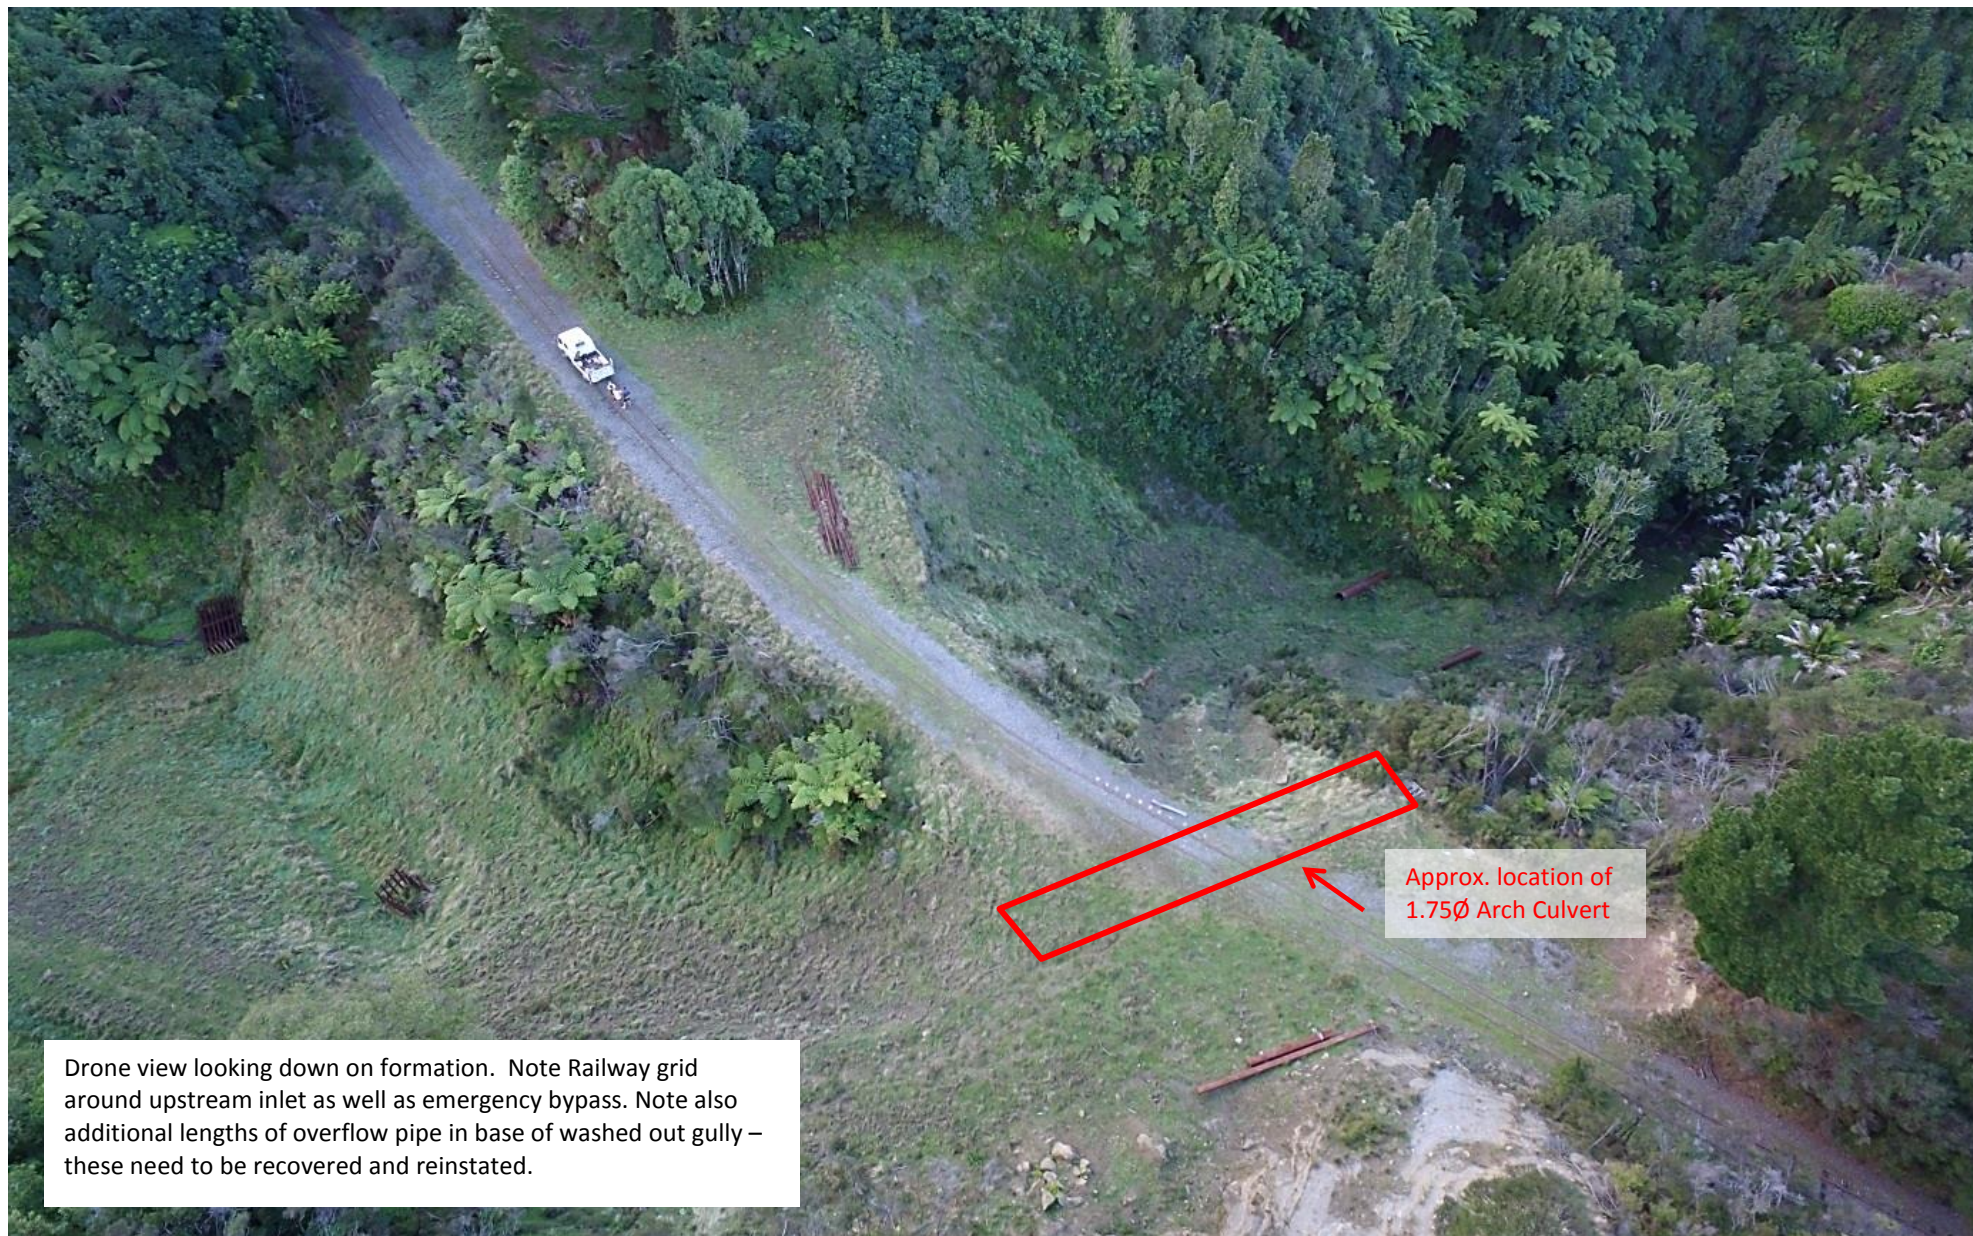
Drone view looking into current embankment from east. Note emergency 900Ø pipe overflow approx. 10m from track level on embankment LHS (shown as *). Note also waterfall on RHS of image – this is discharge from arch culvert under the ridgeline

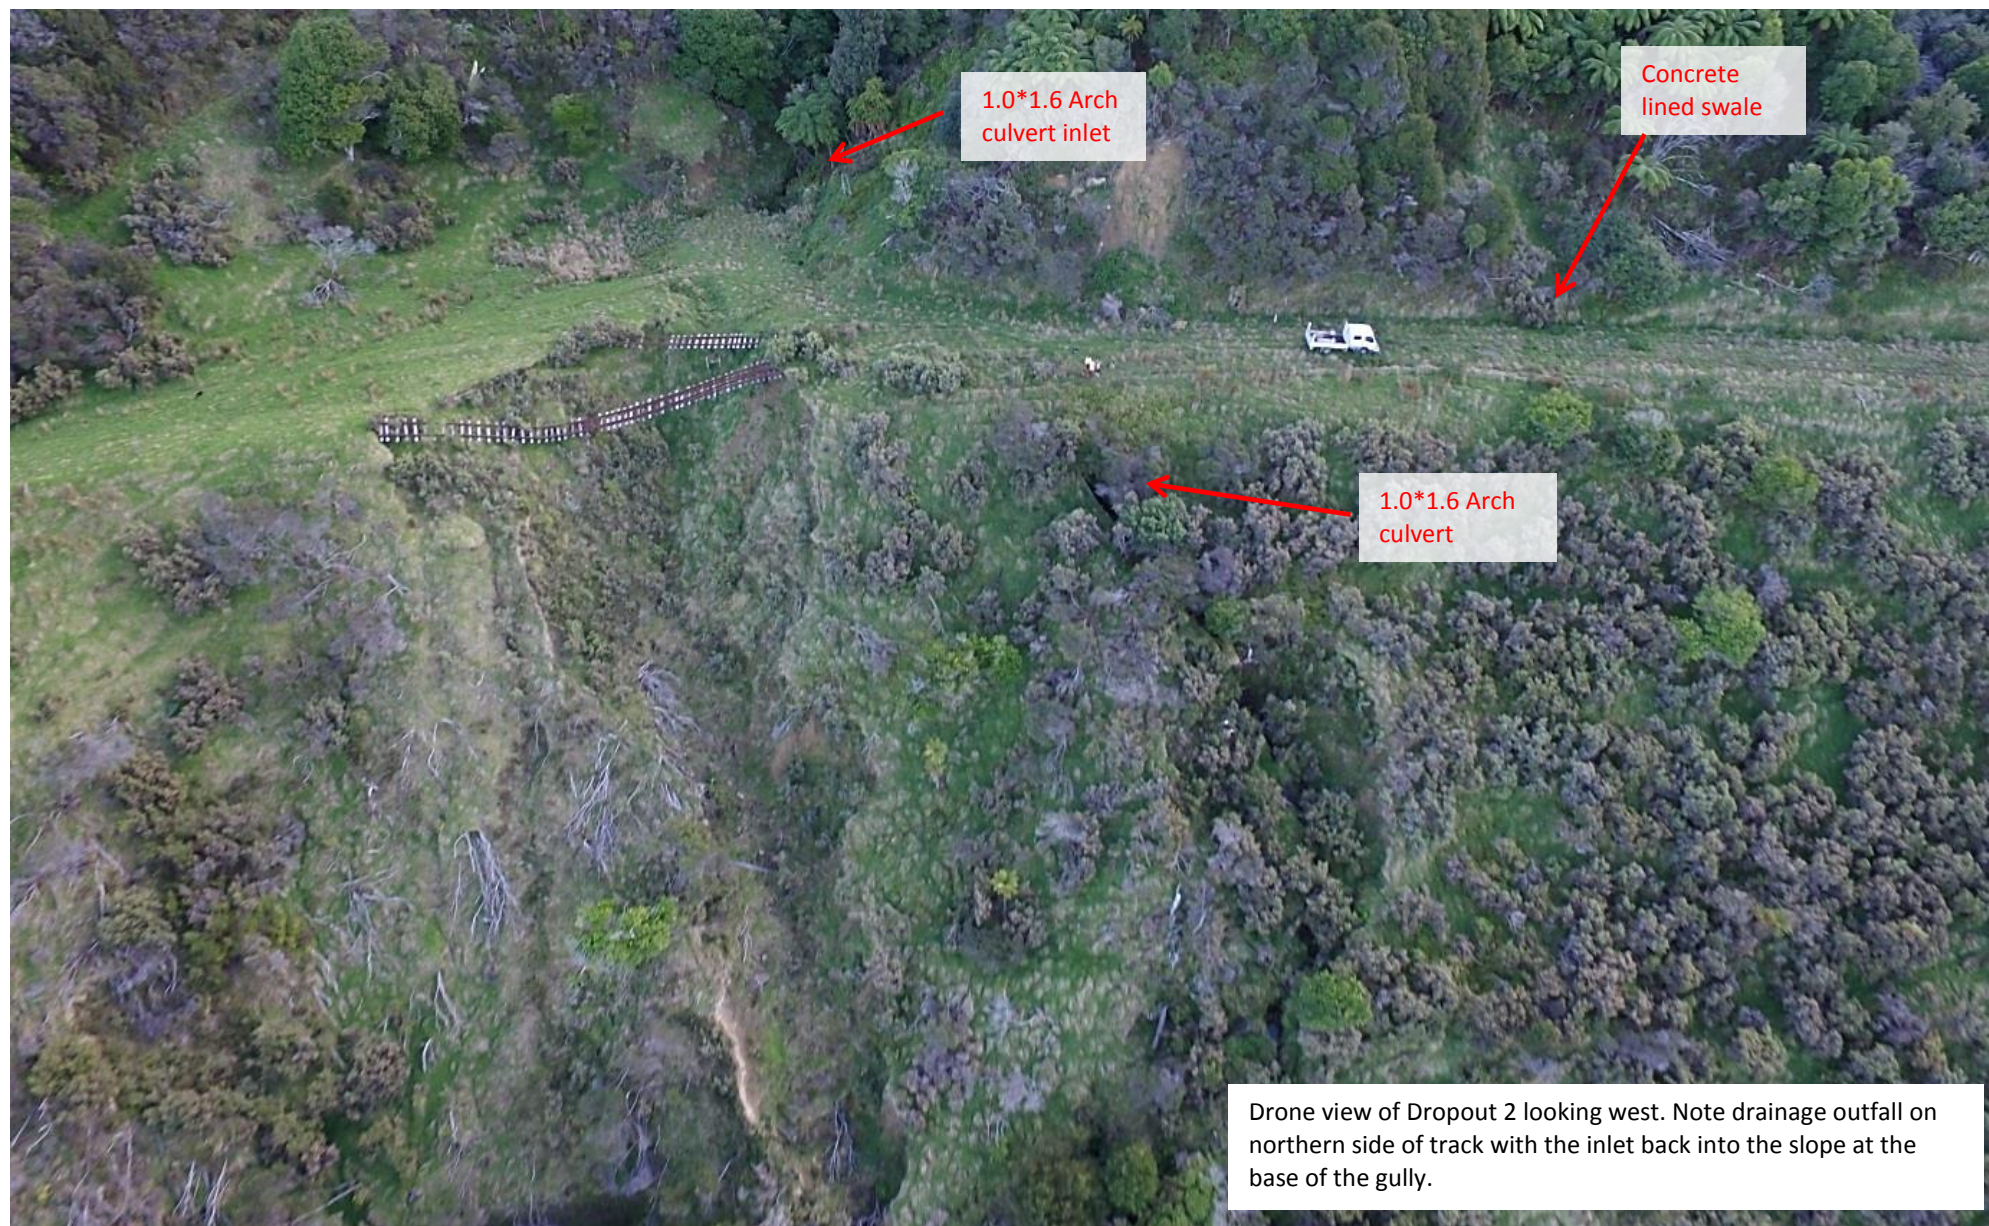
Drone view of Dropout 2 looking south. Note significantly incised erosion into underlying side tipped soils from adjacent 1940s track benching and cutting operations and underlying residual soils

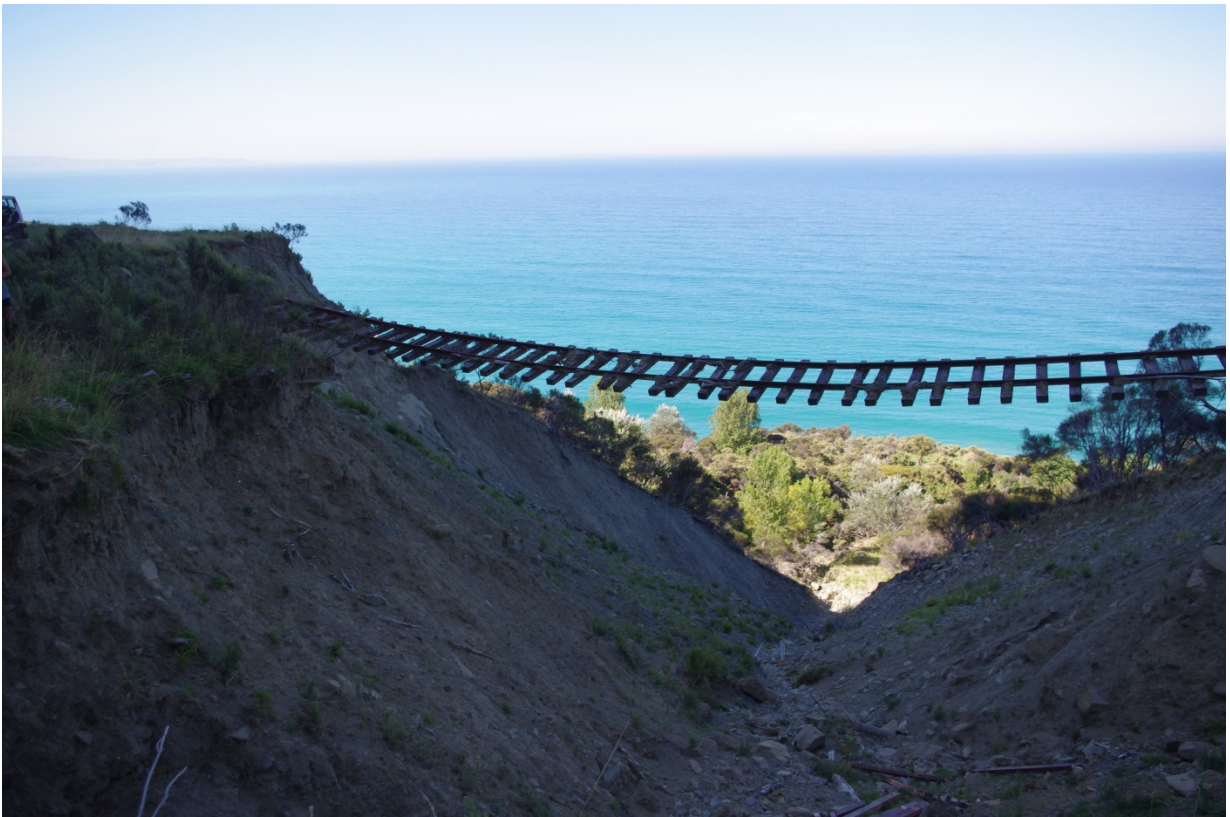
Stitched photo view looking north - note extensive spoil depths on far facing, no intact rockmass visible.

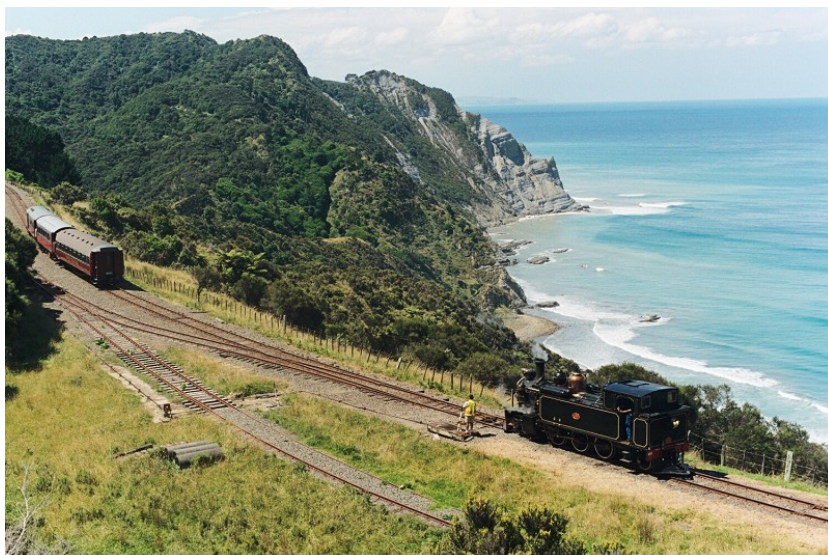
1986 NZR aerial photograph showing Dropout 2 prior to failure - note significant fill material on slope below turnout and clear view of track drainage works on northern side. Note access track above loop area.

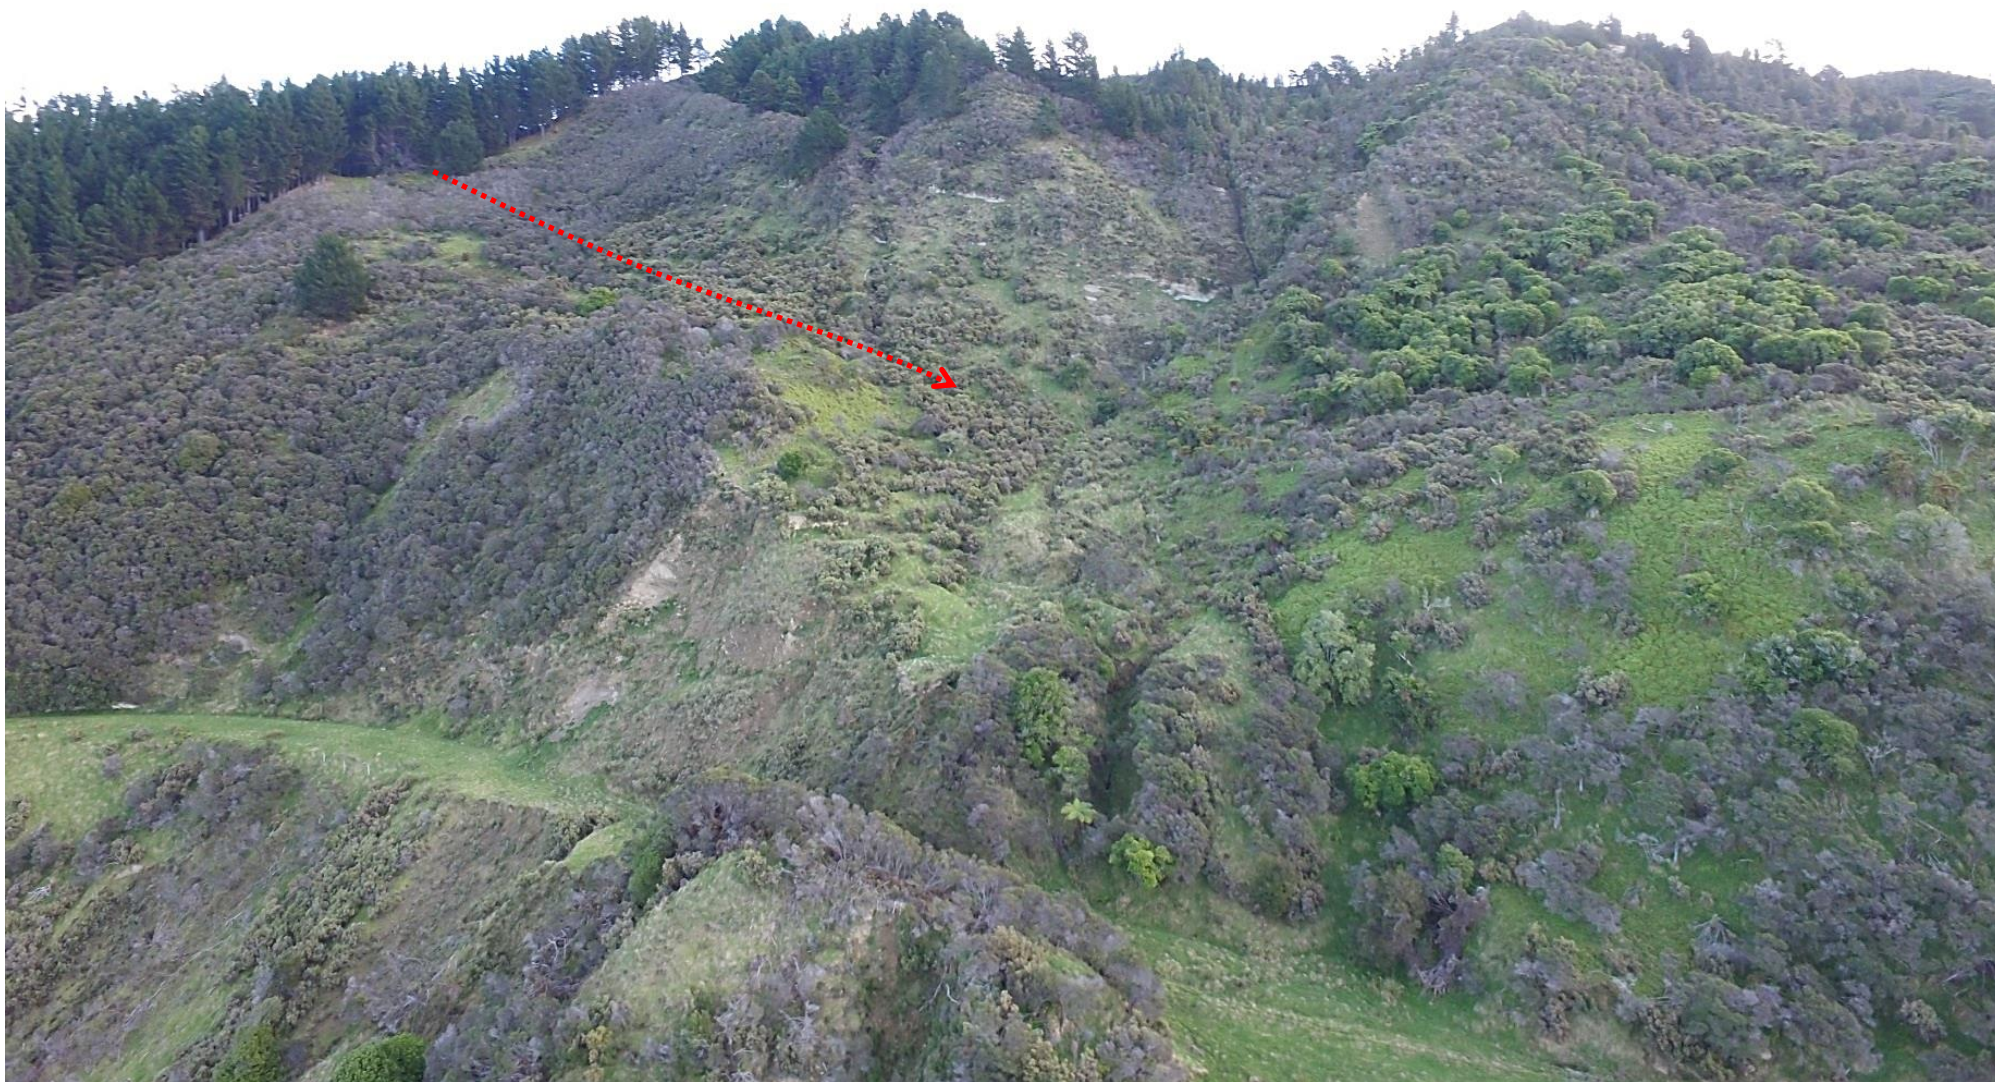
Drone view of cutting looking west. Note potential for new Beach Loop access track from upper right on photo

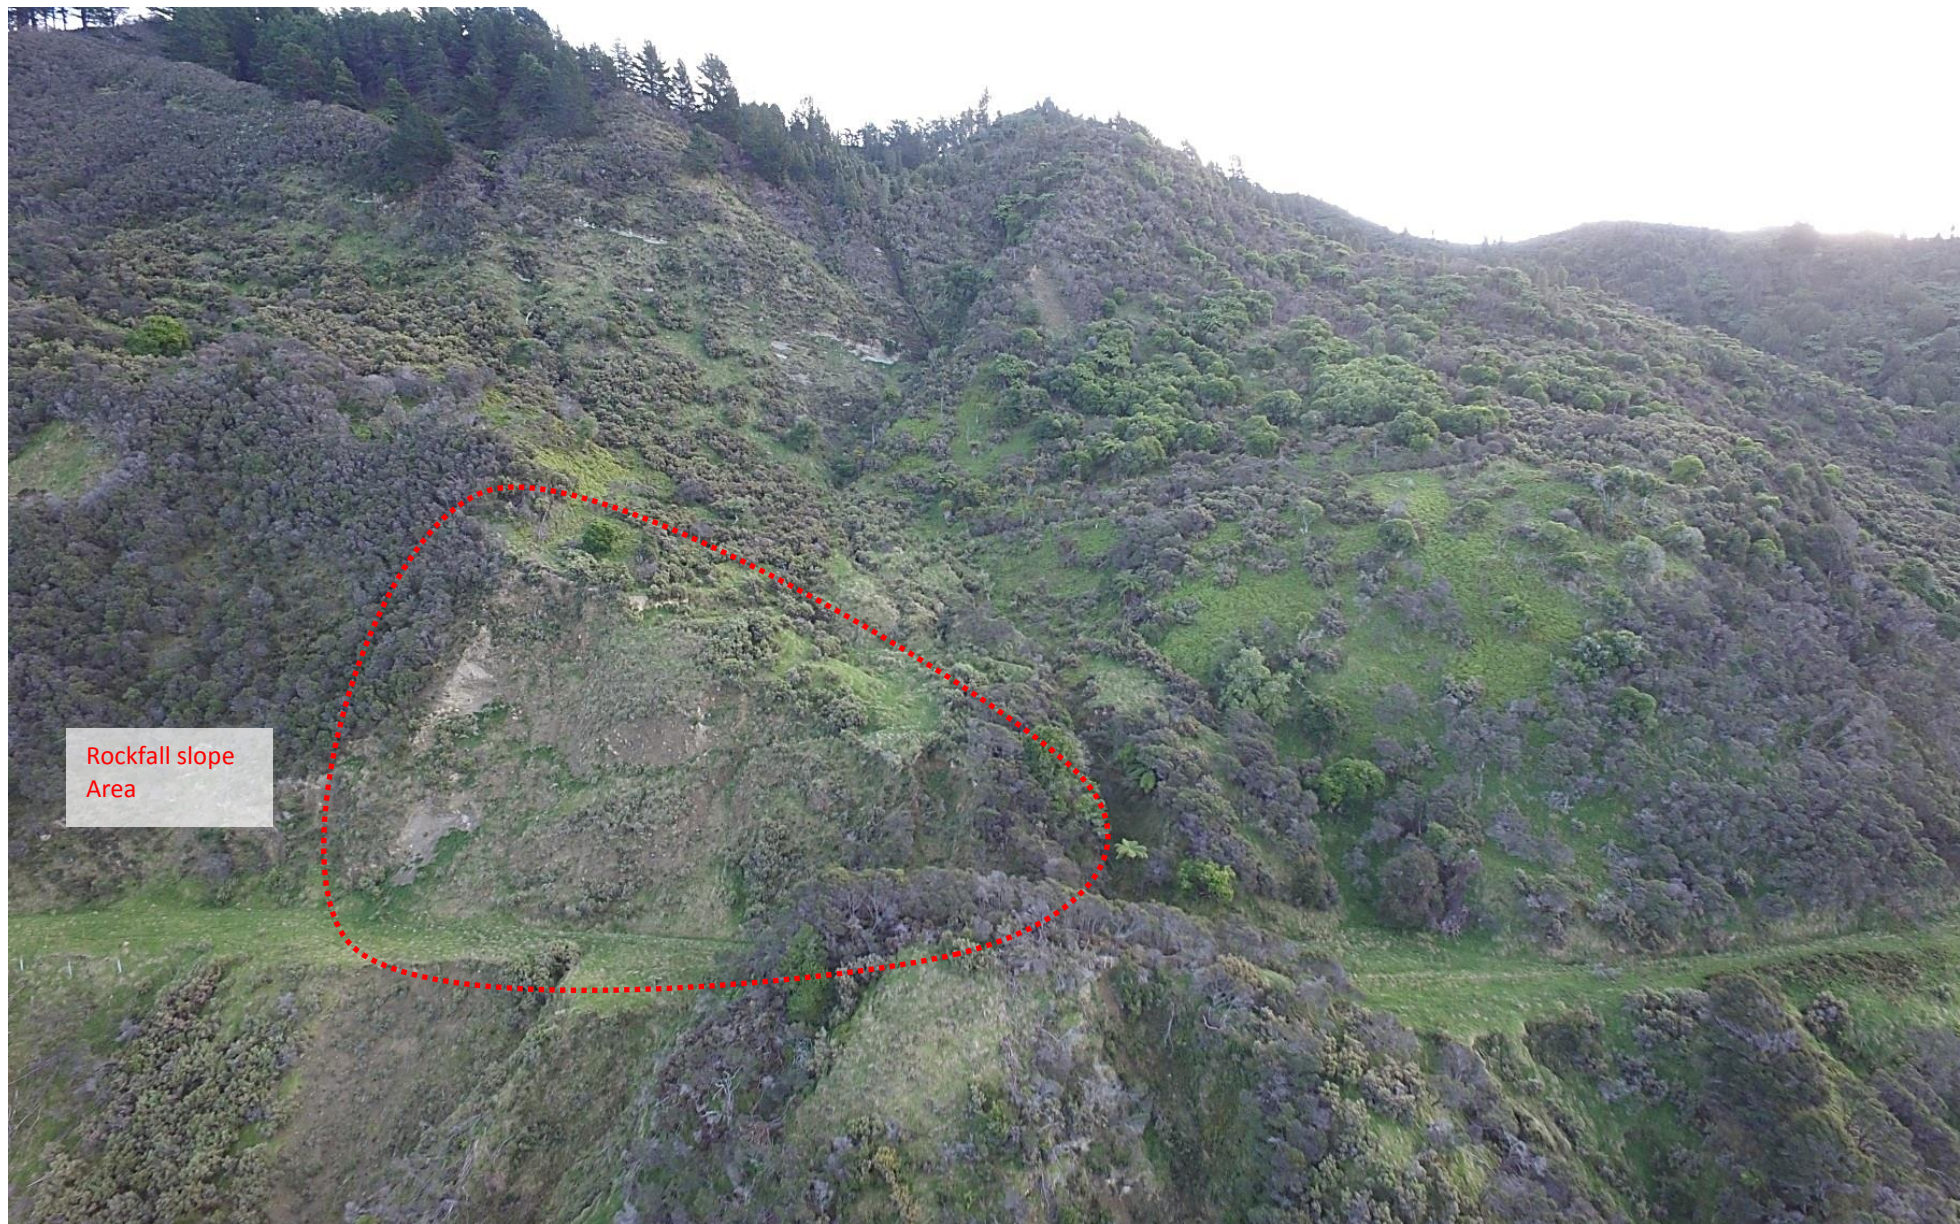
Drone view of rock fall area on left and looking back into cutting area in middle part of photograph. Note eroded mid slope benching on rock fall face

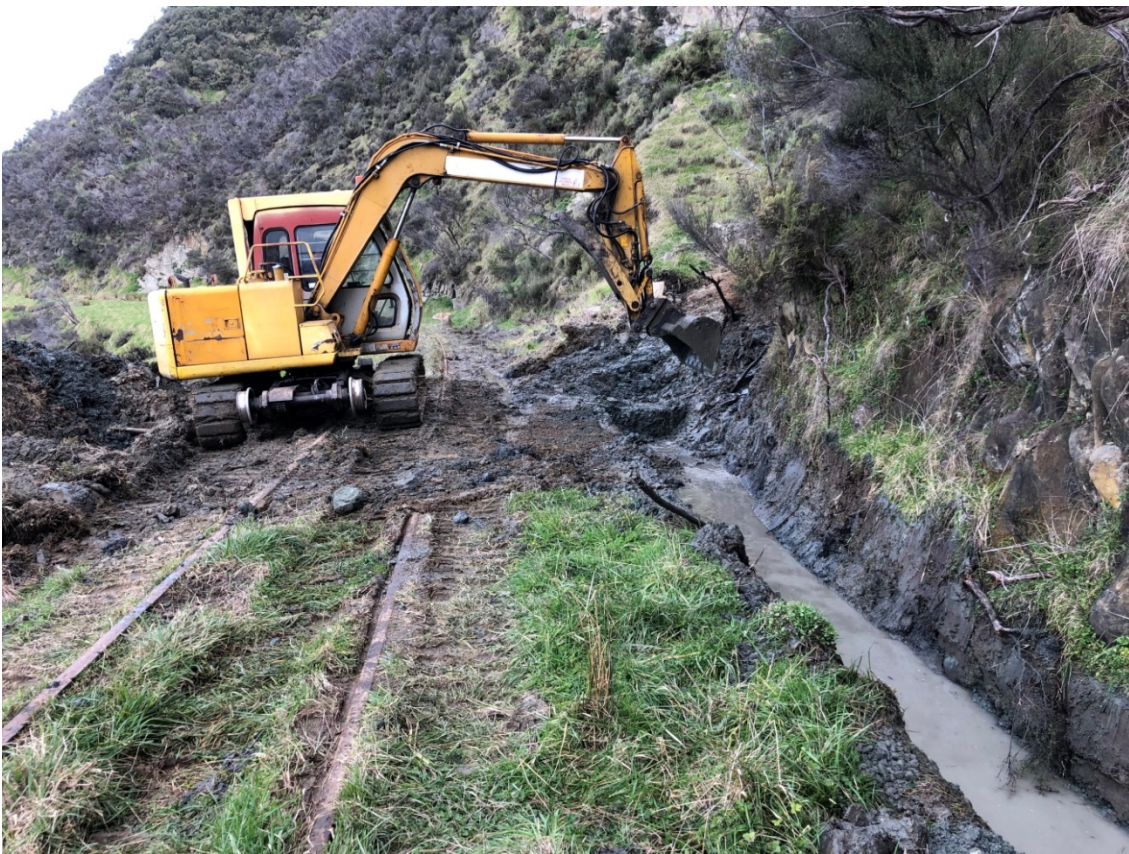
Swale clearance works July 2019 to prevent water flooding across track and destabilising slope on outside edge of track formation.
