PNGL Wairoa – Gisborne 296.3 - 390.5km Track Formation Repair Works Civil Construction Work Packages 30%Design & Pricing – October 2019

Date: 10th October 2019

Project: FGL 1331

Prepared by: Maurice Fraser - Fraser Geologies Ltd

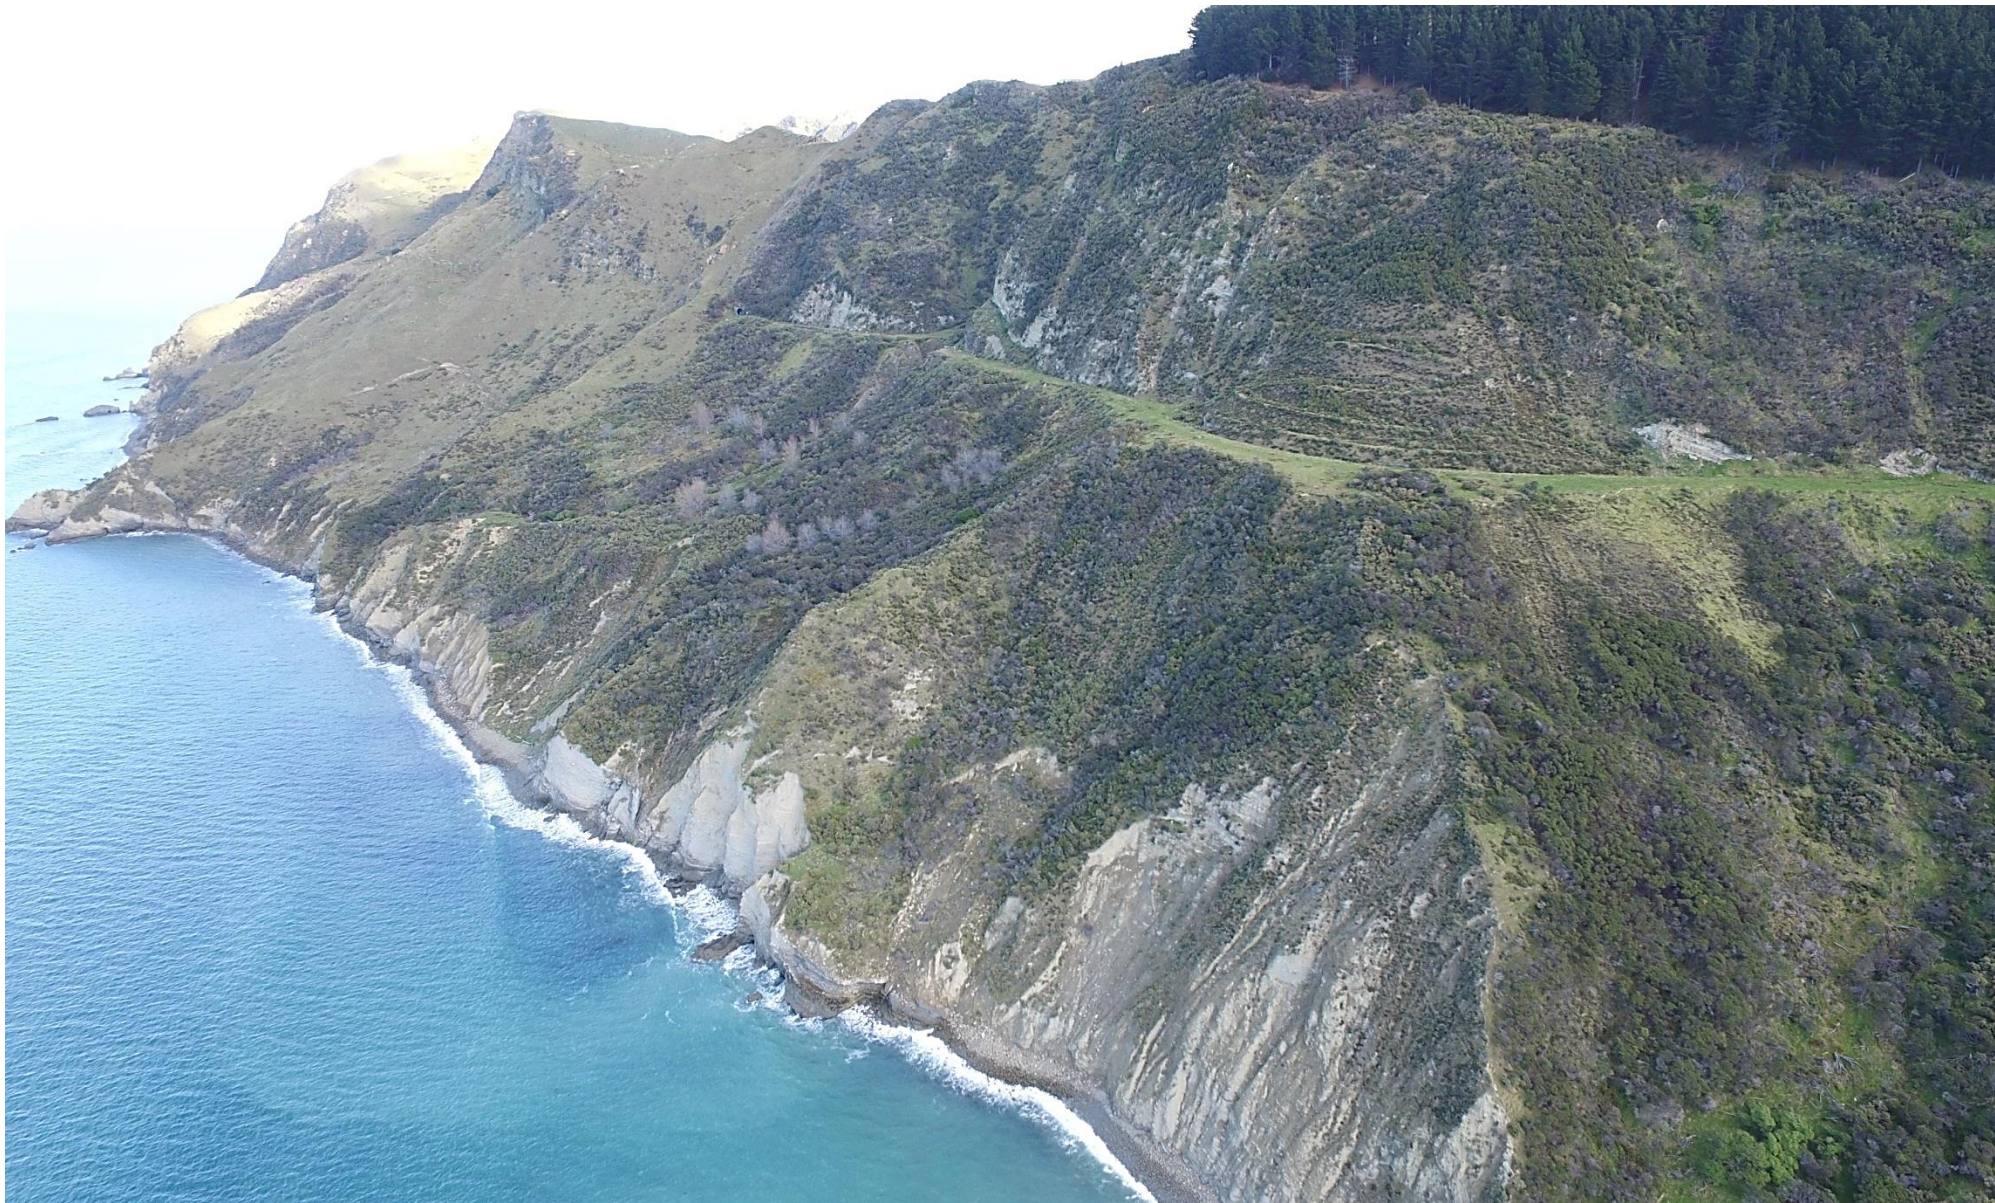
Historical photographs from 1956 tunnel daylighting operations – note benching and fill placement from this area back to Dropout 4

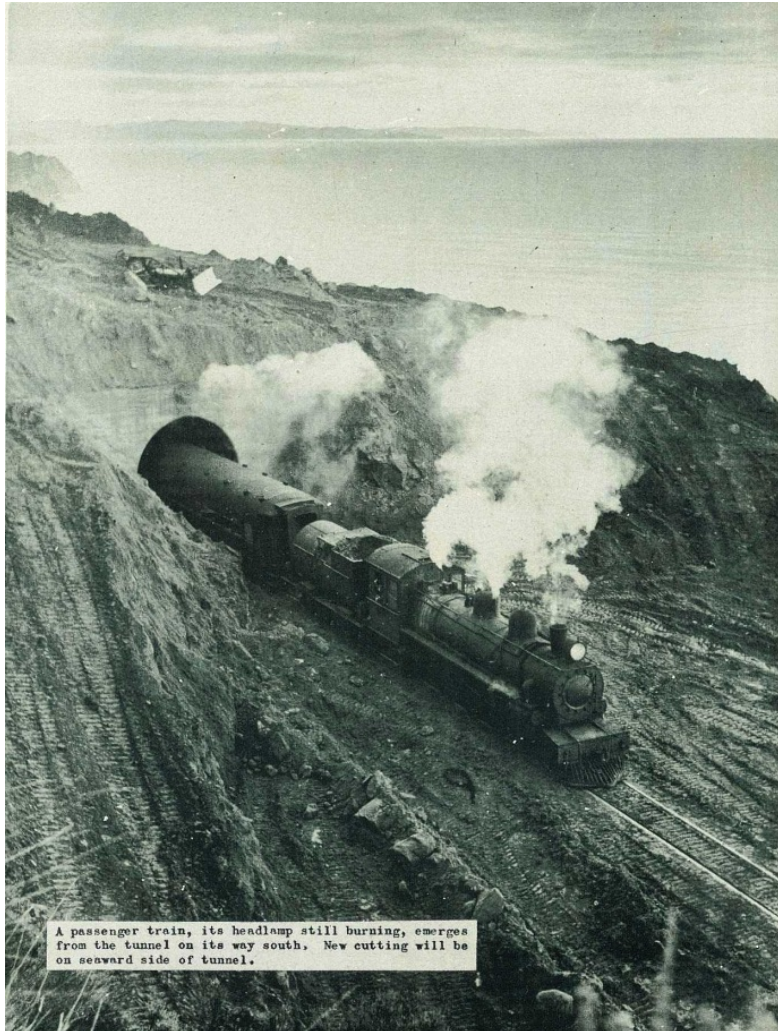
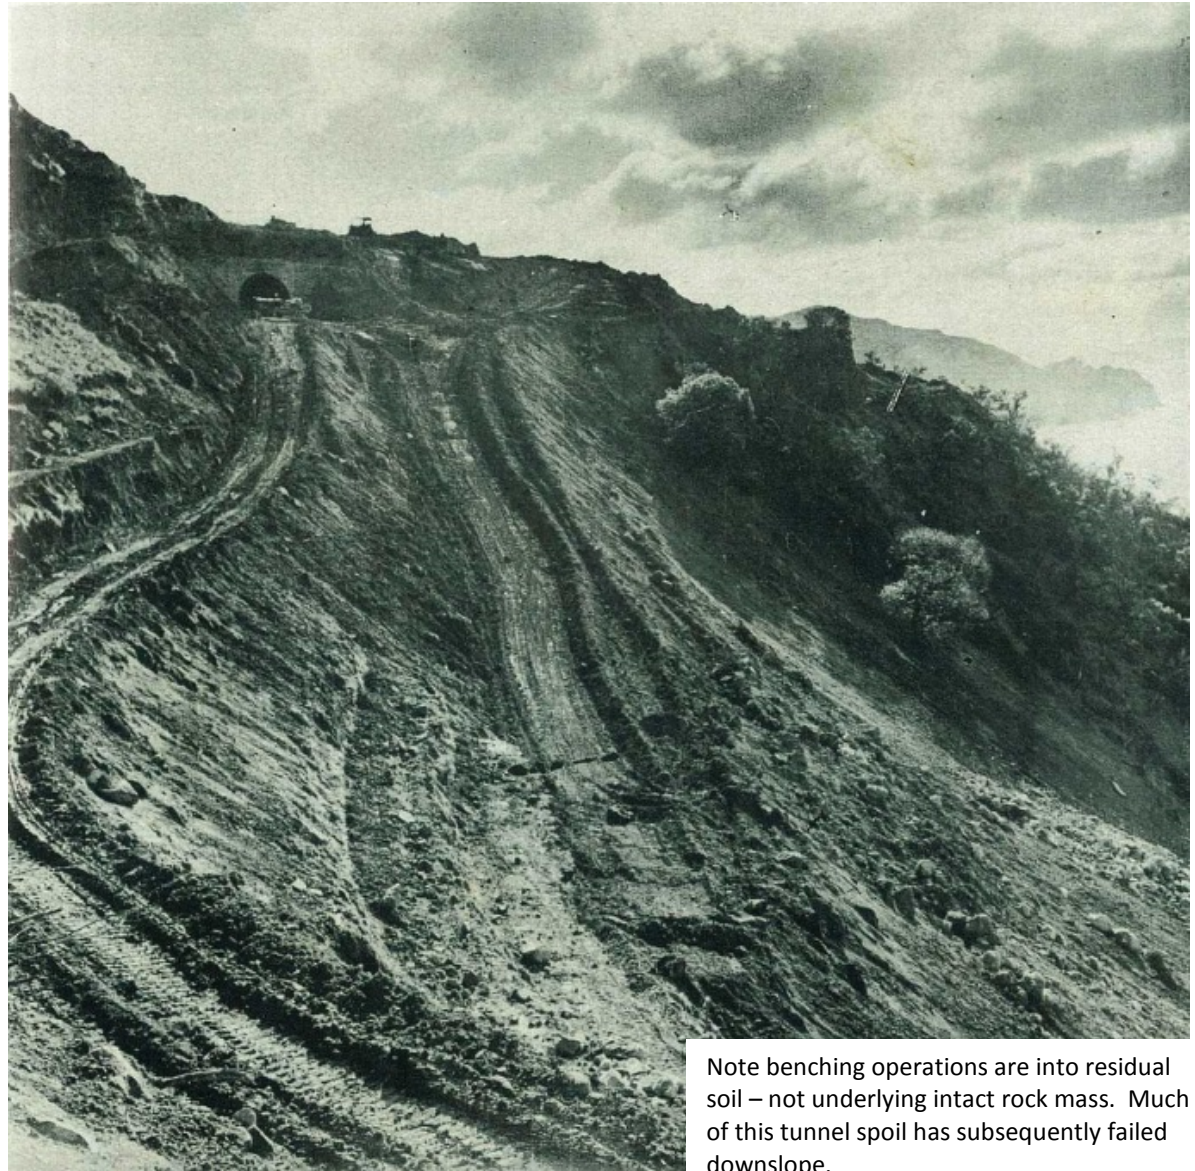
Historical photographs from 1956 tunnel daylighting operations – note benching and fill placement looking back to north
