<b>Repair Task:</b>	<b>Task 12 – Rock Scaling 355.42 - 355.79</b>
<b>Track Location:</b>	Rail Chainage 355.42-355.79
<b>Description:</b>	Cliff face areas require scaling to remove significant rock fall hazard.
<b>Required Works</b>	
<b>Scale/ Scope/Volumes:</b>	Allow to scale cliff face Allow to put 20 tonne excavator up on bench and remove collected rocks - push out onto formation bench below. Remove track and sleeper sets prior.
<b>Construction Comment:</b>	Require expert assistance to define scale and scope of problem - prelim budget 12 days of actual abseil work on site.
<b>Designer Comment:</b>	Require expert assistance to define scale and scope of problem - prelim budget 12 days of actual abseil work on site.
<b>Rail Operations:</b>	Work trains past site, including deliveries for Dropout 3 & 4.

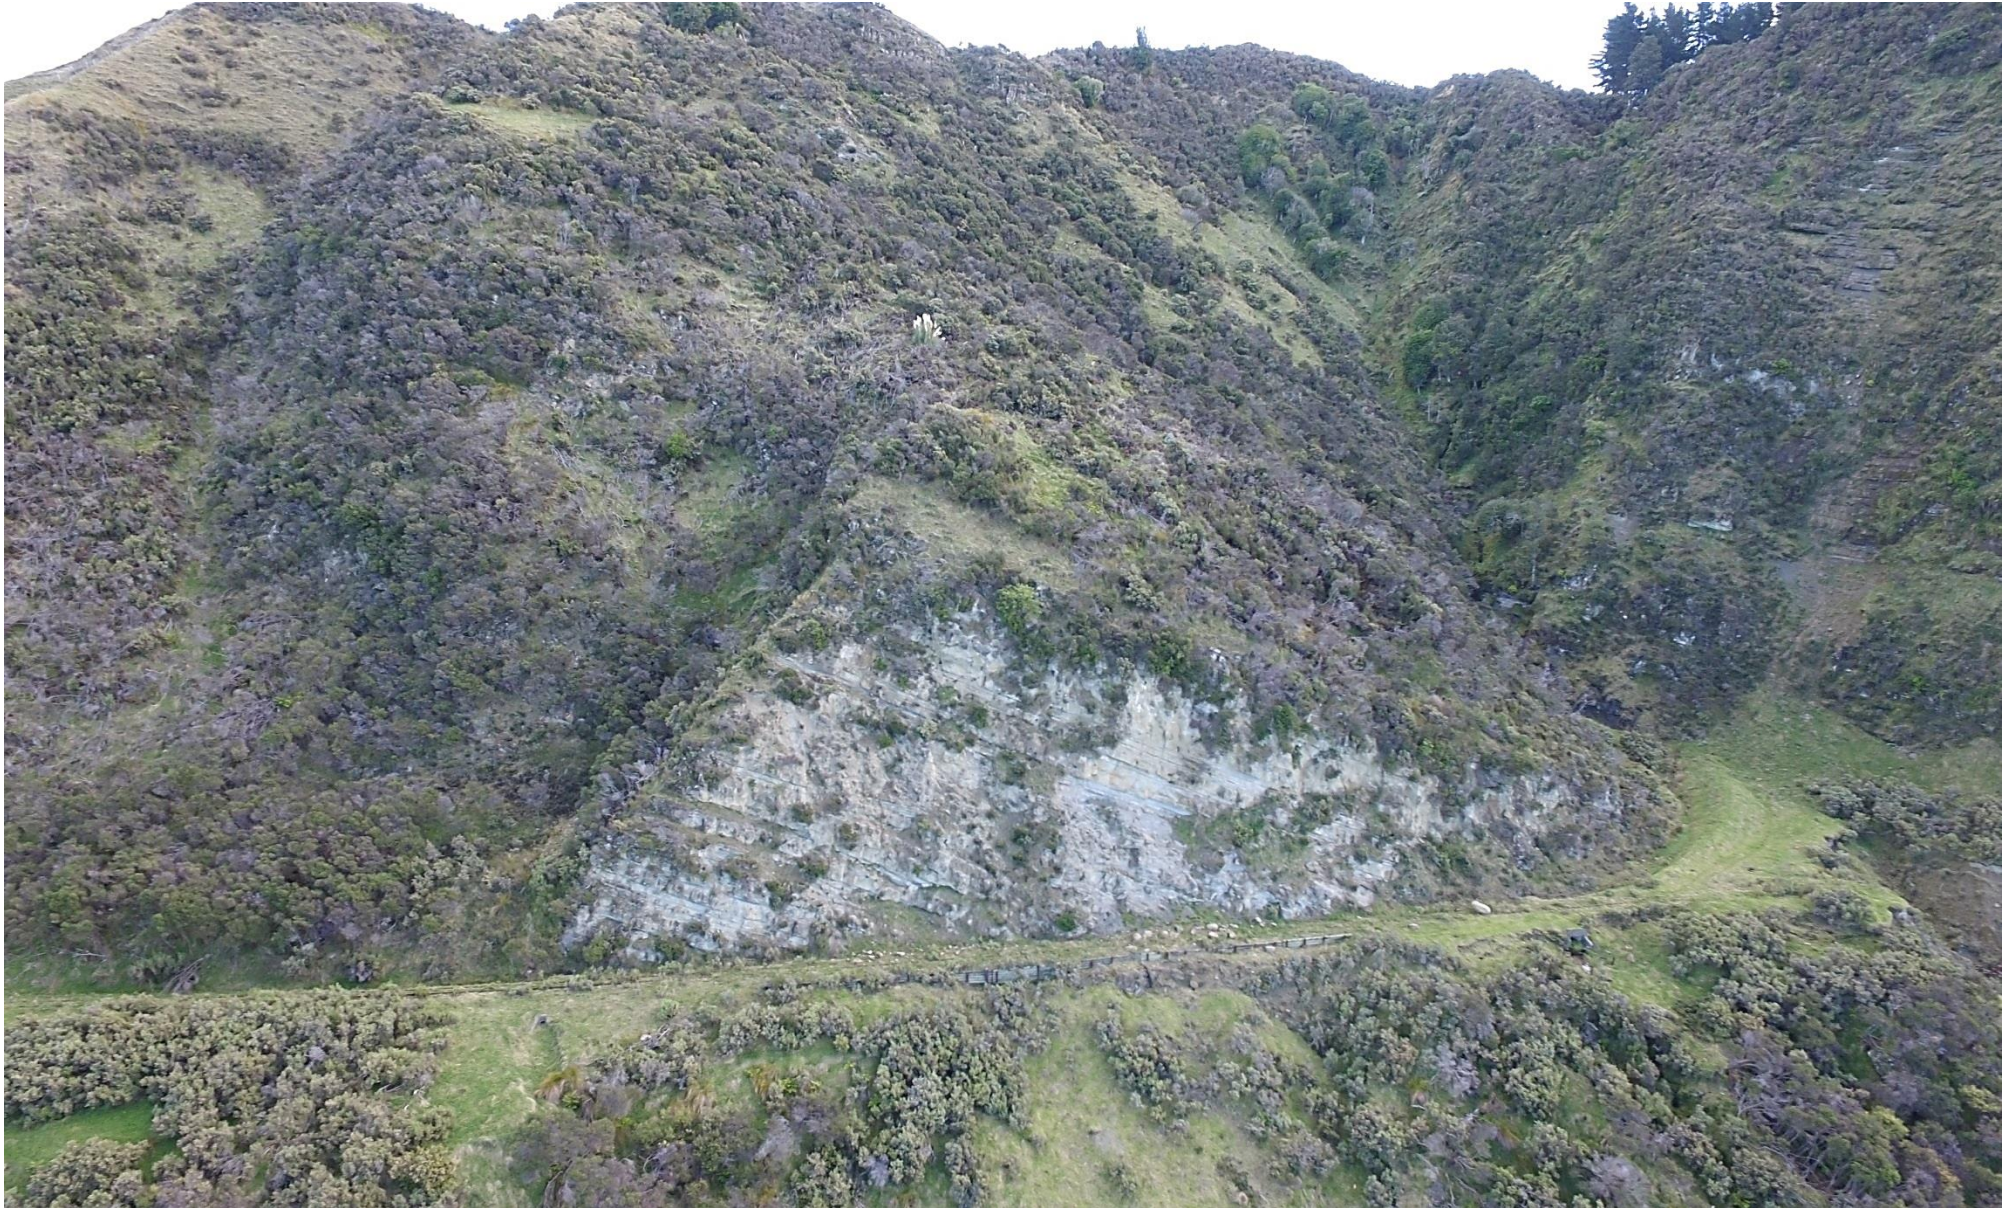
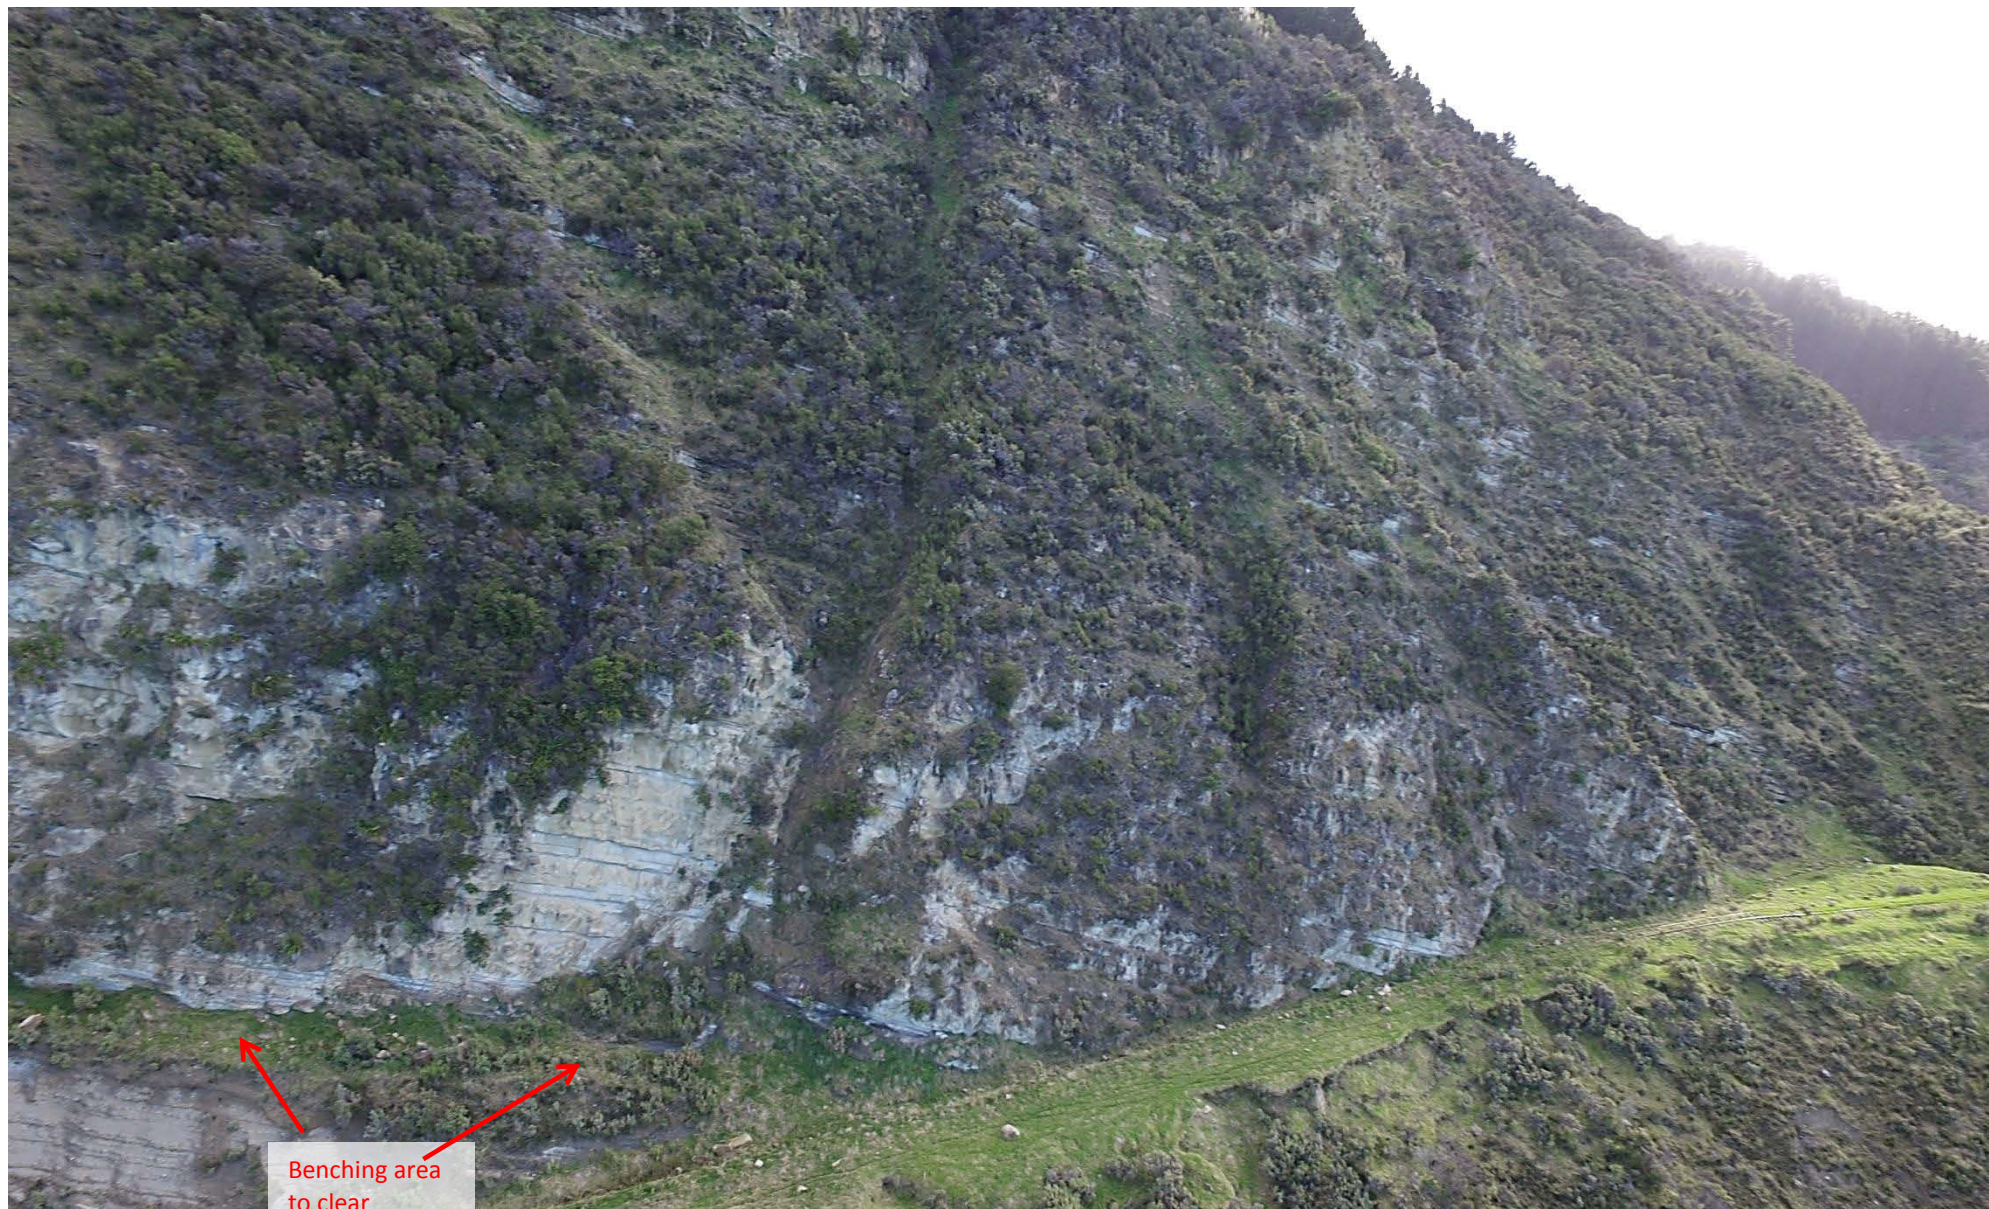
Rock scaling areas essentially bracket Dropout 3. Note previous benching operations on northern side of dropout.

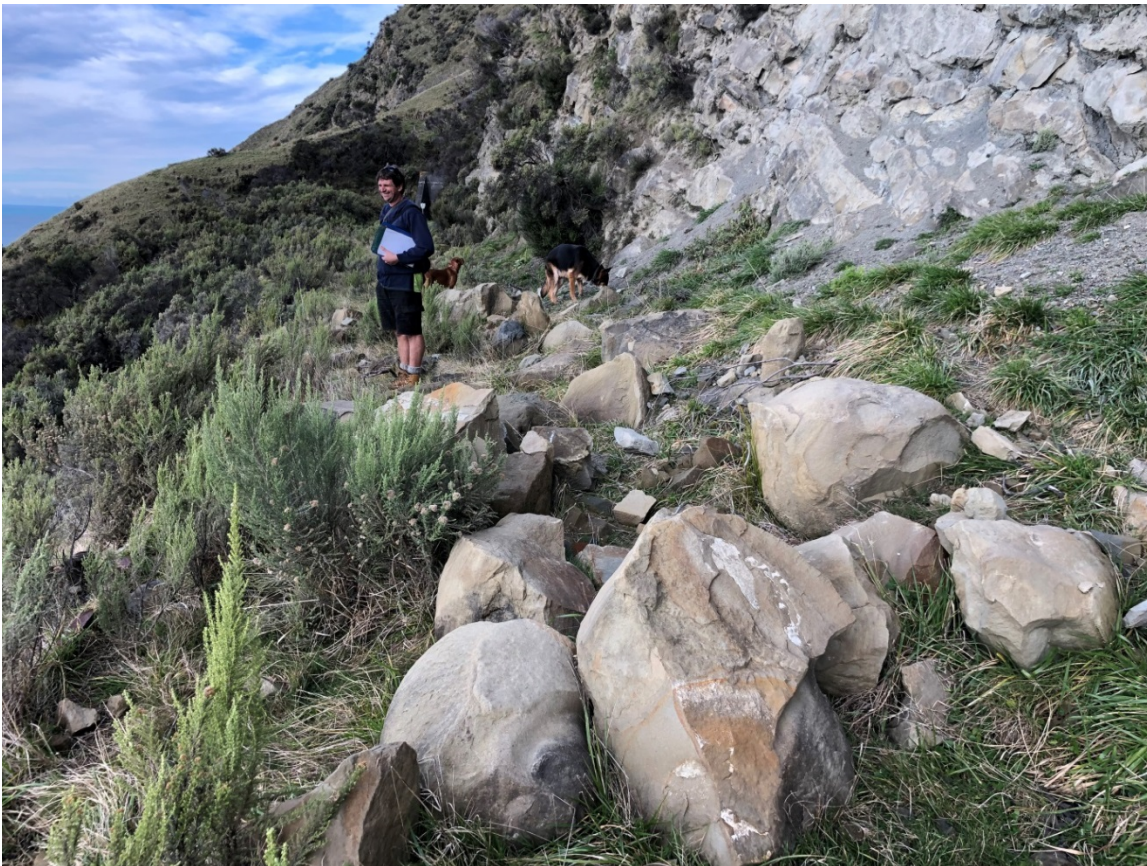
Typical rock fall debris between dropout and Tunnel 23 (note accumulated over 7 years)

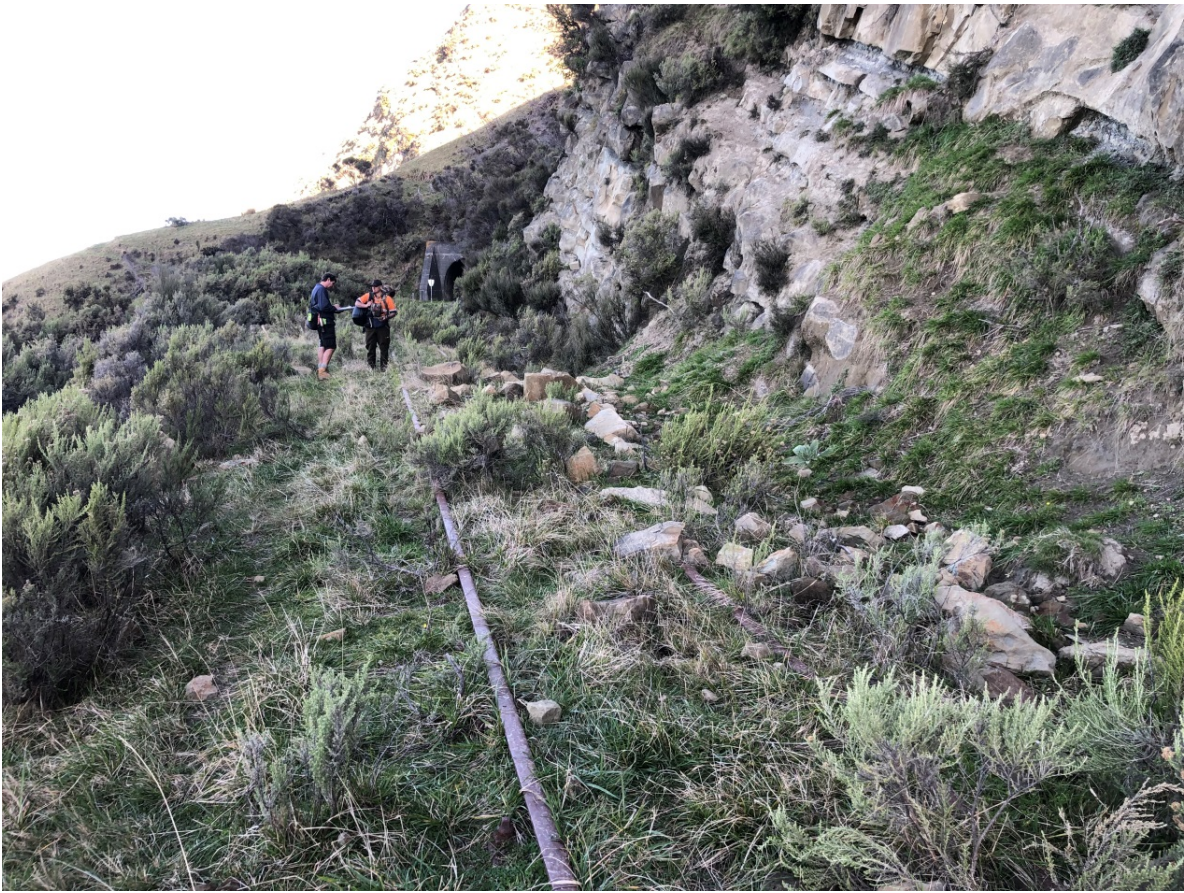
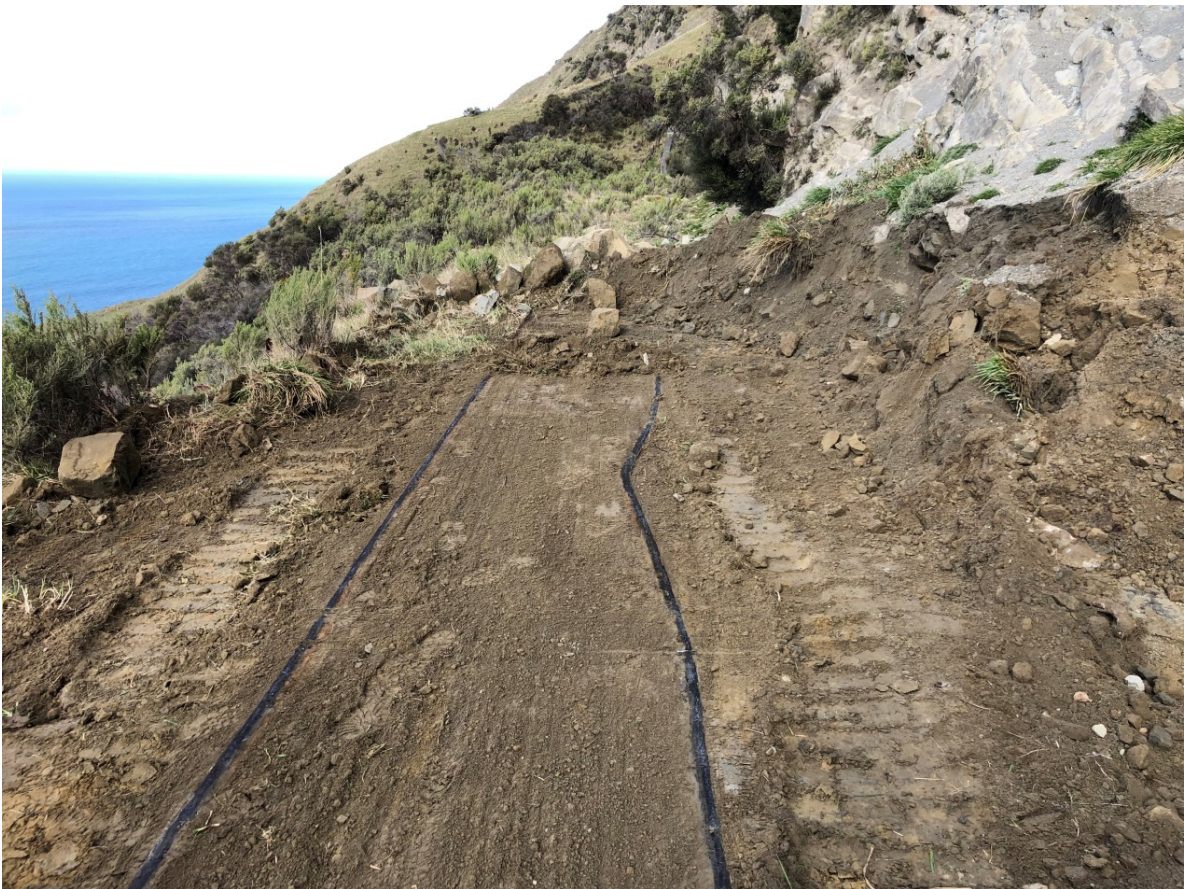
Views of rock face north of dropout 3 – note catch bench in above photo (requires clearance)-.

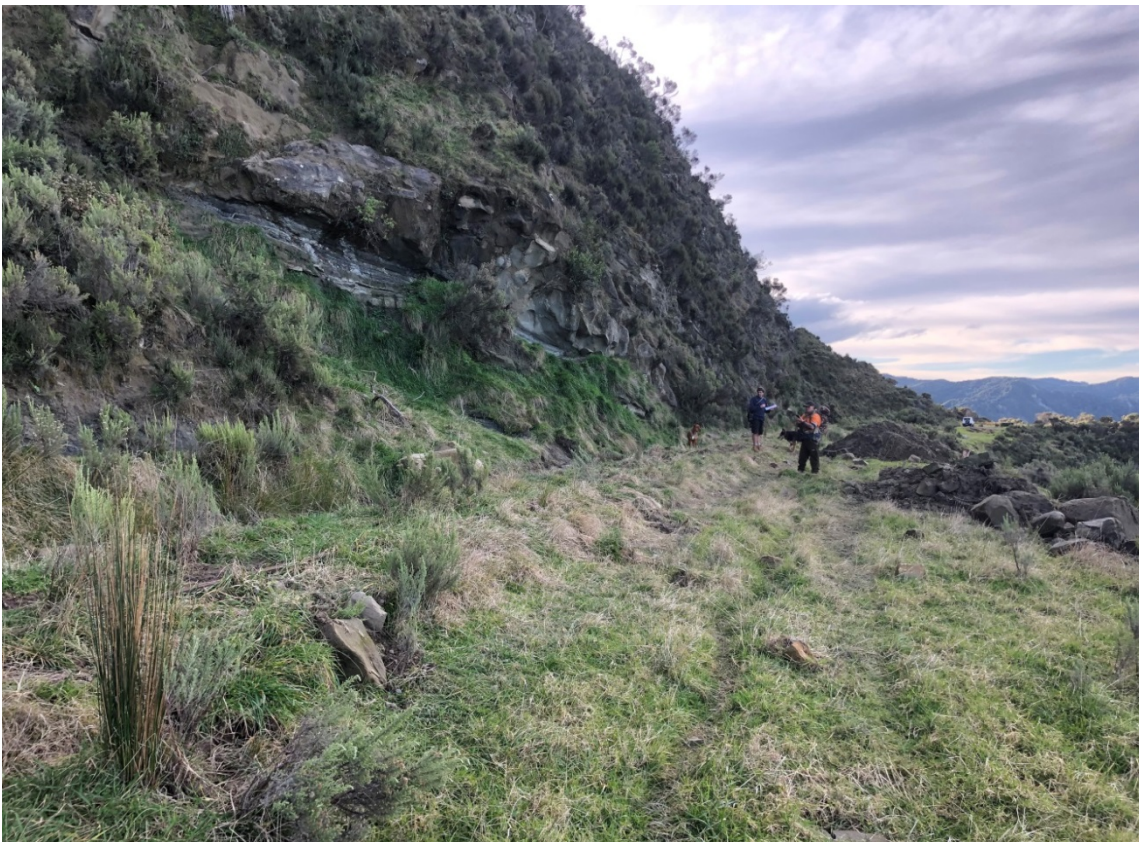
View looking back to Tunnel 24 Area

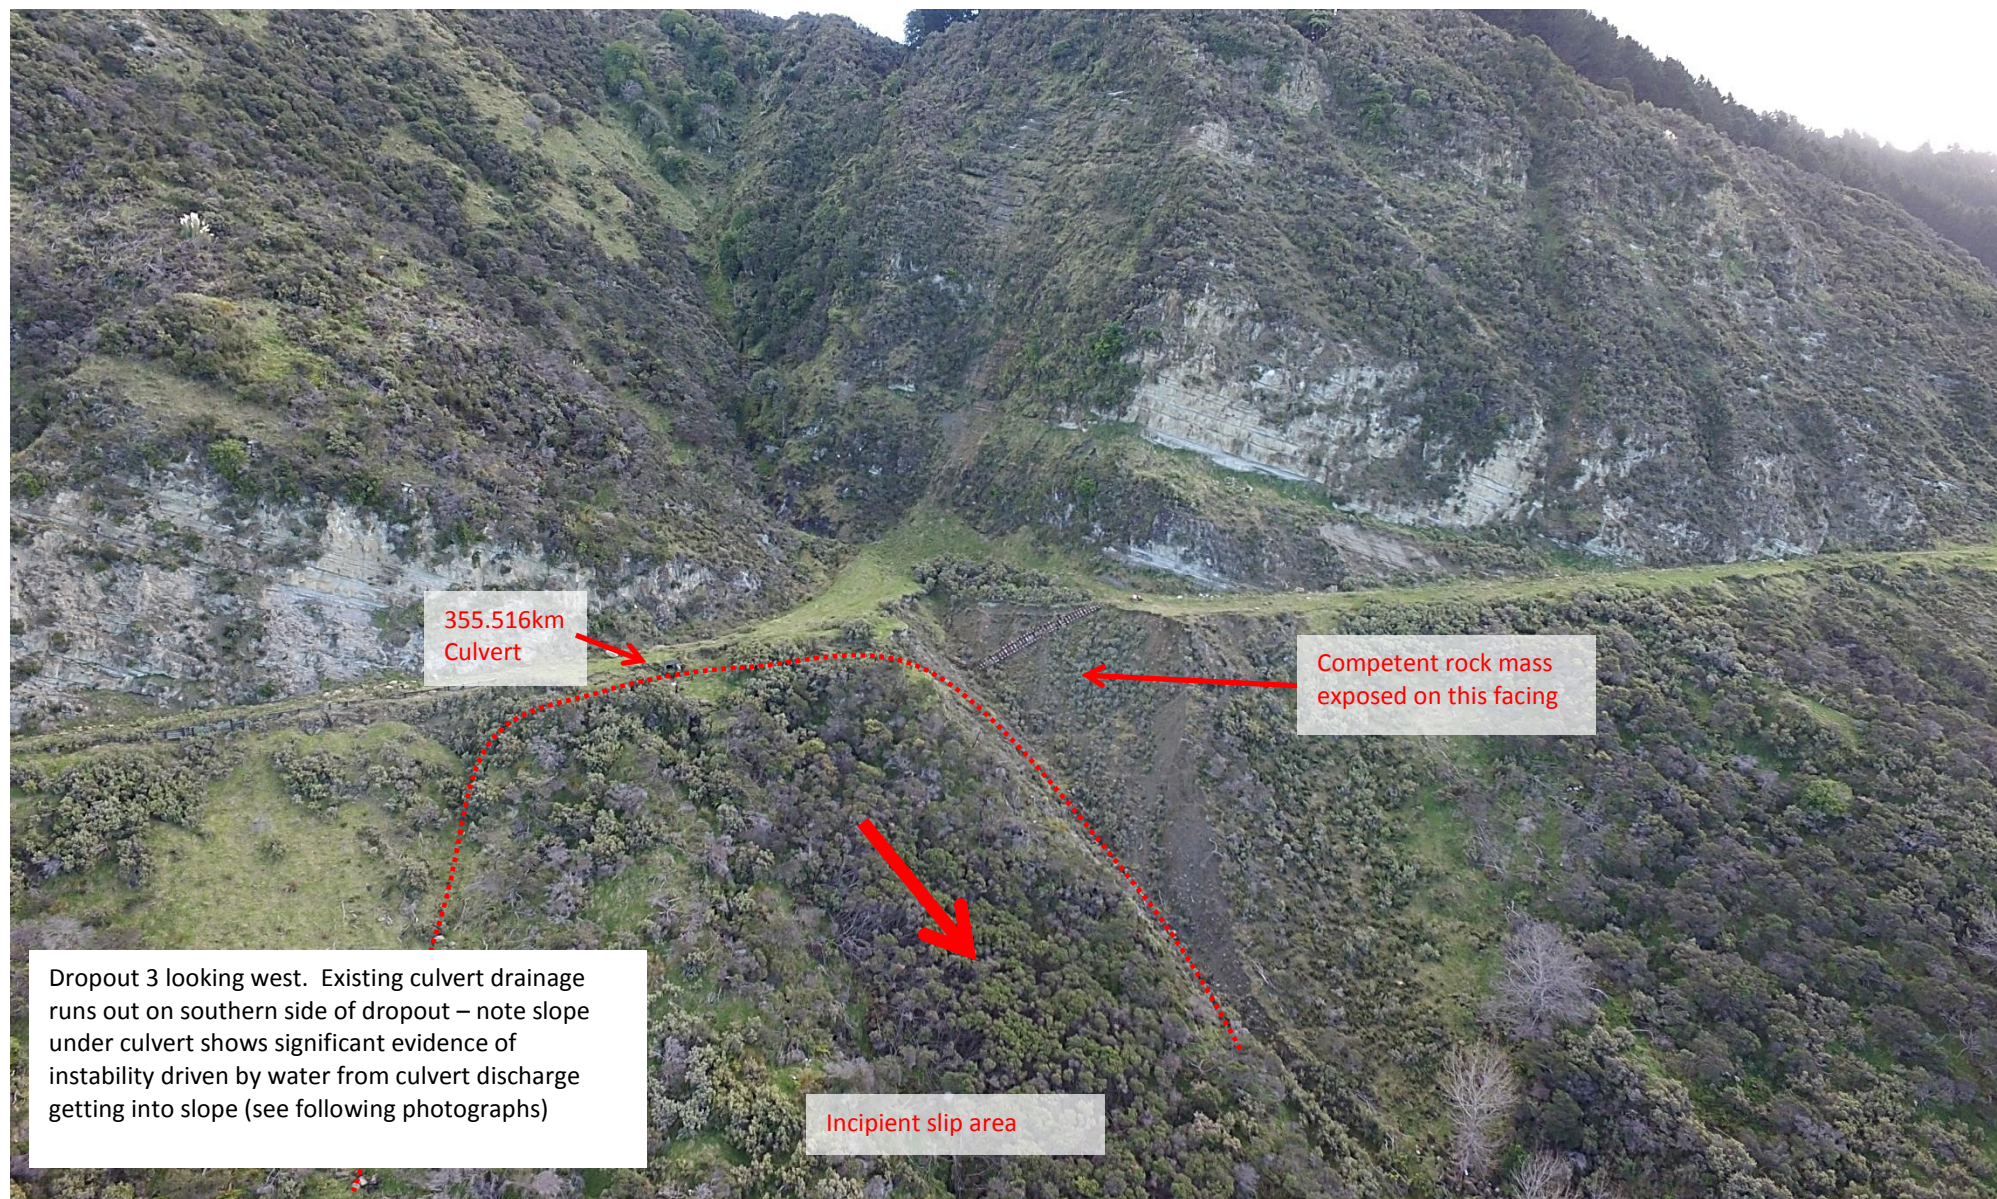
<b>Repair Task:</b>	<b>Task 13 – Dropout 3</b>
<b>Track Location:</b>	Rail Chainage 355.57km
<b>Description:</b>	Reshape and bench out the washout area prior to installing either a 2V:1H (63 degree) sloping Paragrid reinforced MSE slope faced off with hybrid 0.5m high gabion baskets filled with local site soils or a vertically faced retaining wall structure backfilled with Paraweb reinforced GAP 80/ 100 greywacke derived hardfill.
<b>Required Works</b>	As per above
<b>Scale/ Scope/Volumes:</b>	<p>Dropout dimensions are in the order of 45m wide by 90m long and nominally 15 metres deep on the outer edge of track formation. Upstream catchment is some 0.3km<sup>2</sup> with relatively complicated and ineffective drainage system, destabilising the immediate downhill formation slope with potential for a significant landslide event to occur south of immediate dropout area. No secondary or emergency drainage system available.</p> <p>TOR is nominally RL 134m +/- . Base of the dropout on the outer formation edge is around RL120m +/- with the toe of the dropout at nominal RL90, some 60m to 70m downstream of rail centreline.</p> <p>Install new primary drainage system under track formation and discharge to north – current drainage is destabilising adjacent slope below rail formation. Consider use of 1750Ø arch box culvert set nominal 4m deep in intact rockmass, discharge onto Rip Rap or similar, on northern side of fill.</p> <p>Repair culvert outfall at 355.516km - extend outfall out and down to better discharge position, reconfigure as emergency system only.</p>

<b>Construction Comment:</b>	Area uphill of old tunnel lining proposed as fill source for dropout 3
<b>Designer Comment:</b>	<p>Consider design with nominal Ru value for wet soils</p> <p>Consider subsoil drainage design, drainage aggregate, geotextile protection, megaflo Ultra 300 high strength pipe, benching works into underlying SST/ZST - rock breaker required?</p> <p>Culvert outfall extension – steel flume nominal 20m long plus 10m drop structure.</p> <p>Upstream catchment 0.3km<sup>2</sup>, Q100 flood design 5.4m<sup>3</sup>/s</p> <p>Base culvert:</p> <ul style="list-style-type: none"> <li>• New 1750Ø culvert has excess capacity with option to pass significant washed in sediment in flood event. Nominal 10m<sup>3</sup>/s @ 2.0m head – invert depth around 4m to allow sufficient granular backfill over top of arch.</li> <li>• Existing 0.9*1.2 arch culvert at 355.516km has 2.1m<sup>3</sup>/s @ 1.2m head - reconfigure for emergency bypass only.</li> </ul>

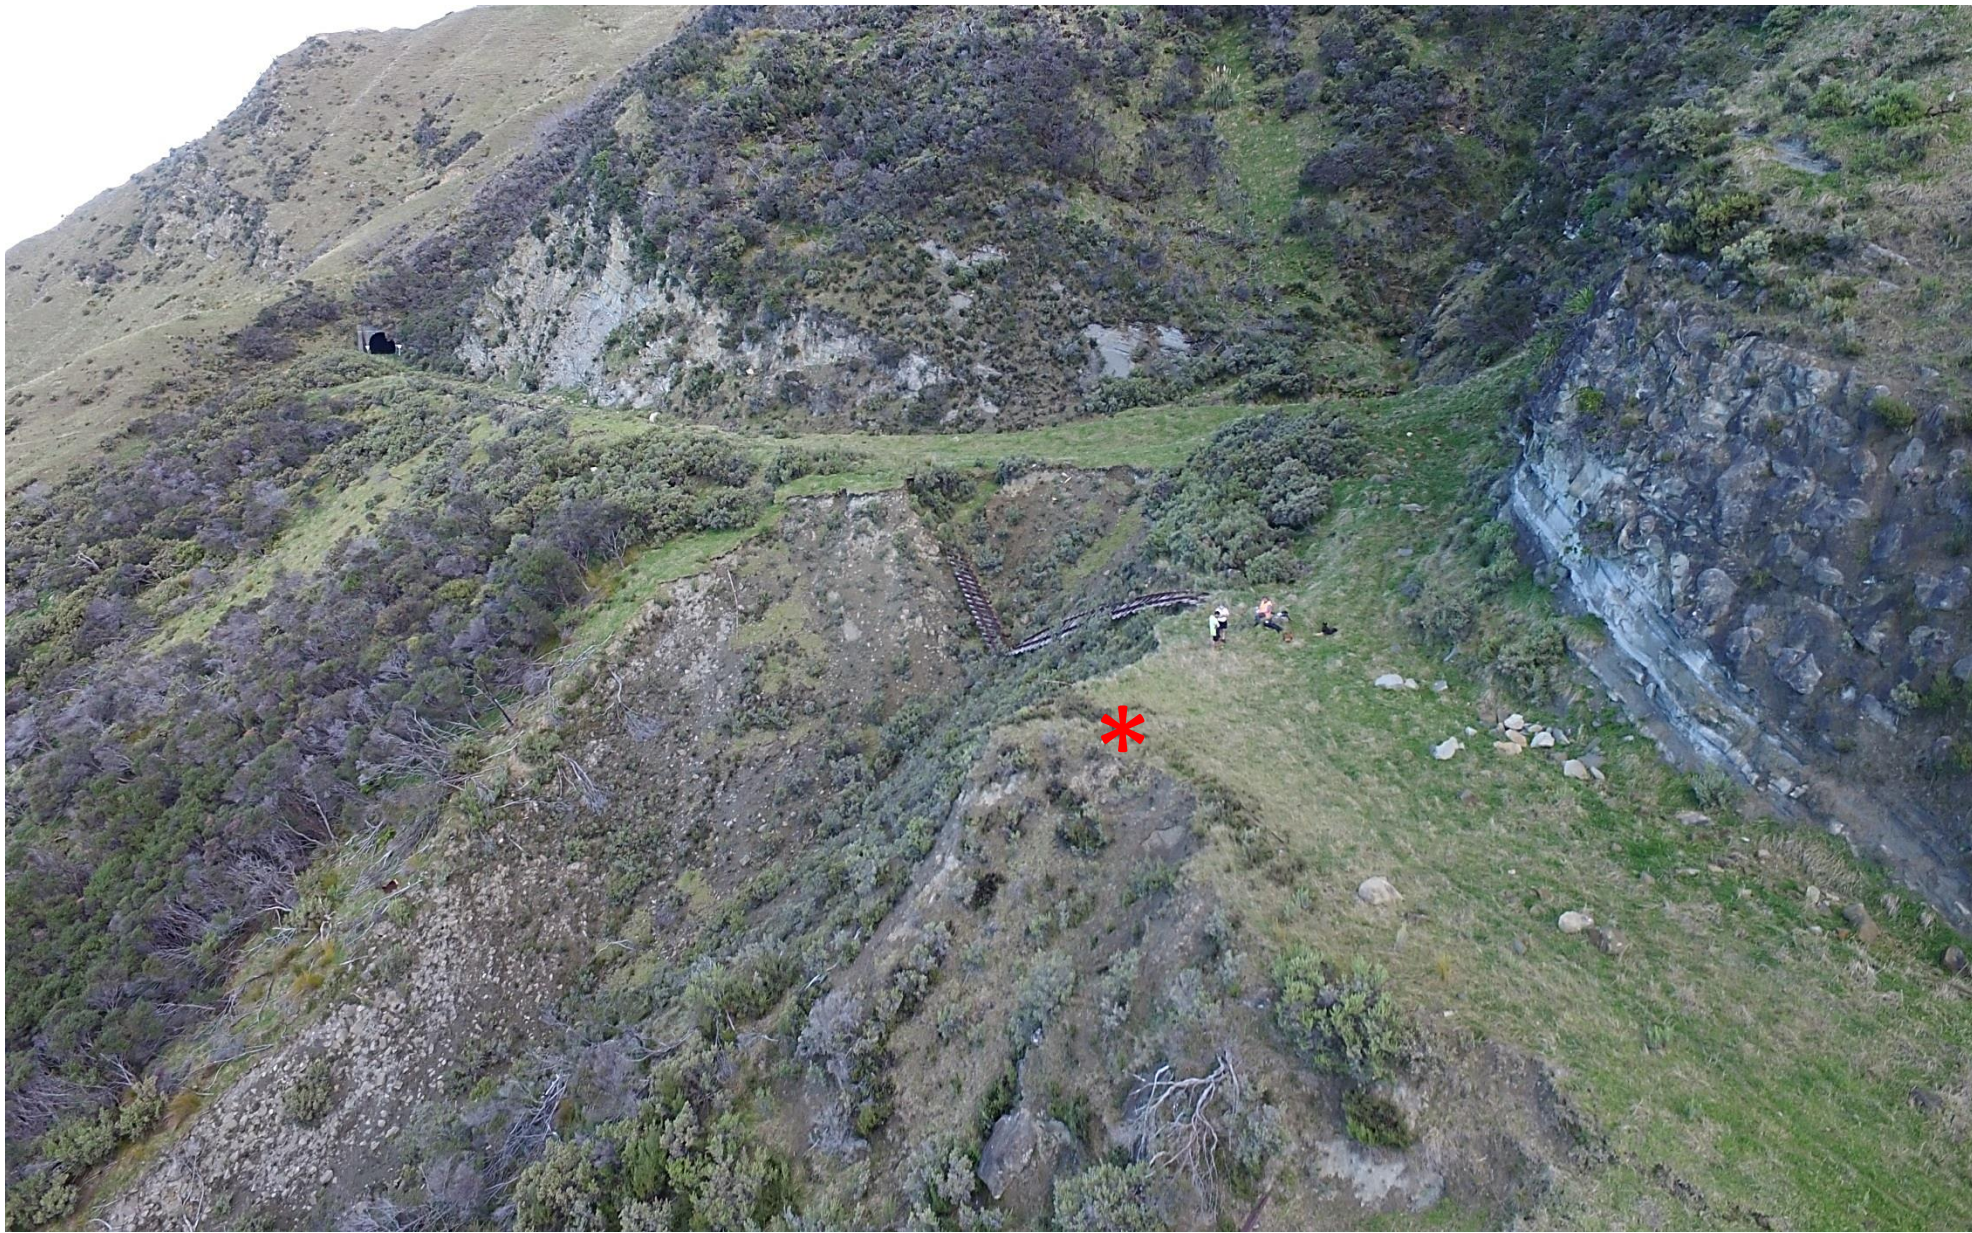
Drone view looking south west. Note instability area south of Dropout 4 highlighted – predominantly this is side cast spoil from formation rock cutting and Tunnel 23 excavation spoil.

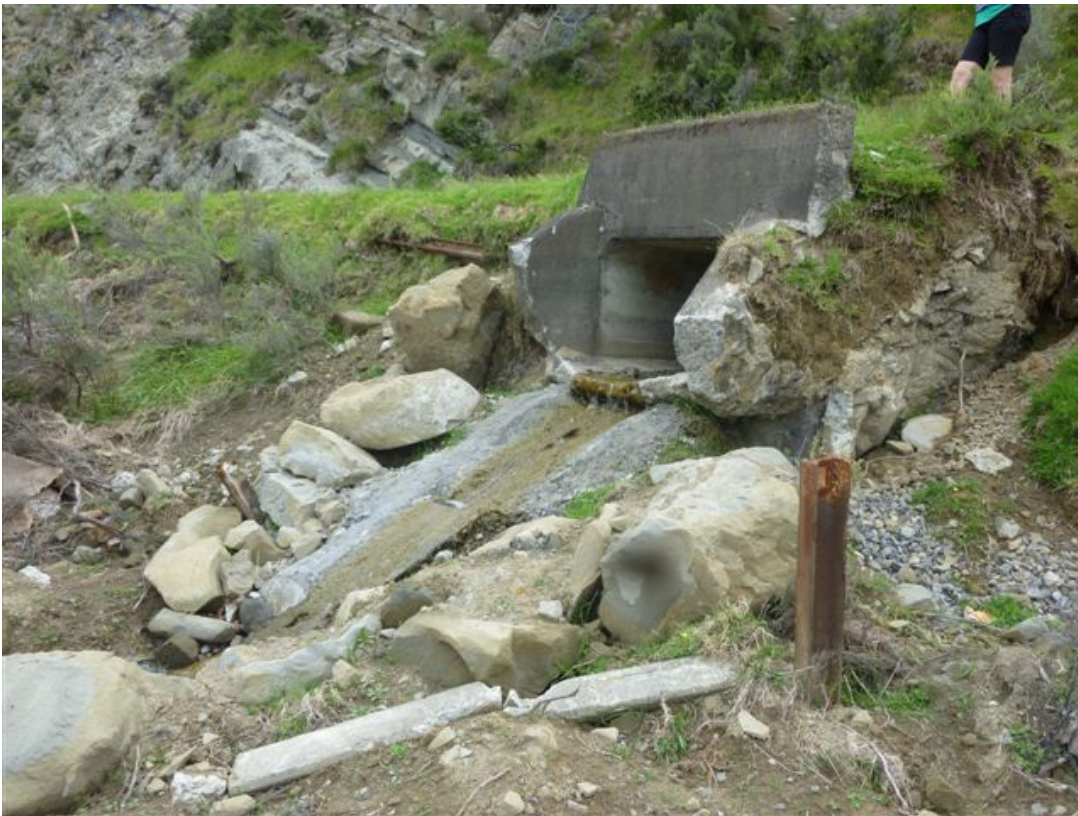
Outlet culvert@ 355.516km – 2013 photo above, 2019 photo below. Note slope movement / head scarp and ground pulling away from under culvert edge. Nominal 400mm downwards movement over 6 years due to water getting into slope from culvert discharge

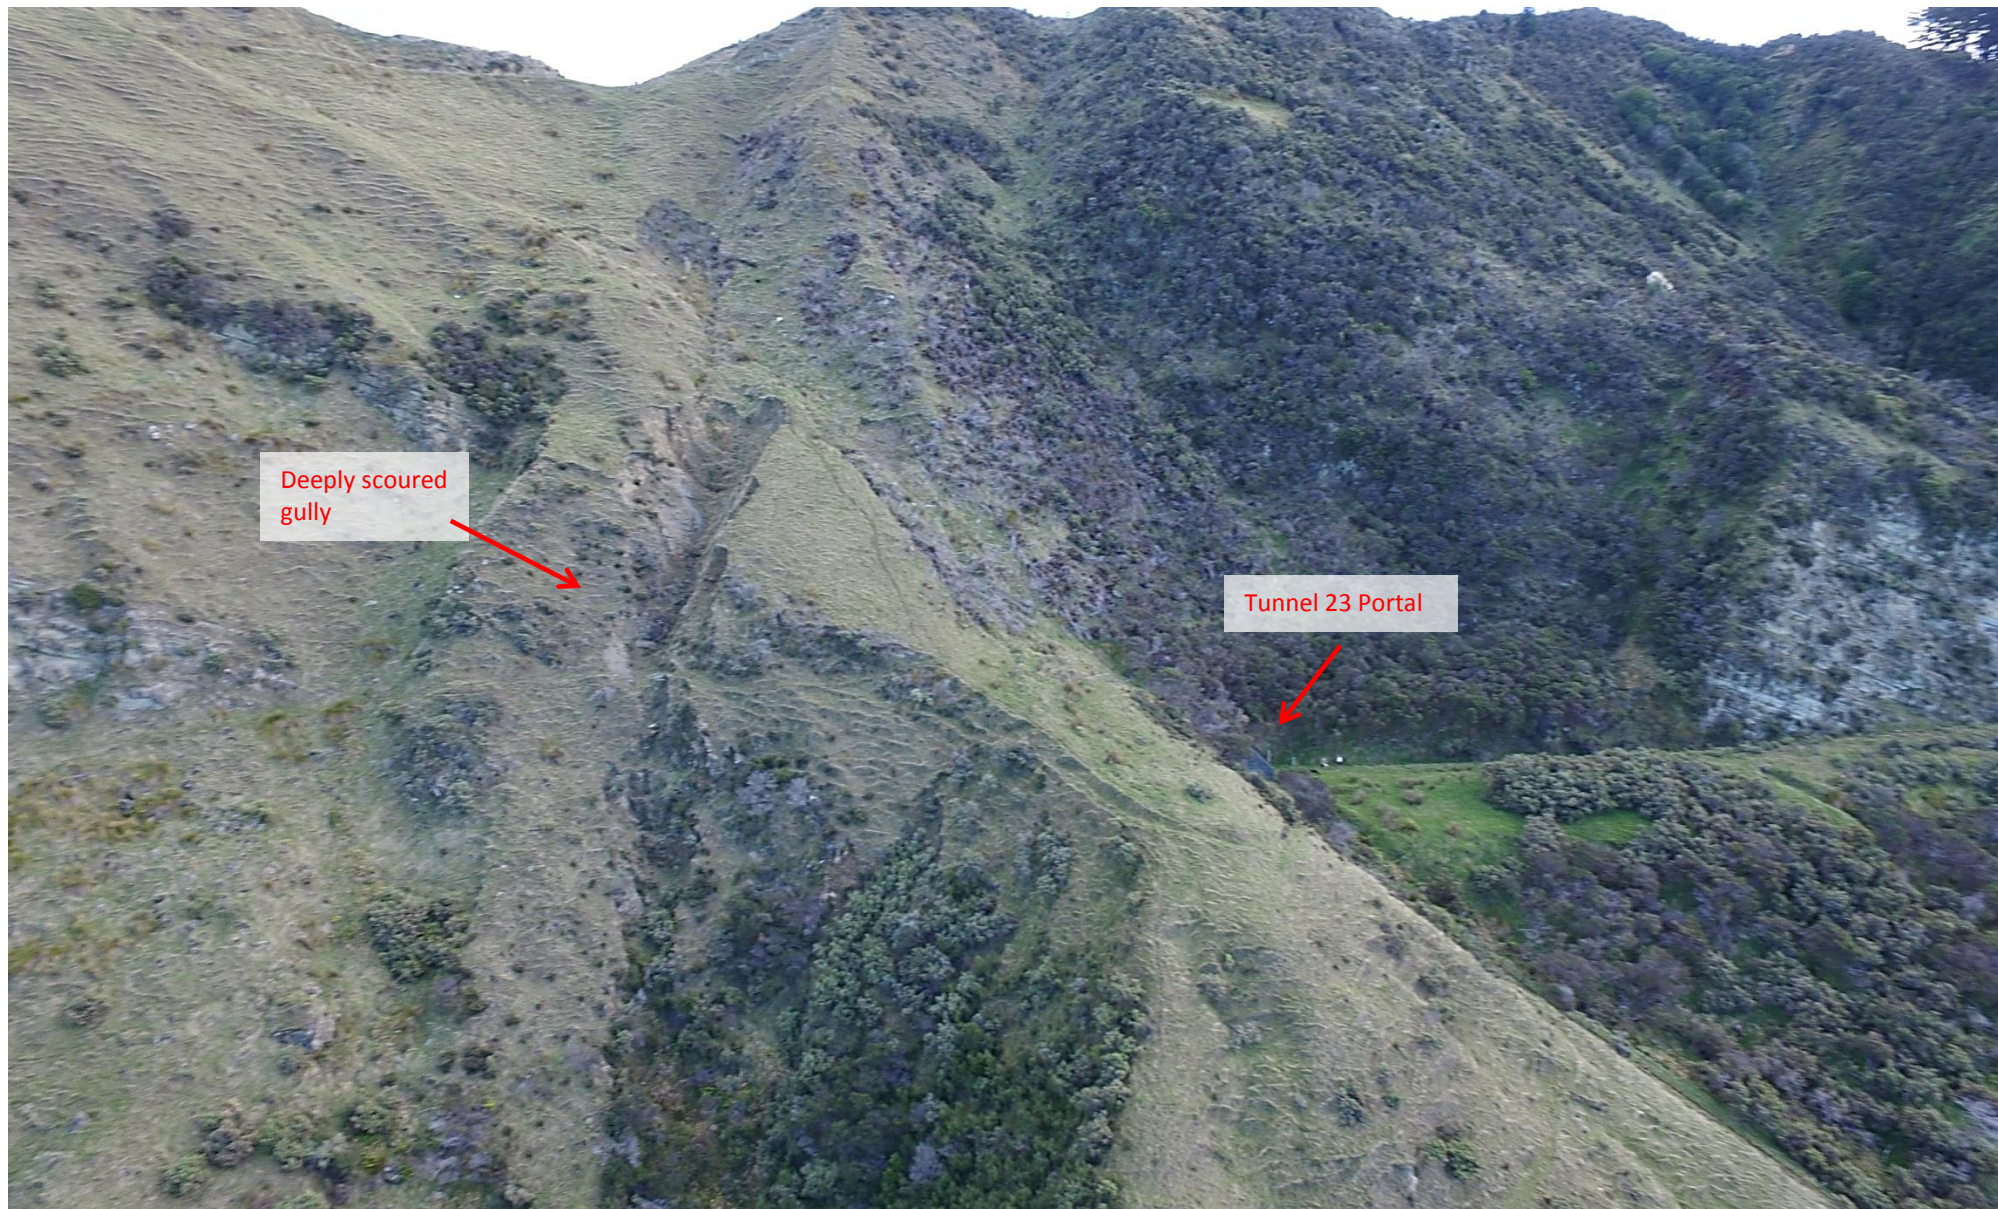
Tunnel 23 drainage outlet in picture foreground – requires cleanout.

<b>Repair Task:</b>	<b>Task 14a – Tunnel 23 Northern Portal</b>
<b>Track Location:</b>	Rail Chainage 355.354km
<b>Description:</b>	Drainage works @ Northern Portal
<b>Required Works</b>	Clean out swale and outfall drainage at northern portal Establish where significant sound of water coming from nominal 355.28km inside tunnel - google & drone images suggest deeply scoured narrow gully on slope above tunnel centreline, is water getting down in behind tunnel lining ?
<b>Scale/ Scope/Volumes:</b>	Scale & volumes TBC Predominantly clean up work, minor works package
<b>Construction Comment:</b>	
<b>Designer Comment:</b>	Tunnel drainage in generally good condition – clean out outfall, track down exterior lining inflow. Note tunnel is acting as drainage under slope to south, inflow unlikely to be an issue provided tunnel lining is not exposed
<b>Rail Operations:</b>	Work trains past site, including deliveries for dropout 4.

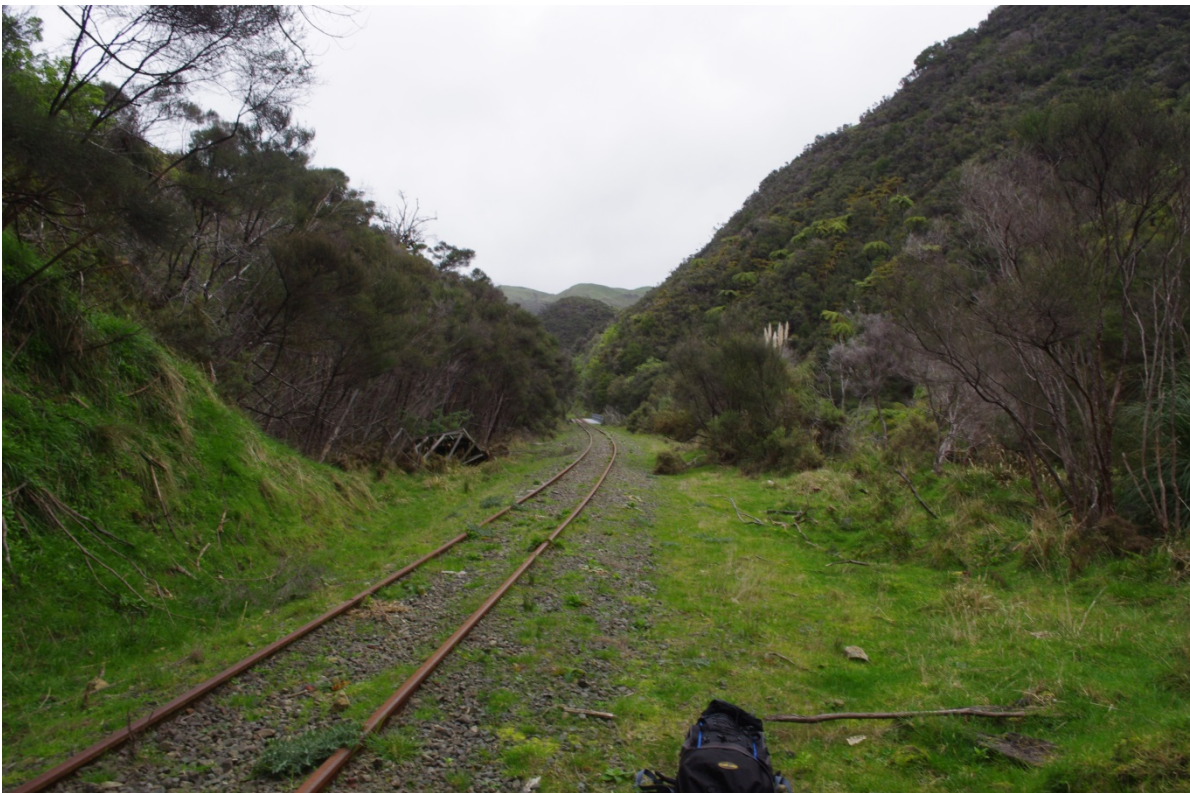
View south looking to Bridge 271 – note blocked swales

<b>Repair Task:</b>	<b>Task 14b – Tunnel 23 Southern Portal</b>
<b>Track Location:</b>	Rail Chainage 355.41km
<b>Description:</b>	Drainage works @ Southern Portal
<b>Required Works</b>	Clean out swale drainage - extend and deepen towards south. Install new 900mm diameter culvert adjacent to existing culvert @ 355.420km as additional bypass capacity
<b>Scale/ Scope/Volumes:</b>	Scale & volumes TBC
<b>Construction Comment:</b>	Two 455mm diameter culverts recorded on KR culvert log (positions need checked against mobile road data): 355.411km, 455mm diameter, 10m long, 1.5m deep ( note seen on site – blocked) 355.420km, 10m long, 1.5km deep ( next to portal)
<b>Designer Comment:</b>	Evidence of water and silt flowing back into tunnel for 50 to 100m – additional outlet capacity required plus swale cleanouts. Extend swale cleanout southwards to Tikiwhata stream next to Bridge 271 – approx. meterage 355.080km New 900mm culvert.

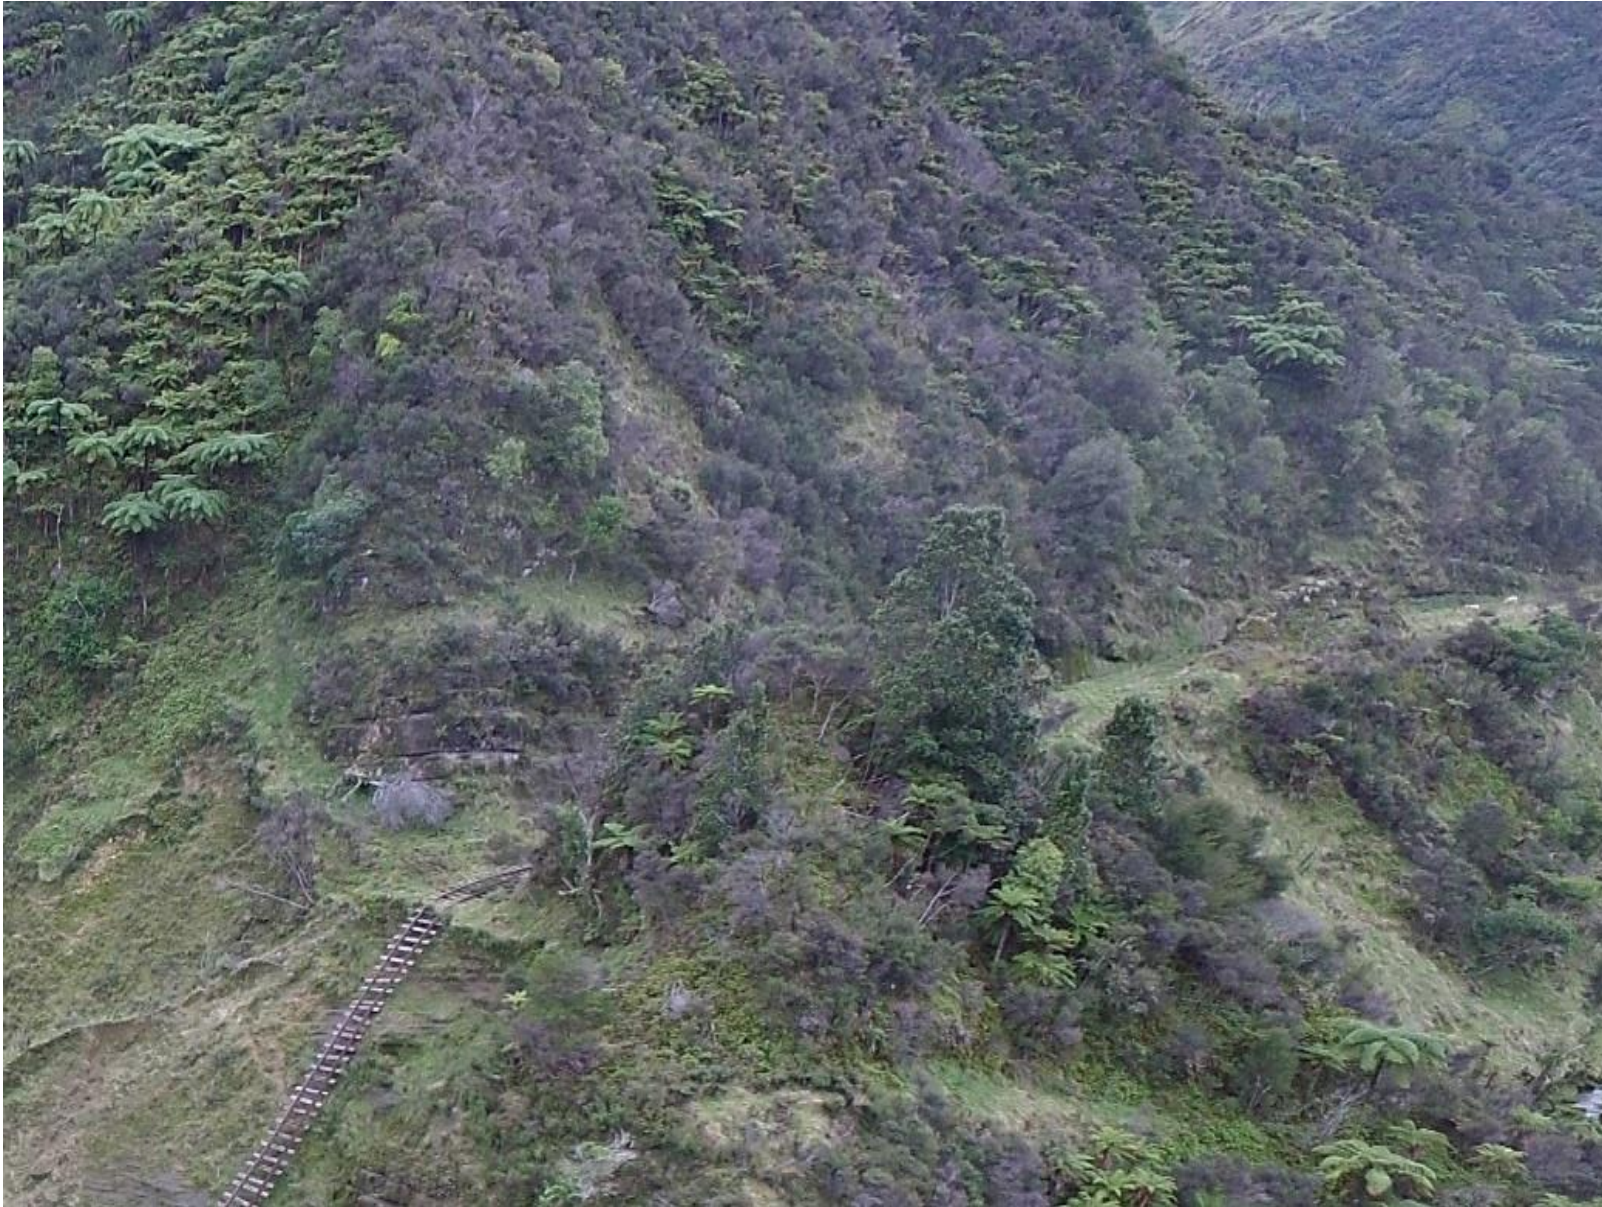
Drone view looking northwest into rock facing. Bedding dips into slope, note two ballast deck bridges (B269 & B270), SPG span bridge (B271). Minimal rock fall issues expected.

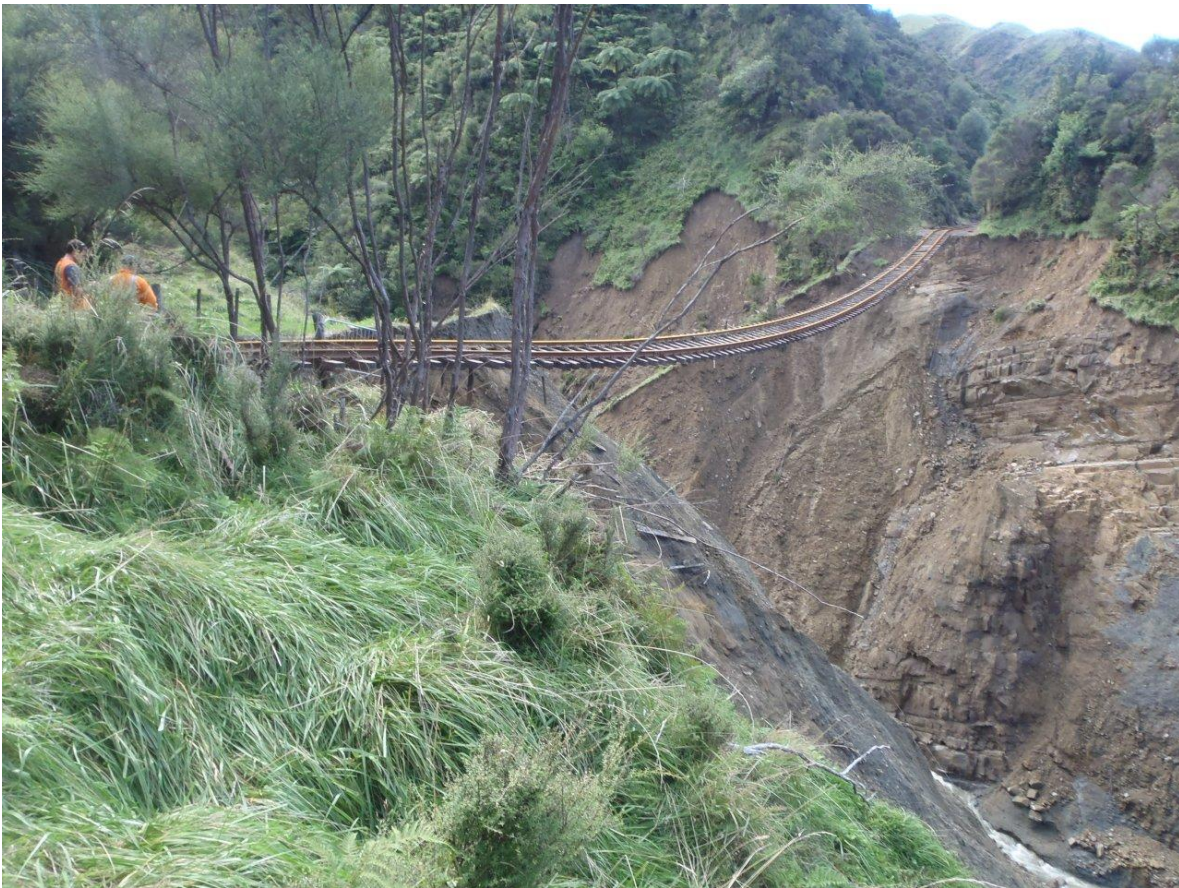
2013 view looking south. Note remnant tunnel spoil in base of gully along base of southern facing – this is mostly eroded away in 2019 photos
