<b>Repair Task:</b>	<b>Task 12 – Rock Scaling 355.42 - 355.79</b>
<b>Track Location:</b>	Rail Chainage 355.42-355.79
<b>Description:</b>	Cliff face areas require scaling to remove significant rock fall hazard.
<b>Required Works</b>	
<b>Scale/ Scope/Volumes:</b>	Allow to scale cliff face Allow to put 20 tonne excavator up on bench and remove collected rocks - push out onto formation bench below. Remove track and sleeper sets prior.
<b>Construction Comment:</b>	Require expert assistance to define scale and scope of problem - prelim budget 12 days of actual abseil work on site.
<b>Designer Comment:</b>	Require expert assistance to define scale and scope of problem - prelim budget 12 days of actual abseil work on site.
<b>Rail Operations:</b>	Work trains past site, including deliveries for Dropout 3 & 4.

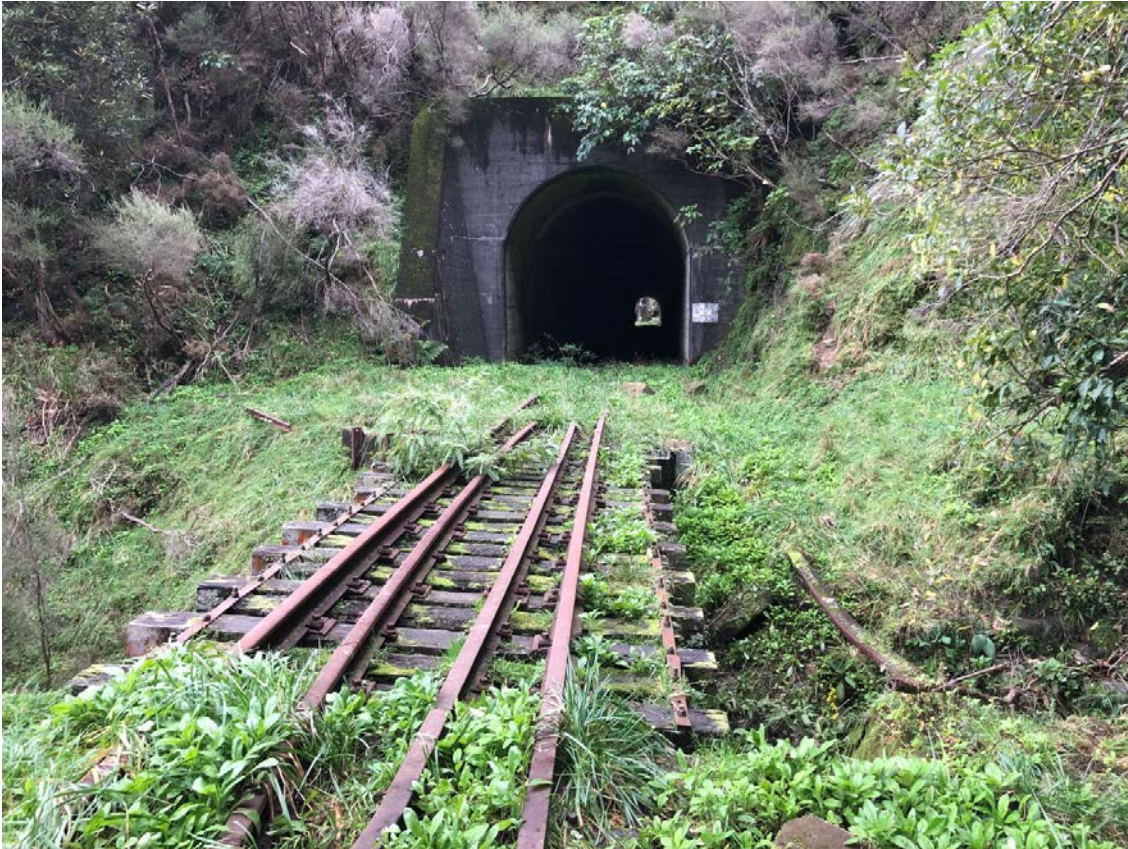
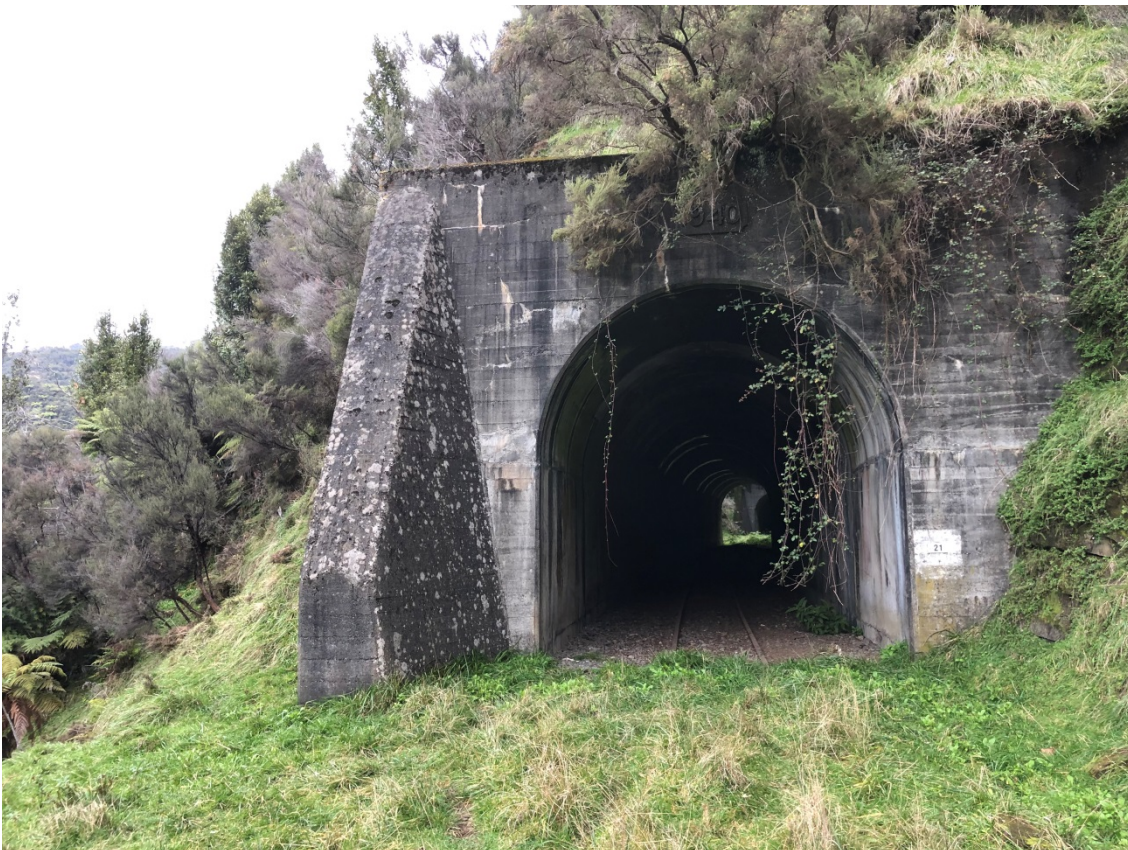
View looking into Tunnel 19 northern portal – note minor slip above portal entrance with debris on track. Bridge 268A in foreground.

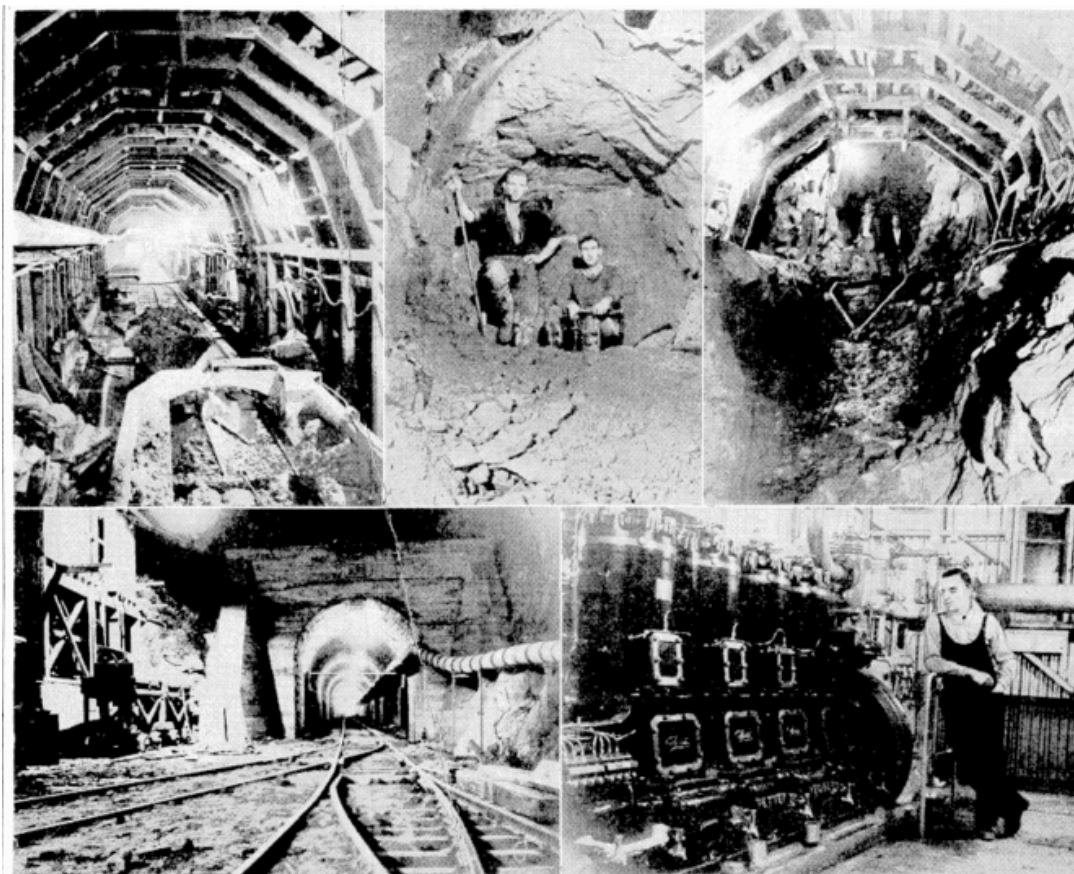
<b>Repair Task:</b>	<b>Task 18 – Tikiwhata Tunnel 19 Lining</b>
<b>Track Location:</b>	Rail Chainage 352km+/- ( nominal)
<b>Description:</b>	Crackling in concrete tunnel lining
<b>Required Works</b>	Allow for baseline lazer scan survey through tunnel (Woods Consultants) as part of track reopening works
<b>Scale/ Scope/Volumes:</b>	Assess concrete lining cracking - has been in place for nearly 80 years, in good condition for age. No physical works anticipated
<b>Construction Comment:</b>	Assess concrete lining cracking - has been in place for nearly 80 years, in good condition for age. No physical works anticipated
<b>Designer Comment:</b>	
<b>Rail Operations:</b>	Survey works early in program – no work trains expected during survey operations.

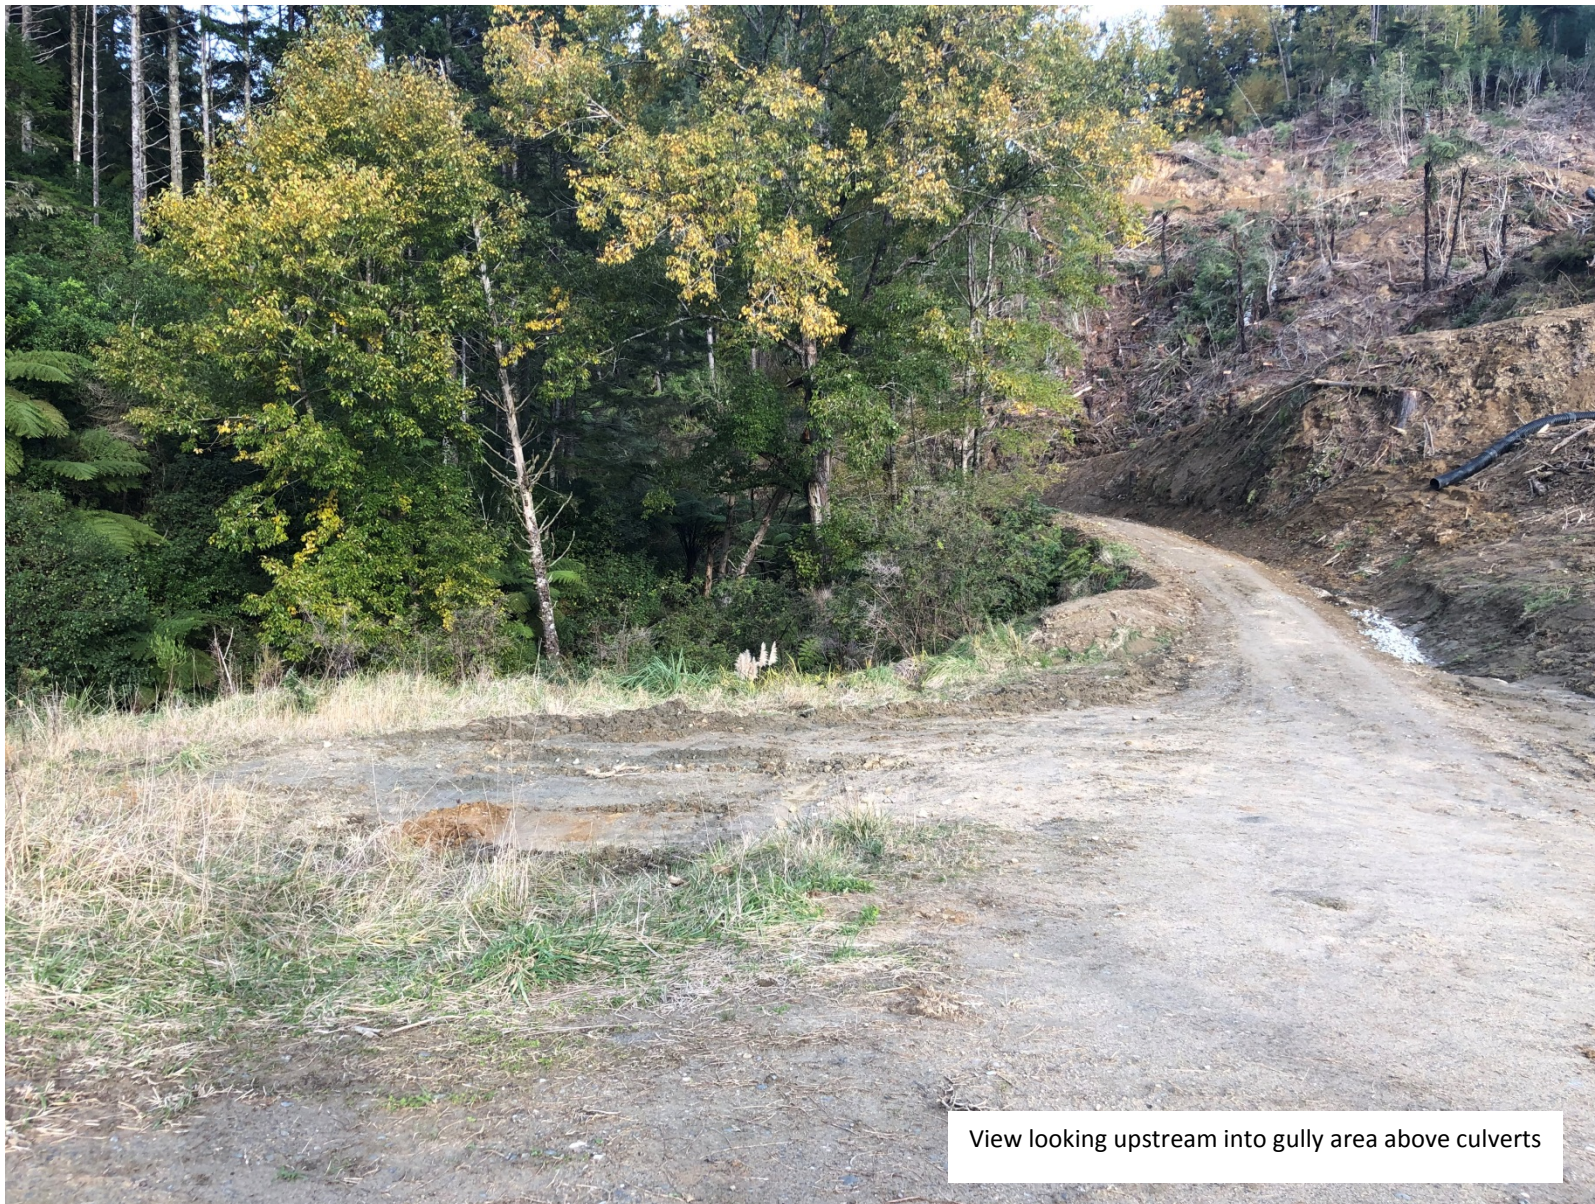
<b>Construction Comment:</b>	Access down Railway Road – JNL forestry access.
<b>Designer Comment:</b>	<p>Upstream catchment 2.05km<sup>2</sup>; Q<sub>100</sub> =37m<sup>3</sup>/s flood flows.</p> <p>Base culvert size is 1.3m wide by 2.0m high, 20m long, 10m deep @ 90 skew. Discharge 28.5m<sup>3</sup>/s with 8m of driving head in extreme event. KR culvert log advises secondary outlet of 1050Ø pipe @ 3m deep – discharge 4.0m<sup>3</sup>/s with 3m head (floodwater@ sleeper level). This pipe not seen on site – inlet overgrown / blocked with recent earthworks? (TBC)</p> <p>Additional 4.5m<sup>3</sup>/s required for Q<sub>100</sub> event.</p> <p>Allow to replace 1050Ø pipe with nominal 20m length of 1.75Ø arch box culvert @ 5m invert depth – capacity of 18.5m<sup>3</sup>/s which provides significant additional coverage in the event of the main culvert being partially blocked with timber slash.</p> <p>Downstream lower outlet is undermining back into bank – scour protection required ( large rock / concrete)</p>

<b>Repair Task:</b>	<b>Task 21 – Railway Road Culvert Works</b>
<b>Track Location:</b>	Rail Chainage 349.32km
<b>Description:</b>	Upgrade base culvert entrance and repair outfall, install larger high level emergency bypass for Q100 flood design requirements
<b>Required Works</b>	Upgrade base culvert entrance and repair outfall, install larger high level emergency bypass for Q100 flood design requirements
<b>Scale/ Scope/Volumes:</b>	<p>Clean out upstream outlet area; install new railway iron protection works around inlet and additional rail iron screen upstream. Install all-weather track into culvert headwall &amp; screen areas so emergency access is available 24/7 from Railway Road for timber slash clearance.</p> <p>Install a high level culvert inlet (nominal 1500/1800mm manhole riser with a scruffy dome top) or similar box structure to provide a high level inlet on the base culvert.</p> <p>Install a single set of 1.7m dimensioned arch box culverts set nominally 5 m below TOR to act as an emergency overflow as well as provide additional Q<sub>100</sub> flood capacity. . Excavate in rockmass following the line of the tunnelled culvert below, will replace the current 1050Ø pipeline and will discharge over the rockmass slope above the existing outlet.</p>

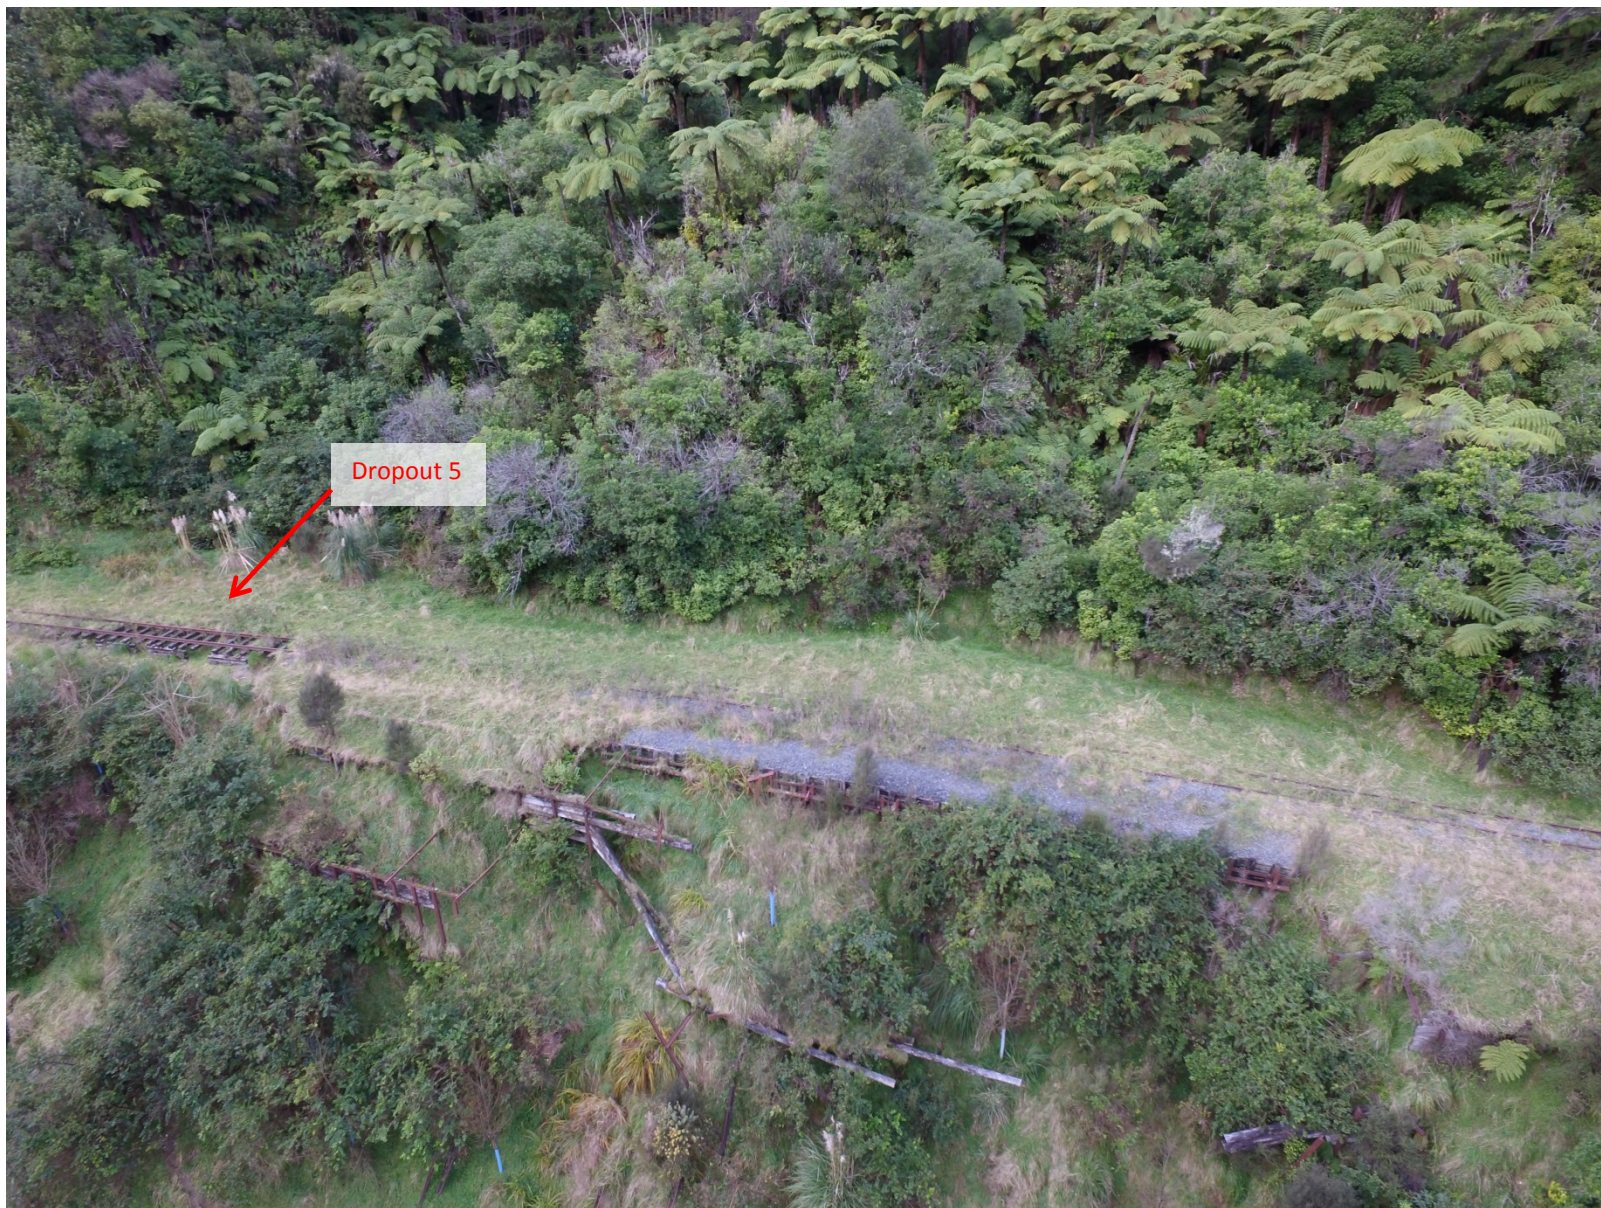
Drone shot looking down on Dropout 5 – note extensive retaining works in various states of repair, south of current washout area

<b>Repair Task:</b>	<b>Task 22 – Dropout 5</b>
<b>Track Location:</b>	Rail Chainage 349km
<b>Description:</b>	Formation repair, track drainage upgrade, possible minor track slew
<b>Required Works</b>	
<b>Scale/ Scope/Volumes:</b>	<p>Repair scour under track and reinstate formation with low height concrete block walls.</p> <p>Assess swale drainage and upgrade water movement - likely blocked culverts, may require additional culverts or upgrading.</p> <p>Track slew dependant on rebuild proximity to bank - significant erosion has occurred immediately downstream. Consider large rock scour protection or short river structure to push water out from bank toe.</p>
<b>Construction Comment:</b>	Relatively minor works to repair; additional erosion protection should be considered while plant and machinery are in area.
<b>Designer Comment:</b>	<p>Dropout 5 constructed on extensive 1940s embankment filling – see photos.</p> <p>Repair scour under track and reinstate formation with concrete block walls. Consider additional erosion protection at toe of embankment.</p> <p>Assess swale drainage and upgrade water movement - likely blocked culverts, may require additional culverts or upgrading.</p> <p>Track slew dependant on rebuild proximity to bank - significant erosion has occurred immediately downstream. Consider large rock scour protection or short river structure to push water out from bank toe.</p>

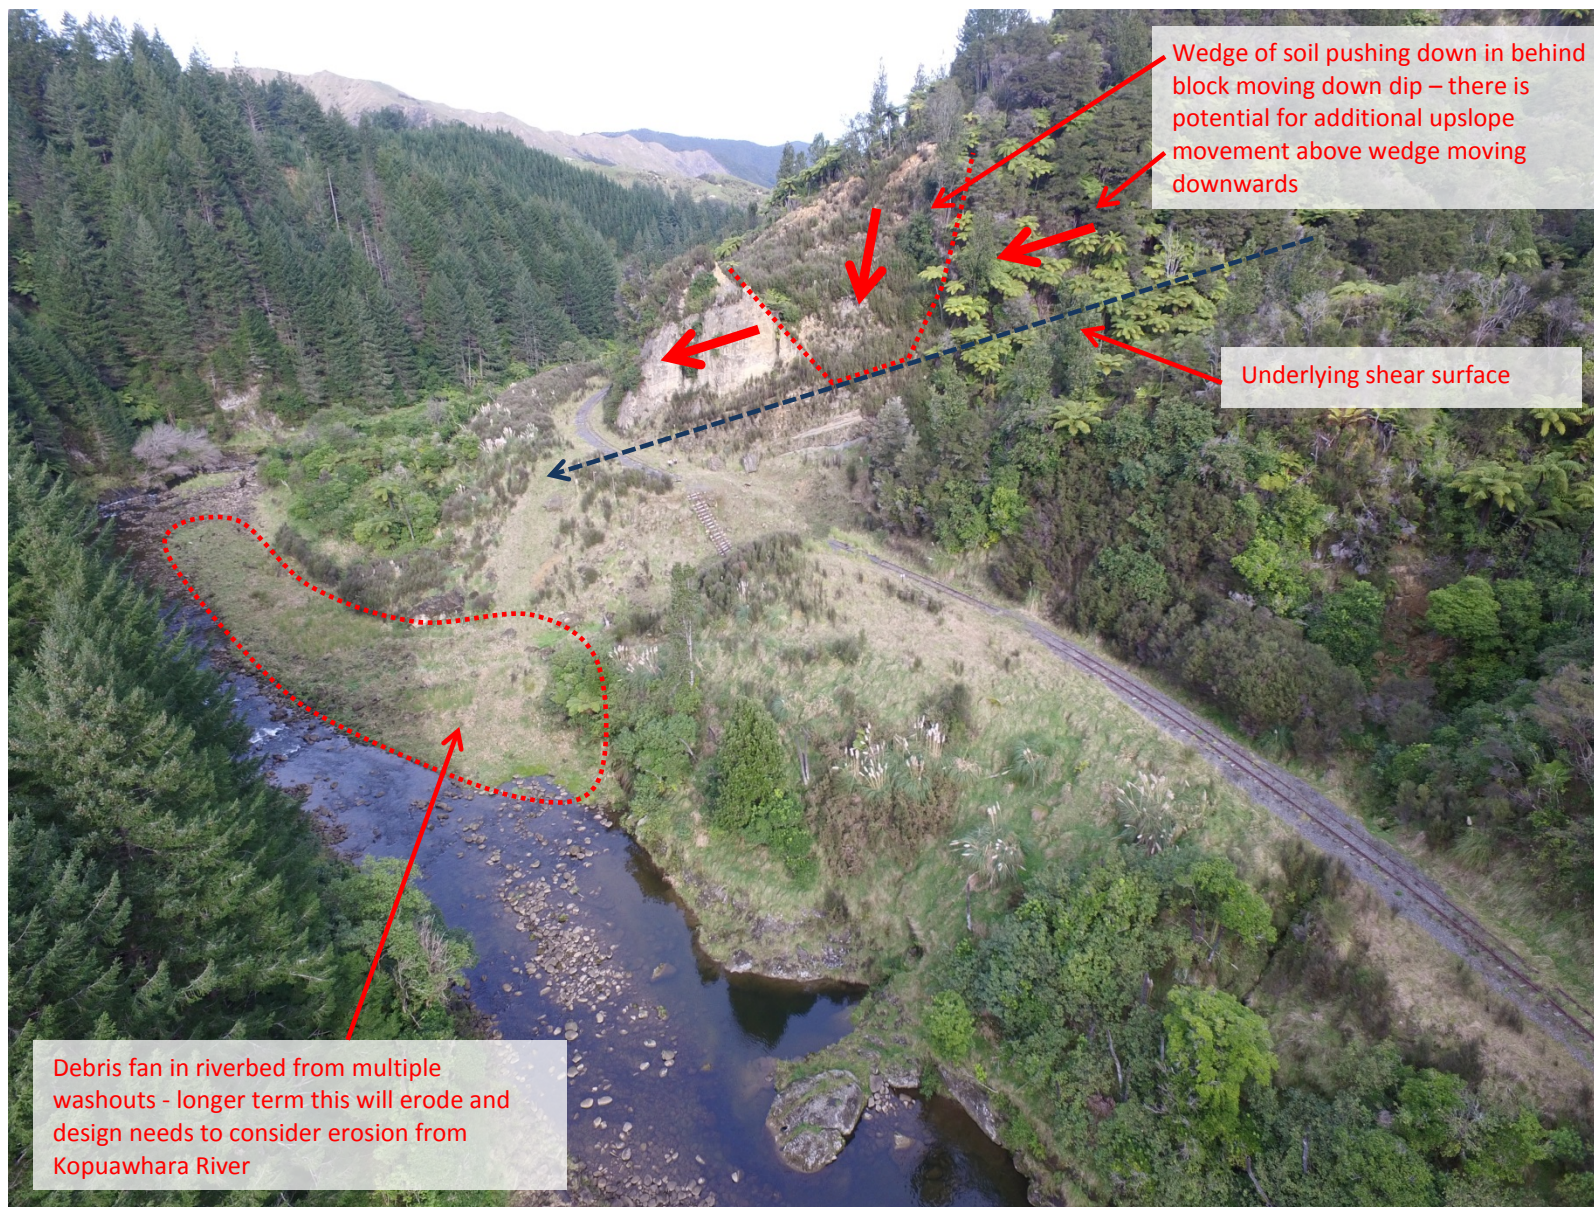
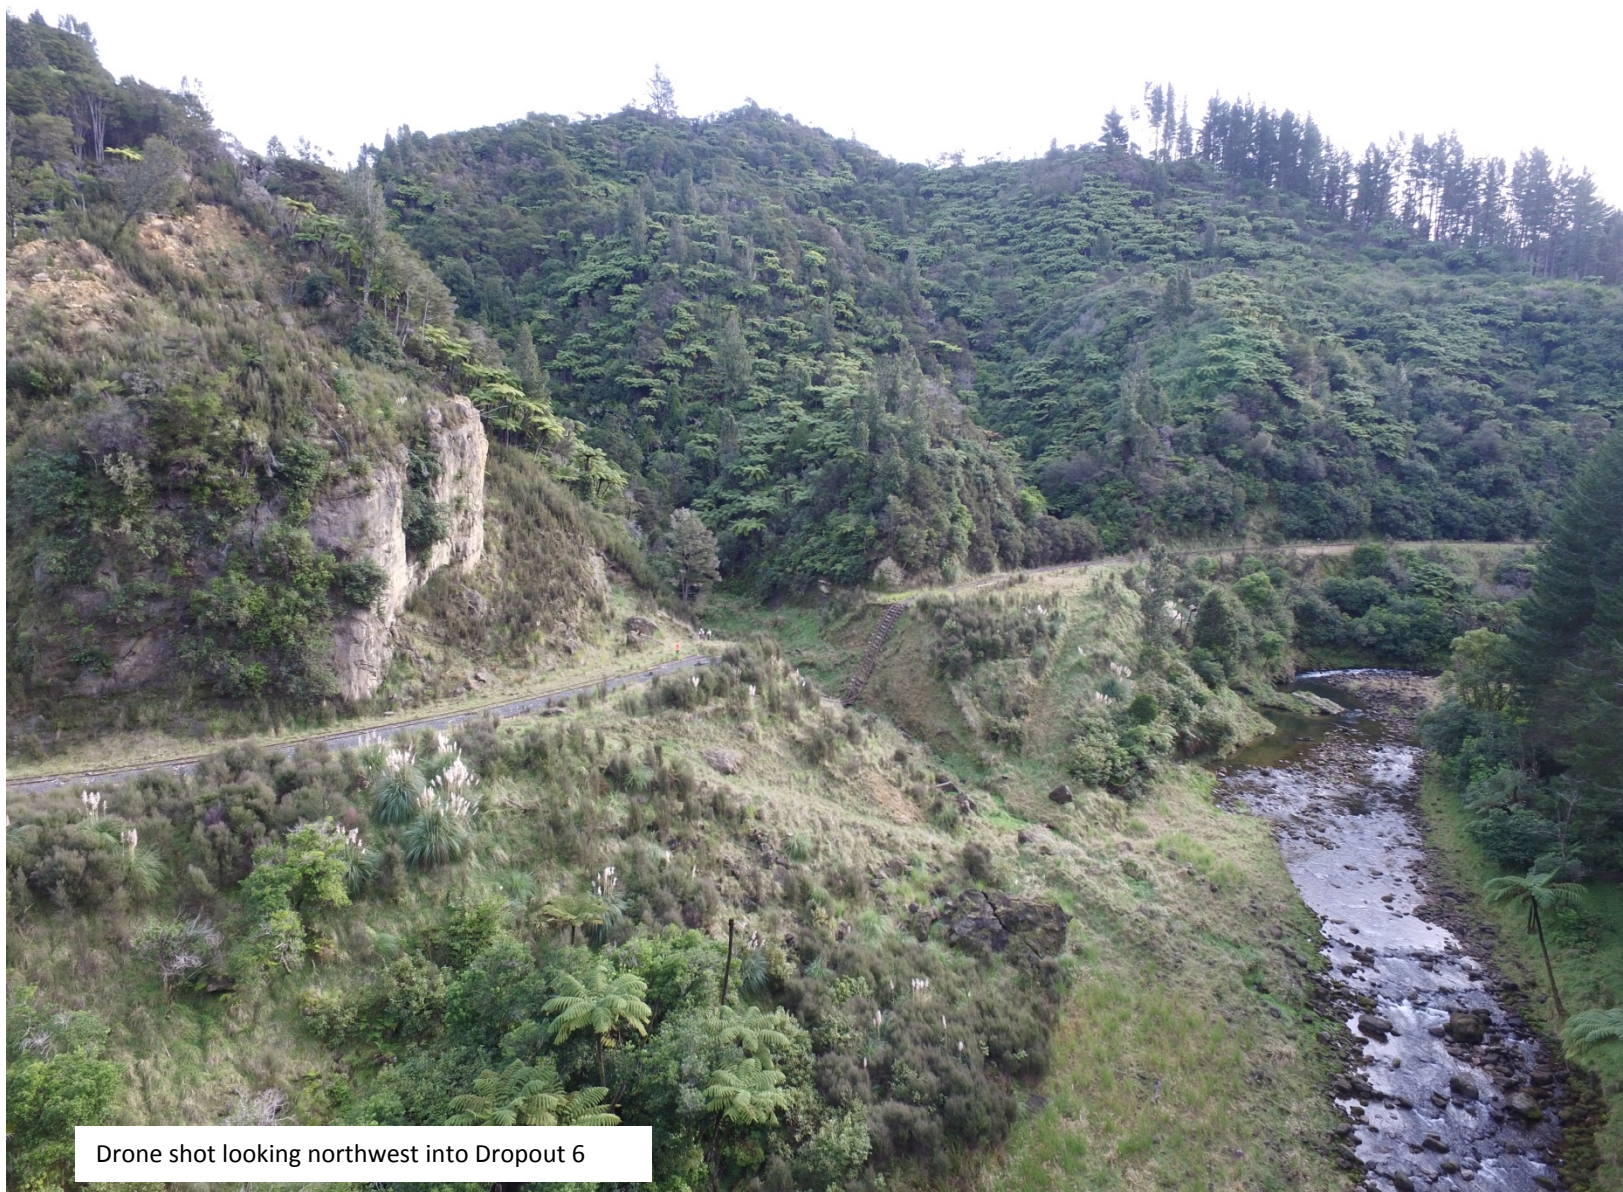
<b>Repair Task:</b>	<b>Task 23 – Dropout 6</b>
<b>Track Location:</b>	Rail Chainage 347.73m
<b>Description:</b>	Drop out six nominal upstream catchment area of some 0.3km <sup>2</sup> , washout dimensions nominal 30m wide by 40m long by 10 – 12 metres deep.
<b>Required Works</b>	Requires formation repair, track drainage upgrade, possible minor track slew around bluff to south
<b>Scale/ Scope/Volumes:</b>	<p>Note this work is additional track damage post March 2012 event – failed sometime in 2014 / 2016 ( date unknown)</p> <p>Repair overtopping washout under track and reinstate formation with steep reinforced MSE slope on downstream edge, local cohesive fill on upslope side. Use either imported Nuhaka Quarry fill or GAP 80/ 100 from Maraetaha Station stockpile for MSE block.</p> <p>Cleanout existing culvert to act as low level bypass and install new higher level culvert as emergency bypass. ( note existing culvert is not on KR culvert list)</p> <p>Assess swale drainage and upgrade water movement on either side of washout - likely blocked culverts, may require additional culverts or upgrading.</p>

Drone shot looking northwest into Dropout 6

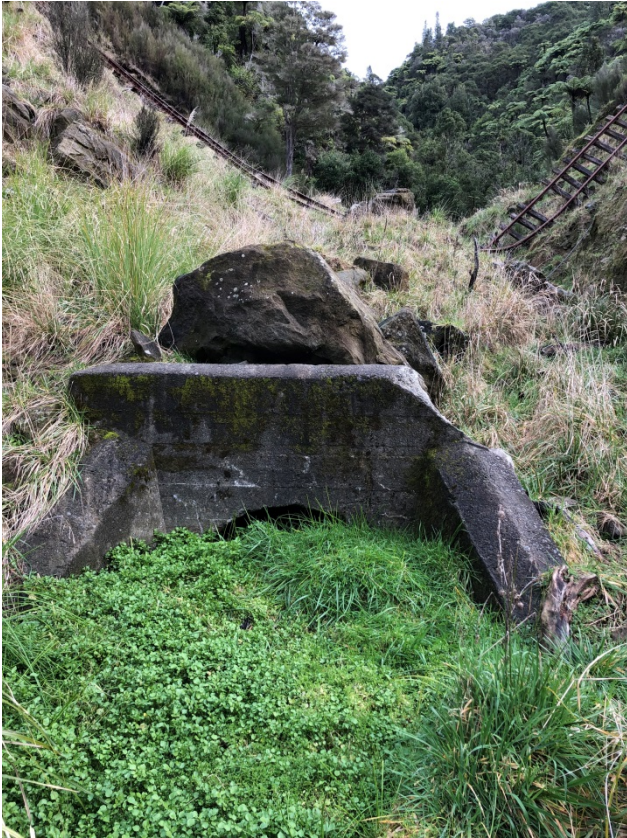
Existing culvert under washout – note details not on KR culvert log (Dimensions TBC)
